Kielty Arborist Services

October 15, 2019, revised June 28, 2021

Site: 851 Sierra Vista, Mountain View, CA

TREE PRESERVATION PLAN

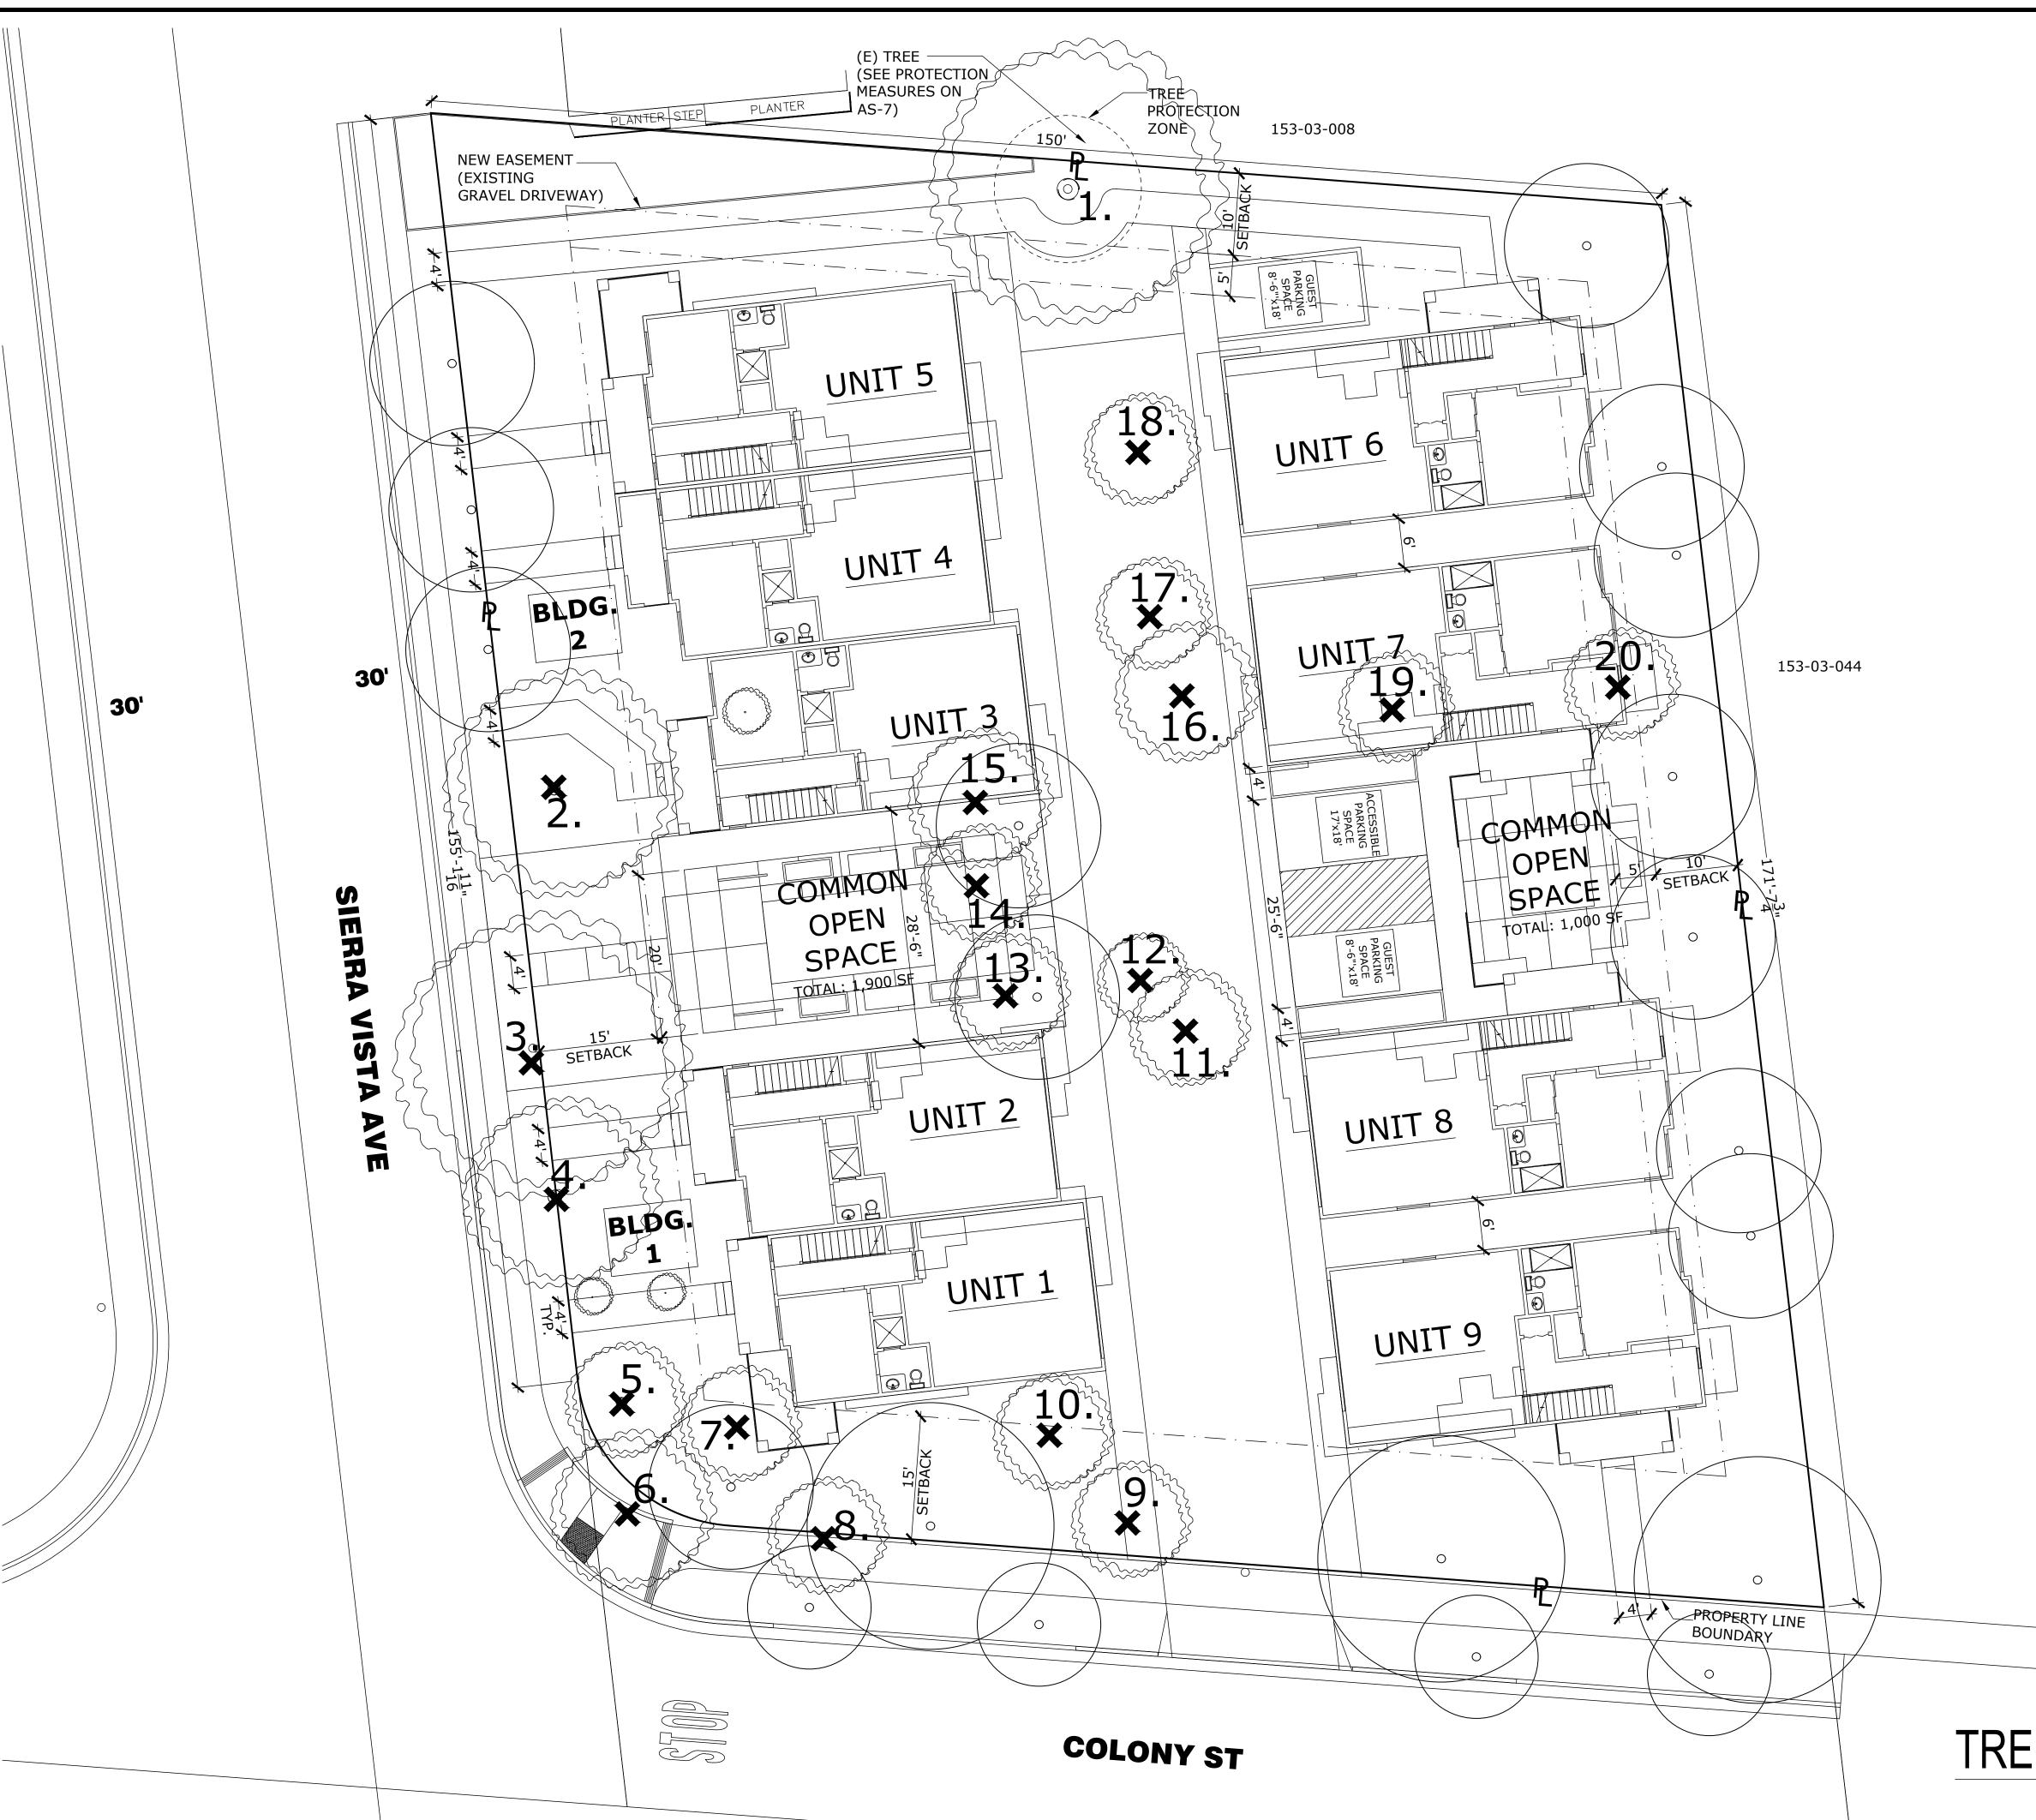
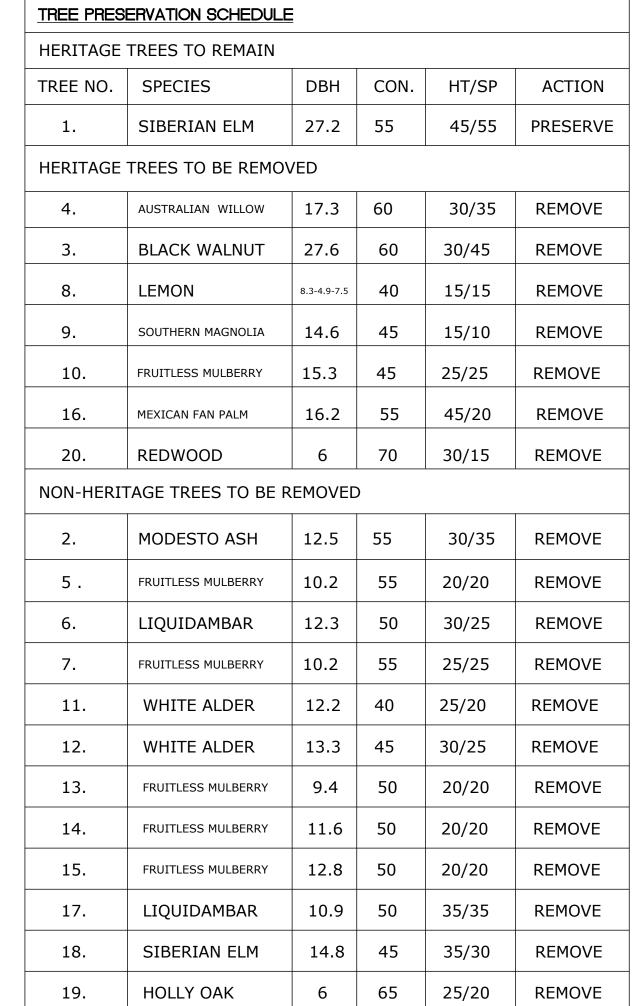
- REFER TO LANDSCAPE SHEET (L-1.0) FOR PLANTING PLAN CONTRACTOR TO MEET WITH THE PROJECT ARBORIST FOR MONTHLY INSPECTIONS
- TREE PROTECTION ZONE SHALL BE USED FOR (4) EXISTING TREES. FOR DETAILS ON TREE PROTECTION ZONE, SEE ARBORIST REPORT

TREE PROTECTION ZONES SHOULD BE ESTABLISHED AND MAINTAINED THROUGHOUT THE ENTIRE LENGTH OF THE PROJECT. FENCING FOR THE PROTECTION ZONES SHOULD BE 6 FOOT METAL CHAIN LINK FENCING SUPPORTED BY METAL POLES OR STAKES POUNDED INTO THE GROUND. THE SUPPORT POLES SHOULD BE SPACED NO LESS THAN 10 FEET APART ON CENTER. THE LOCATION FOR THE PROTECTION FENCING SHOULD BE AS CLOSE TO THE DRIPLINE AS POSSIBLE STILL ALLOWING ROOM FOR CONSTRUCTION TO SAFELY CONTINUE. SIGNS SHOULD BE PLACED ON FENCING SIGNIFYING "TREE PROTECTION ZONE - KEEP OUT". NO MATERIALS OR EQUIPMENT SHOULD BE STORED OR CLEANED INSIDE THE TREE PROTECTION ZONES. THE PROJECT ARBORIST WILL INSPECT THE SITE PRIOR TO THE START OF DEMOLITION AND AGAIN BEFORE THE START OF CONSTRUCTION.
