Preliminary Arborist Report

**555 Middlefield Road
Mountain View, CA**

October 14, 2016

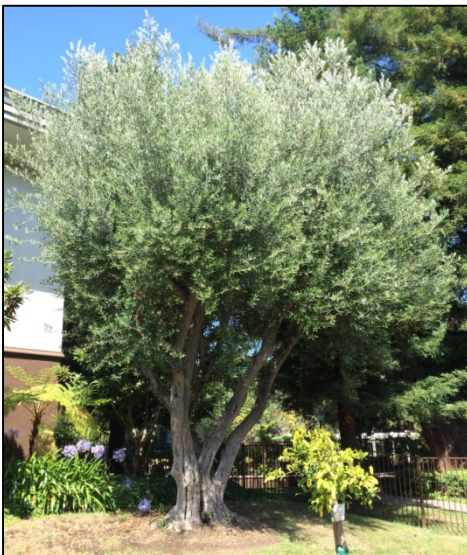
Photo 1 (far left): Olive #318 had been previously topped at 15', but had a full, dense crown and was in good condition.

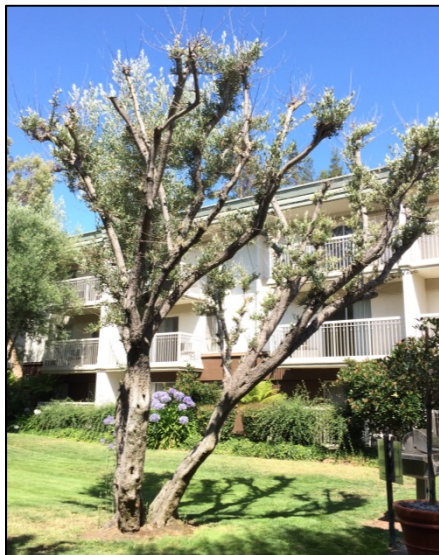
Photo 2 (left): Tree #319 was in poor condition with very little live foliage.

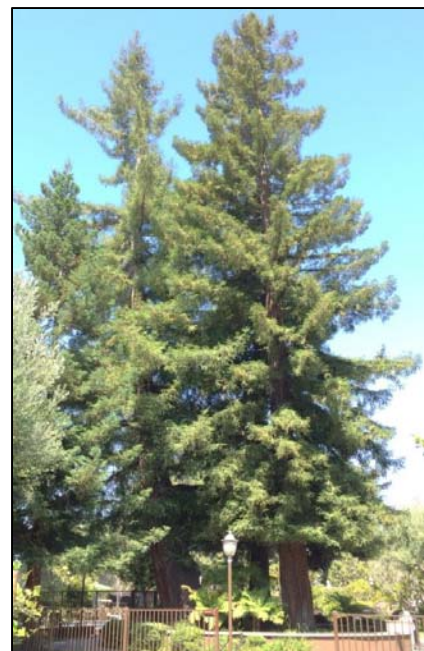
Photo 3: A group of three coast redwoods (#178-180) was located in a planter near the center of the site. Tree # 179 (left) was in fair condition with corrected trunk lean and thin crown, while trees #178 and 180 were in good condition with dense crowns.

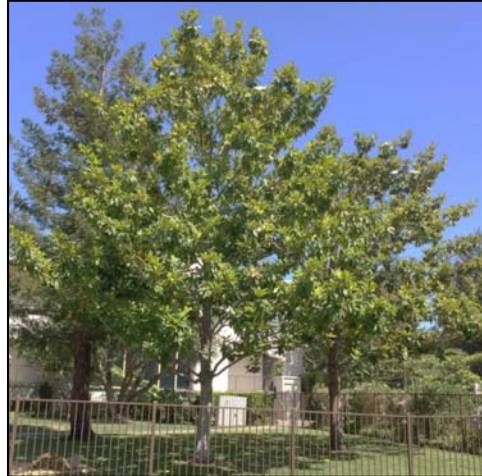
Photo 4: Southern magnolia #174 was in good condition with good form and structure.
