FOUNDATION INSPECTION PROPOSAL

Property: 1577 Latham Street Mountain View, CA. 94041

Subject: Foundation Inspection

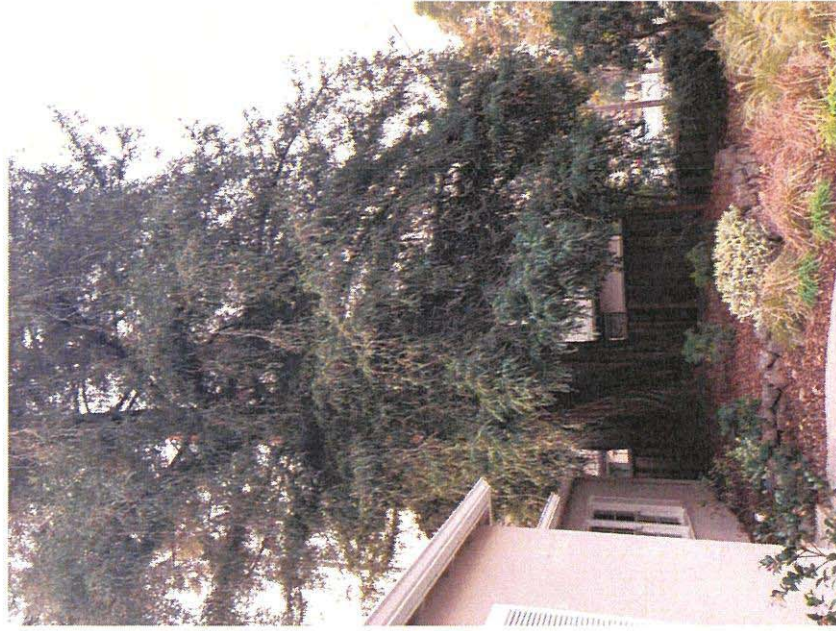
There were 9 vertical foundation cracks. Eight of them range from 1/16th of an inch to an 1/8th of an inch and 1 crack is about 1 inch to 1¼ inch wide found at the front of the house near the front right corner. This crack appears to be part of the damage from the tree roots from the redwood tree outside. The rest of the cracks are due to the typical ground movement in the area.

Although the front section of the house foundation appears to be lifted by the roots of the exterior redwood tree, we measured the levelness of the interior floor and it appears to be about one inch higher than the rest.

Figure 1. View across the front yard, from the Driveway

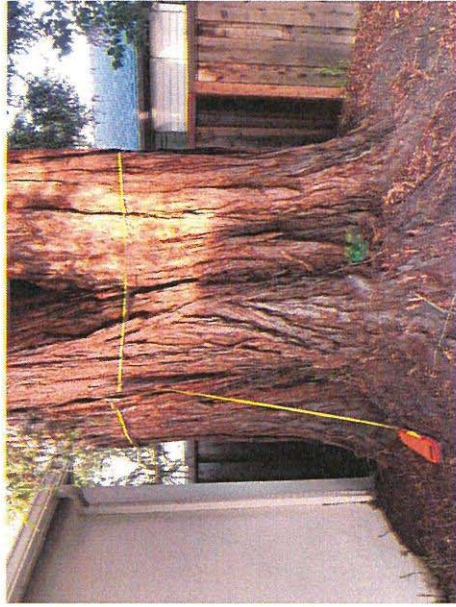
Figure 2. Tree trunk is within 2 feet of the exterior wall.

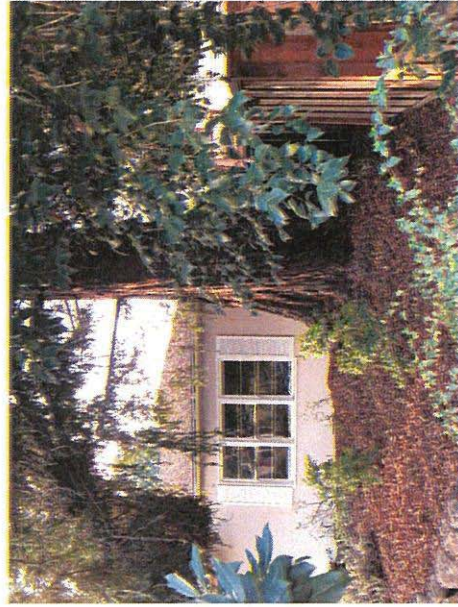
Figure 3. View from the street, along the property line.
