Kleinheinz Arborist Services LLC

March 18, 2022

Site Address: 1553 Meadow Ln., Mountain View, CA 94040

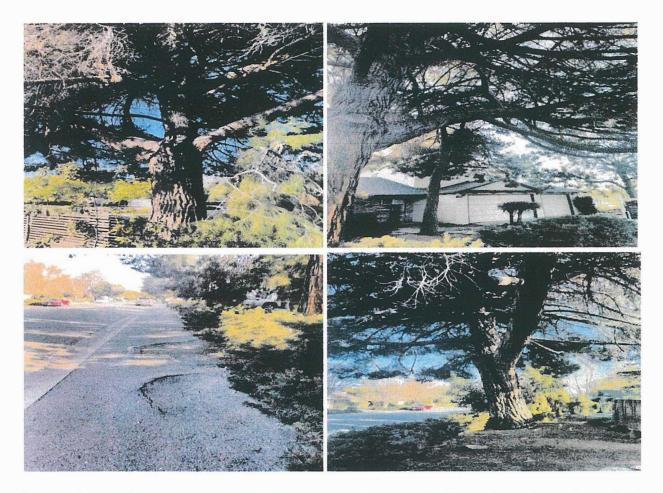
<u>Tree#</u>	Species	<u>DBH</u>	HT/SP (ft.)	COND	Notes
1	Italian Stone Pine (Pinus pinea)	39"	35'/100'	55	remove/poor form/lean over street

This tree is an Italian Stone Pine (**Pinus pinea**), located in the front of the property along the street. This tree stands approximately 35 feet in height and has a DBH of approximately 39 inches. This tree has a lean towards the street and a very poor form throughout the canopy of the tree. At about 12 feet up, there is a large lateral area that appears to be around 30 inches in diameter that extends out over the house and driveway. On the opposite side of the tree, there are multiple laterals that extend out towards the neighbors house over the yard; these laterals are around 15 to 20 inches in diameter. The canopy of this tree almost extends to the other side of the street and is full of dead and dying branches.

There appears to be significant damage to the walkway between the base of the tree and the street. This damage appears to be caused from the roots of the tree.if area was to be repaired this would consist of damaging up to around 30% of root zone.

Suggestions: This tree has significantly overgrown its area. I feel it is a hazard to not only the houses, but any vehicles and pedestrians within the area of the canopy. I feel this tree should be removed immediately and a new tree planted in a more suitable location on property no where tree could over hang public right away s or homes.

<u>Note:</u> There are two smaller pine trees located below the canopy of this tree that have very poor form and heavy leans that I feel should be removed at the same time.
