December 3rd, 2018

Arborist Report

Andy Martin
1187 High School Street
Mountain View CA 94041
650-575-6076

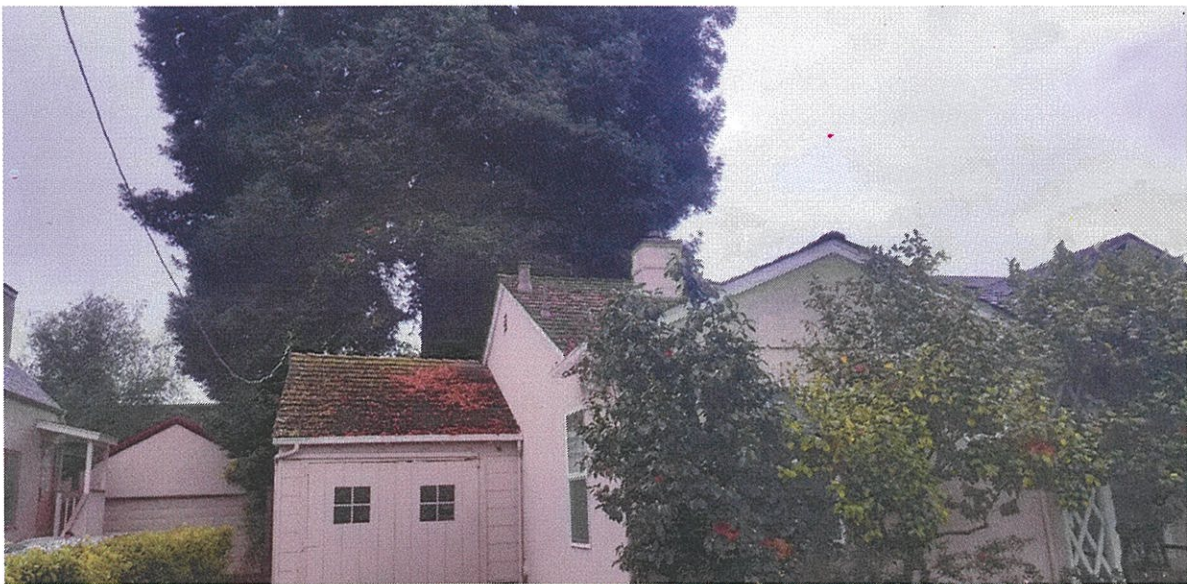
Overview: The Coast Redwood Tree is a mature tree 105' feet tall, 35' canopy spread and measured for diameter 6' feet 3" inches above ground level DBH or (diameter breast height); this tree at visual inspection it's on a good condition with vigor and foliage. During the inspection at the root collar at the main trunk this tree is causing a potential damages to the garage of the home owner property by pushing the walls, lifting and cracking the concrete making this tree a potential hazard.

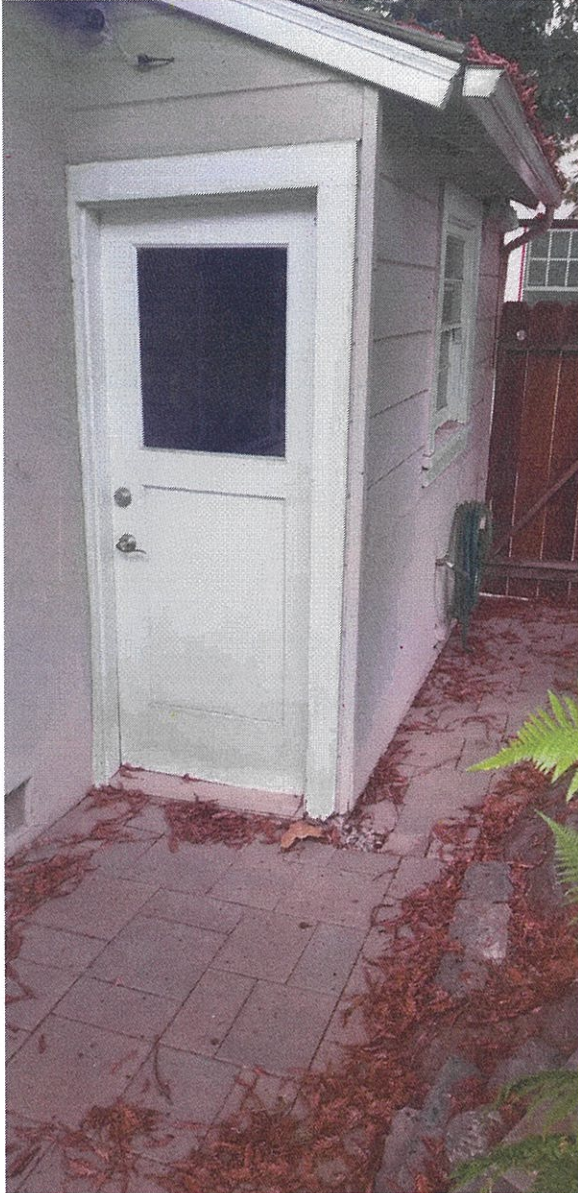
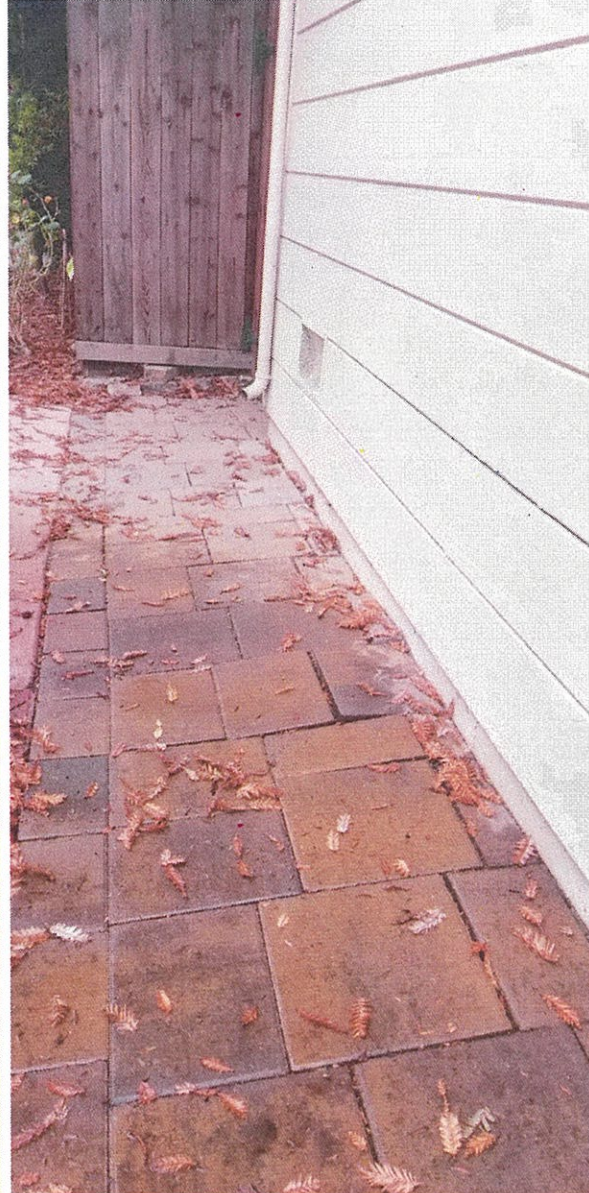
Site Observations: The Coast Redwood Tree is growing in clay soil conditions. Irrigation system is nearby and working normal. This tree is growing very close to the house approximate 20" inches away from the garage. Continuing with the inspection of the damages been cause by the root system, I also found that the roots system is already under and on the side of the garage where the concrete foundation it's already getting damaged making the floor to crack and the walls as well that is going to cause to the home owner a very high expenses on repairs due of the size and the proximity of the root system of this tree.

Outside Of the garage

- Remove the tree and stump to prevent any more future damages to the property
- After the removal; plant a new 48" inch box tree far away from the house to comply with the City of Mountain View conditions and regulations
- Trees to replant: Coast Live Oak, Valley Oak or Deodar Cedar Trees
- Hire a professional tree trimming company that employs a Certified Arborist and Contractor Licensed

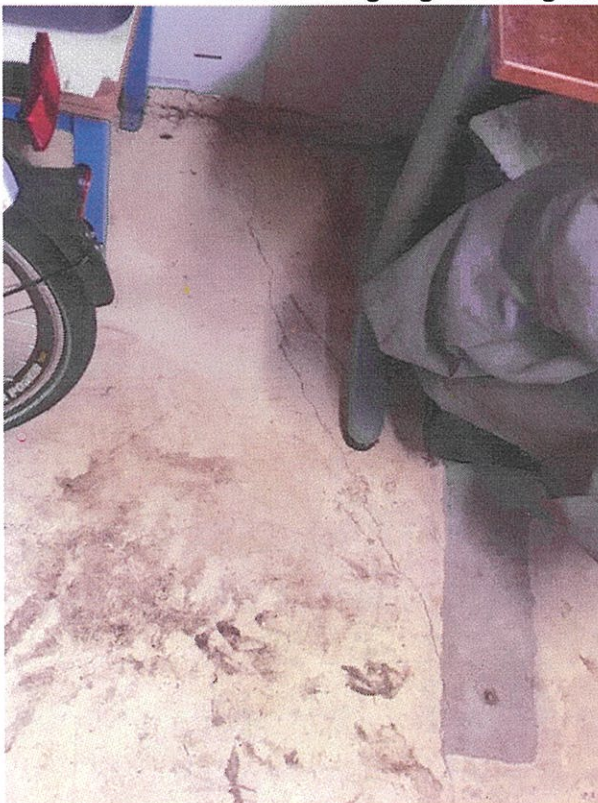
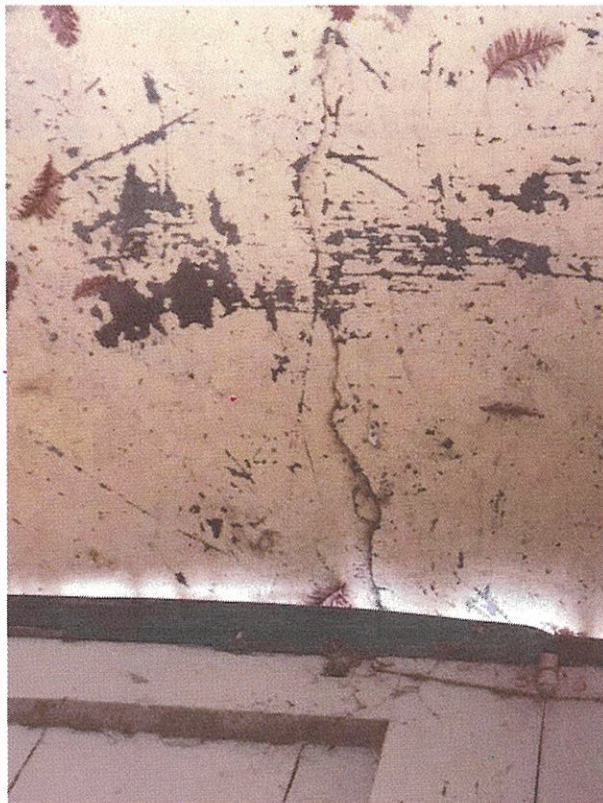
The Coast Redwood Tree it was planted many years back at the wrong spot where now is causing several damages to the property. With this tree we cannot due any root pruning due of the size and their age to install a root barrier; that type of technique will only make more hazardous the tree because by cutting that size of roots it will cause several damages to the root system because roots support the tree and absorb water.
