## Kielty Arborist Services

April 13<sup>th</sup>, 2021  
773 Cuesta LLC  
C/O DeNardi Wang Homes  
Attn: Mr. Kevin DeNardi  
4962 El Camino Real, Suite 223  
Los Altos, CA 94022

Site: 773 Cuesta, Mountain View, CA

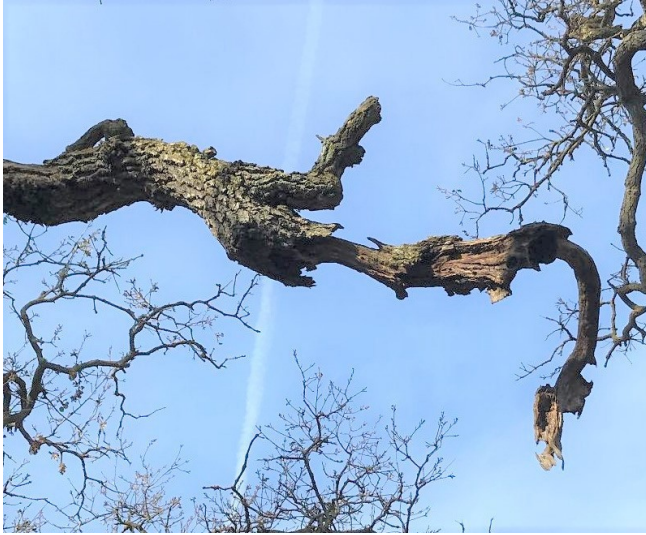
**Showing dead wood in canopy**

**Valley oak tree #31 proposed for removal:** Valley oak tree #31 is poorly located in the center of the lot. The vigor of the tree is declining. A history of limb failures was observed on nearly every limb of the tree. Sprout growth was visible along the large lateral limbs and on the trunk. This type of sprout growth is a sign of tree decline. Oak root fungus scars were visible at the base of the tree. Areas of missing bark were also observed. To determine the tree's suitability for preservation within the landscape, it was recommended to expose the tree's root crown and to drill test the tree for internal decay. This would give a better understanding on the tree's current state of health due to the oak root fungus scars observed.

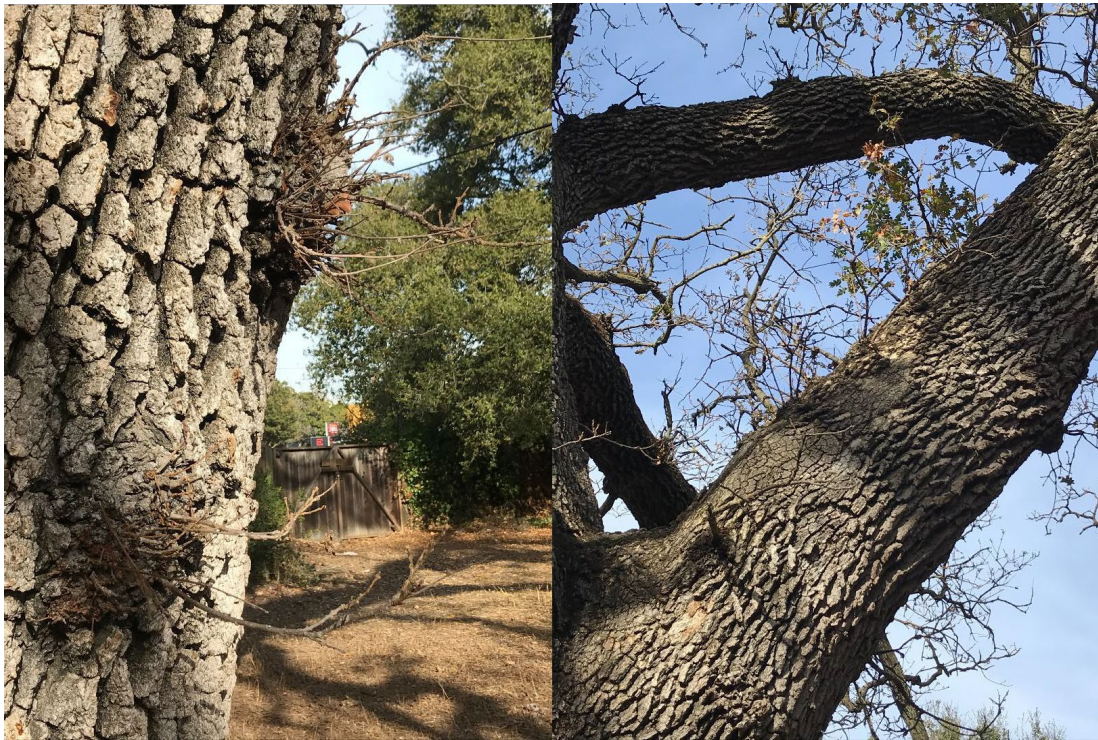
**Showing sprout growth on trunk (left) and along limbs (right)**

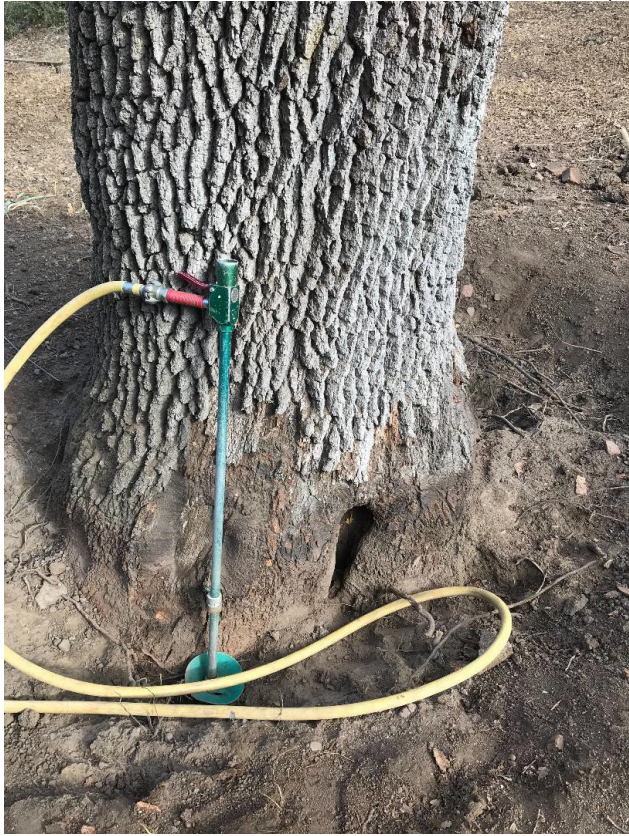
On Tuesday December 15<sup>th</sup>, 2020 Valley oak tree #31 had its root crown exposed. An air spade in combination with hand tools was used to carefully excavate around the root crown of the tree. About 8" of detritus was removed around the root crown of the tree. Below the detritus the soil was very compacted with remnants of old hardscape material encountered (bricks and concrete). The soil at the root crown was compacted enough that the air spade did little to help remove the soil. A well-defined root flare was never found. Decay pockets were encountered on the south and east side of the tree. No decayed areas were visible on the north or west side of the root crown. An average of 18 inches of soil was removed around the root crown and the efforts were concentrated on the south east side of the tree where there were visual decay pockets.

**Showing air spade used, picture showing south side of root crown**

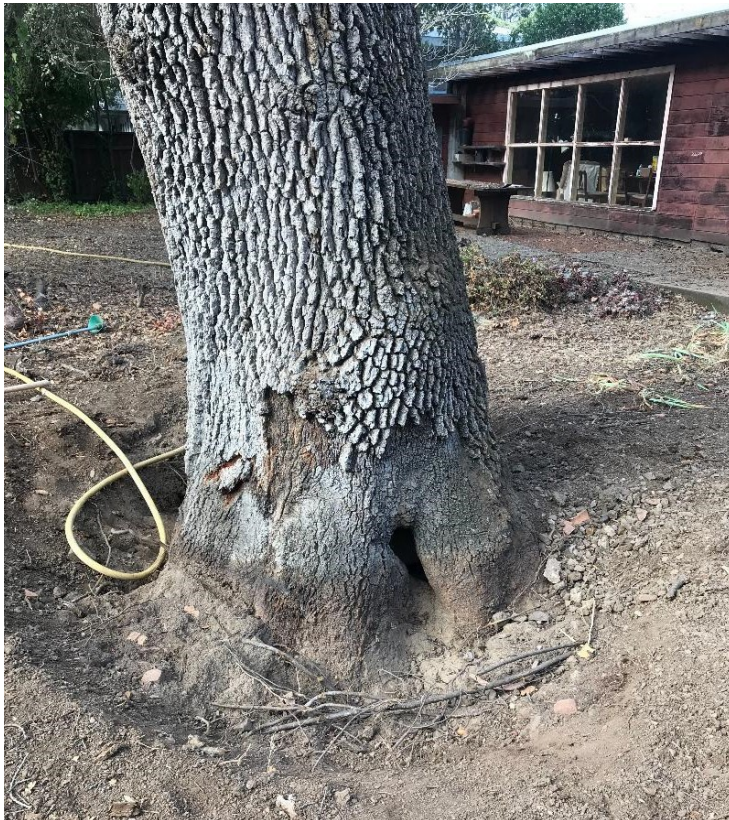
**Showing east side of tree**

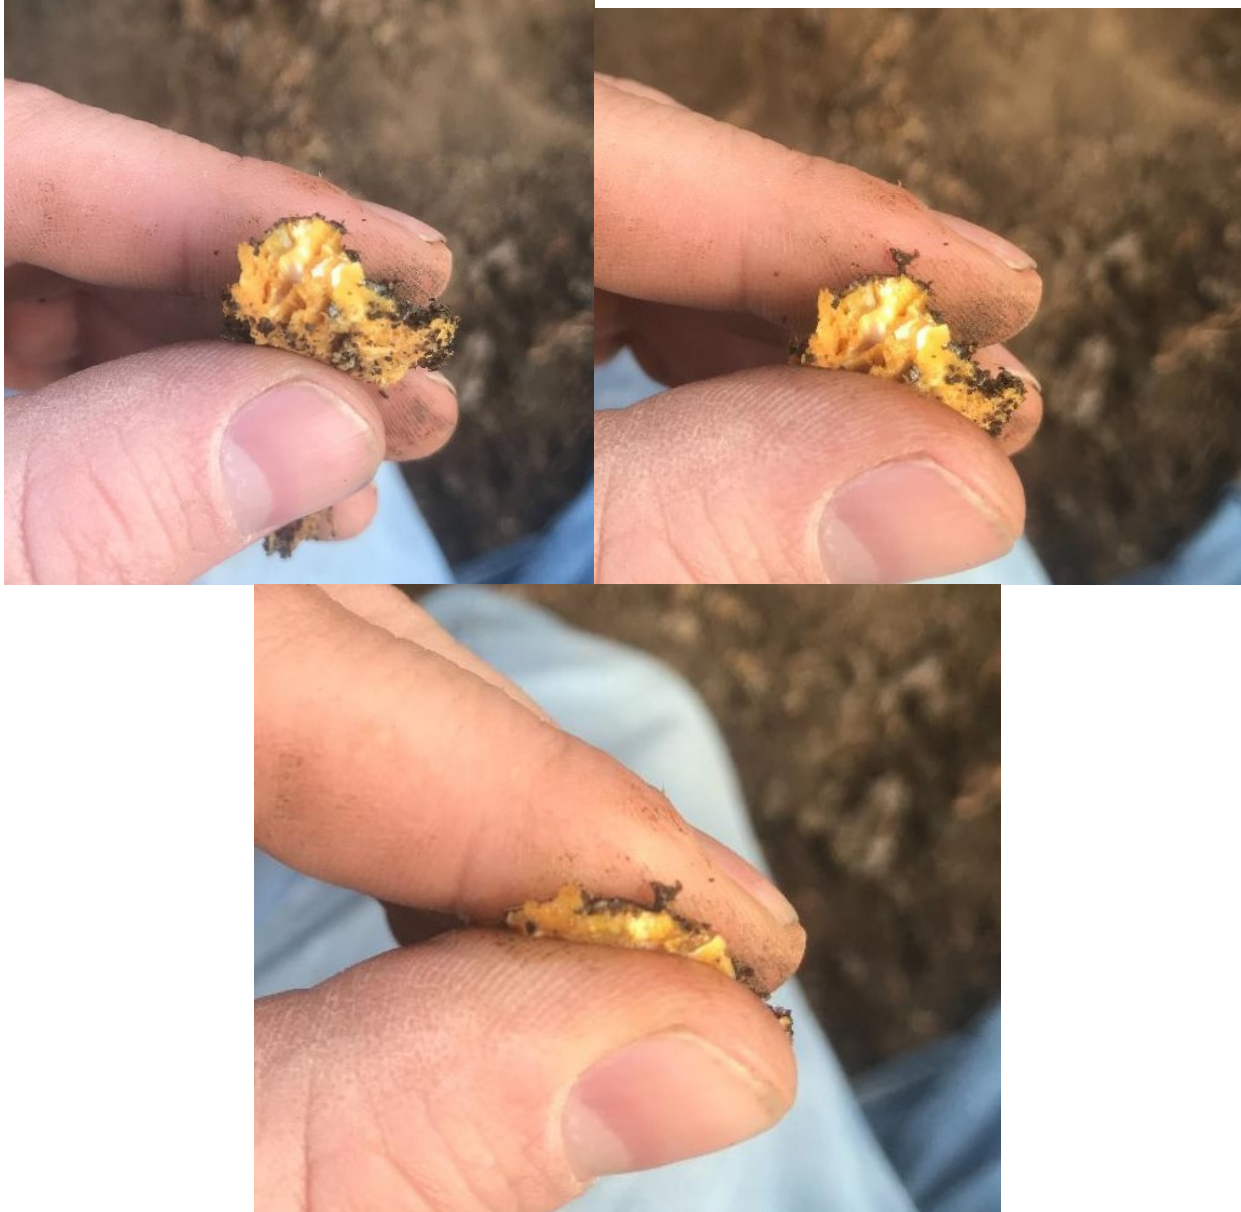
Once excavating around the root crown was completed, I was able to reach the inside of the tree through the decay pockets using my hands. Using my hands, I was able to reach at least a foot into the trunk of the tree where I encountered rotting wood. The wood was wet to the touch and easily removed. The feel of the wood was spongy. Within the inner wood removed by hand, mycelium was observed between the wood fibers. All these findings have resulted in the conclusion that the tree is infected with *Armillaria*, an oak root fungus disease.

**Pictures showing same piece of wood pulled from the inside of the tree. Notice white mycelium in wood. Also notice the spongy like texture when compressing the wood**

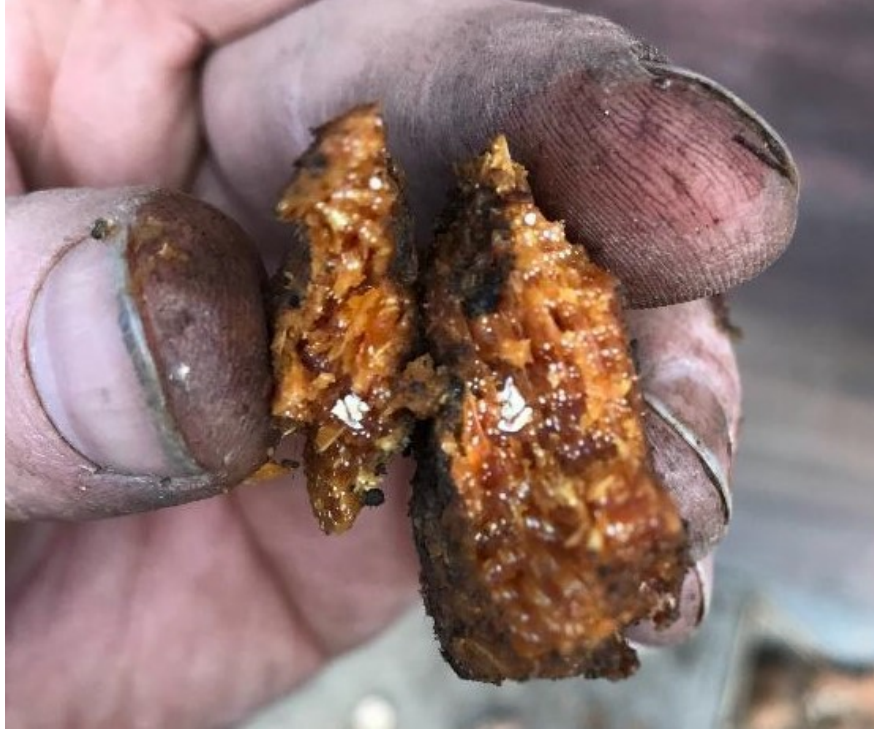
**Showing mycelium growth between wood fibers**

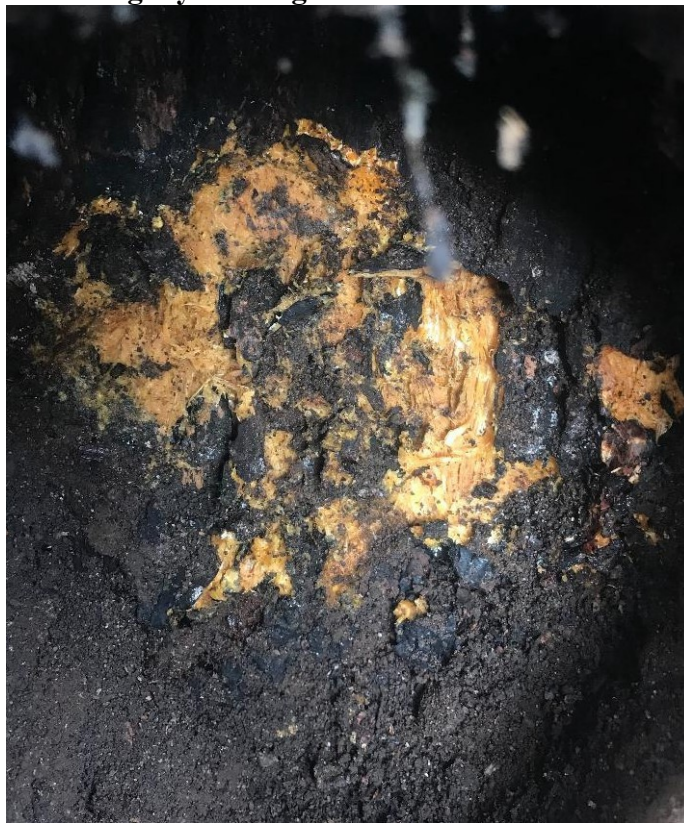
**Showing sponge like wood inside of tree**

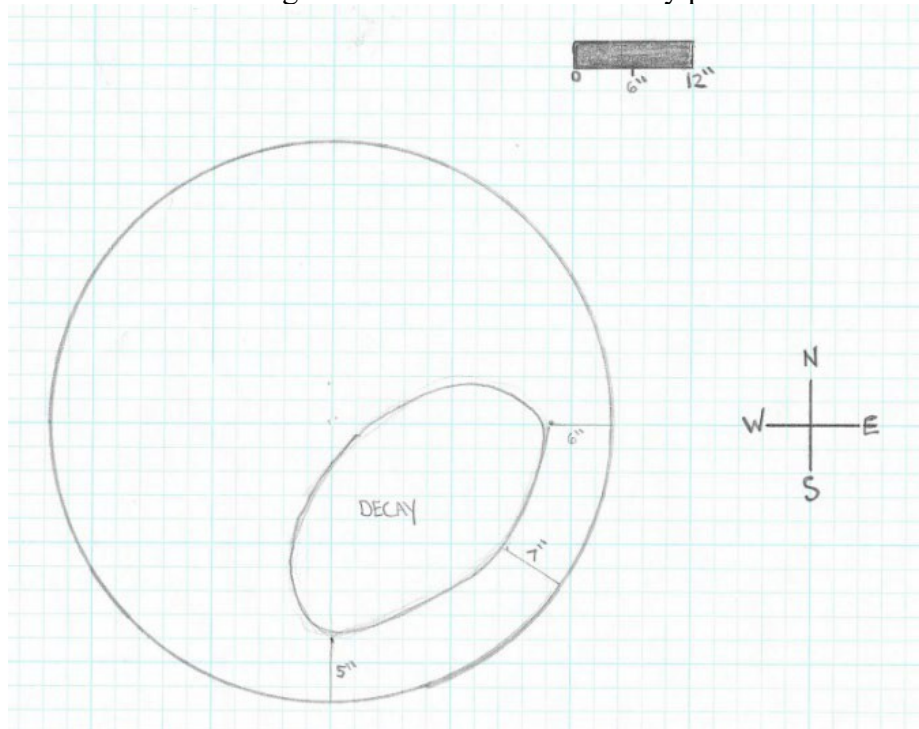
On the same day, a drill test using an IML-RESI MD300 and a cordless drill was conducted to get a better understanding on the extent of decay encountered within the tree trunk. No decay was found on the north or west side of the tree. The only areas where decay was encountered were on the south east side of the tree. The drilled areas were at the base of the tree 8 inches above the observed decay pockets where the diameter was measured at 56 inches in diameter. On the south side of the tree, decay was encountered at 5 inches. On the east side of the tree decay was encountered at 6 inches. On the south east side of the tree, between the 2 decay pockets, decay was encountered at 7 inches. The results show that the *Armillaria* root fungus is

prevalent within the lower trunk/ root crown of the tree and has decayed the inner wood of the tree on one side. An estimated one third of the tree's heartwood has been lost at the base of the tree. The decay is not centralized as it appears that the disease has impacted the south east side of the tree's root crown. Below is a diagram showing a visual estimation of the encountered decay within the tree's trunk near grade 8 inches above the decay pockets.

**Diagram showing the decay encountered at the base of the tree**

The oak root fungus disease (*Armillaria*) has impacted the trees structural stability within the landscape. This tree in its current state is not expected to survive more than 5 years and would be shortened by the proposed development impacts. *Armillaria* root rot is one of the leading causes of oak tree failures within the landscape. Because the decay is not centralized at the base of the tree, risk of failure is increased. *Armillaria* is a white rot decay fungus that destroys the strength of wood in roots and at the base of infected tree trunks, thereby increasing the likelihood of tree failure. There is no registered fungicides for *Armillaria* control in California. The University of California's Statewide Integrated Pest Management Program states that prevention, and cultural control is the only way to slow the disease progression. This should have been done a long time ago. Exposing the tree's root crown, reducing soil compaction through soil fracturing and keeping the area at the base of the tree dry would have helped to slow or stop the disease progression. The disease is well progressed within the tree and mitigation measures are not expected to improve the tree's structural stability. Tree removal is the only option to eliminate risk of tree failure. Tree failure risk are high due to the root rot disease. Below are the two criteria (from city ordinance) met to support the tree's removal.

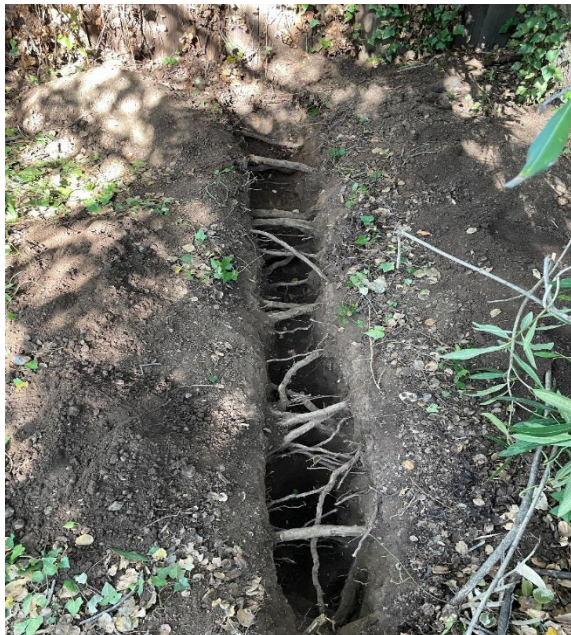
An exploratory trench was conducted at the proposed foundation and patio work near oak trees #1 and #2 as requested by the City Arborist. The trench was conducted with the use of hand tools and air spade. The trench was 12 feet long with the 2 trees on center. The depth of the trench was 2-3 feet deep on average and show cased the entire root zone to be impacted by a foundation or patio work. The proposed foundation was located at 6.5' from the oak tree #1 and the patio at 6.5 feet from oak tree #2. The exploratory trench discovered many roots at this location, some measuring as much as 3" in diameter. The majority of the roots found were within the top foot of soil. At this distance root cutting would have a moderate to high impact on the trees. A secondary trench was then conducted parallel to the trench at 6.5 feet from the trees but at a distance of 9.4' from the trees (an extra 3 feet away from the trees). At this distance far less roots were encountered, and the size of the roots encountered were all under 2" in

**Showing trench at 6.5' from trees**

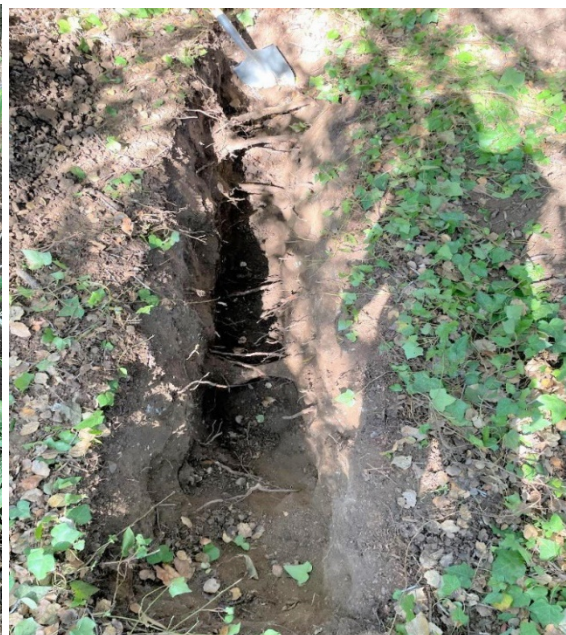
diameter. I then recommended that the foundation and patio work be at least 9.4' from trees #1 and #2 and plans were changed to reflect this recommendation. Only 4 roots measuring larger than 1" in diameter were encountered in the trench at 9.4' from the trees. Root sizes encountered are: 1.5", 1.2", 1.3" and 1.7" in diameter.

**Showing trench at 9.4' from trees**

The entire foundation and patio excavation when within 20 feet from oak trees #1 and #2 is recommended to be excavated by hand with the Project Arborist on site to supervise. All encountered roots must be cleanly cut using a hand saw or loppers. Once the foundation cut is complete, 3 layers of wetted down burlap are recommended to be placed over the cut on the tree side of the oak trees to help keep roots moist. Burlap moisture shall be maintained. Both oak trees are recommended to be deep water fertilized in May of 2021 using 200 gallons of clean water mixed with a well balanced fertilizer. A soaker hose is recommended to be placed along the foundation and patio cut once the materials have been allowed to dry and cure. The soaker hose is recommended to

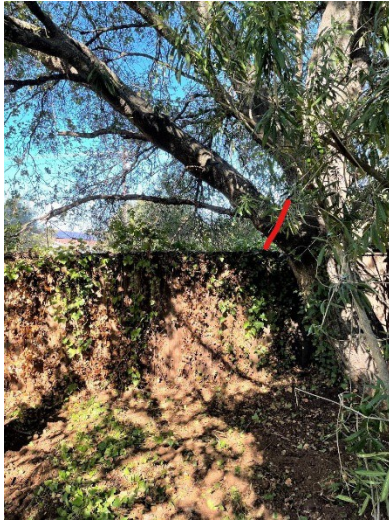
### **Showing limb to be removed**

be turned on every 2 weeks until the top foot of soil is saturated. The soaker hose shall be removed one year following the cut. Oak tree #1 will need to be pruned for building clearance. All pruning shall be done by a Certified Arborist. The lowest limb oak tree #1 was measured at 14". This limb needs to be removed for building clearance. The pruning will have no impact on the tree's health and will be an estimated 10-15% canopy loss. Any hardscapes proposed closer than 9.4' from oak trees #1 and #2 will need to be built up entirely on top of grade to reduce overall impacts. These trees will need continual monitoring throughout the entire length of the proposed construction. Impacts are expected to be minor. The following tree protection plan will help to reduce impacts to any retained trees.

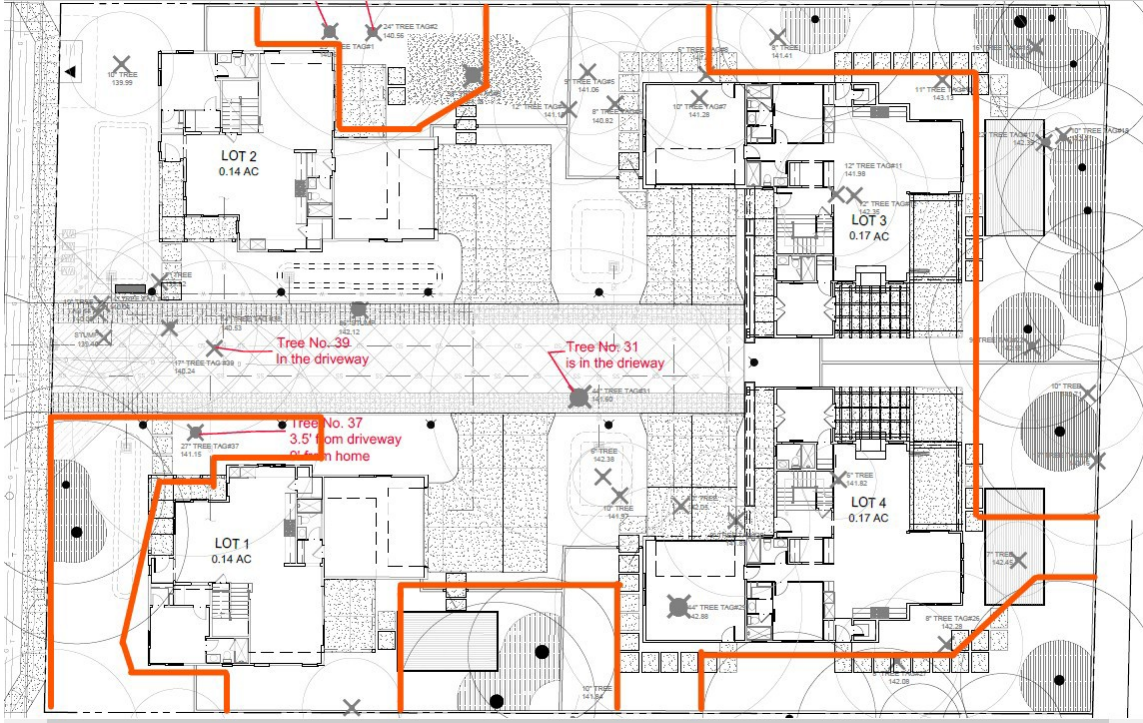
**Showing tree protection for home construction**

Tree protection zones should be established and maintained throughout the entire length of the project. Fencing for the protection zones should be 6-foot metal chain link fencing supported by metal poles or stakes pounded into the ground. The support poles should be spaced no more than 10 feet apart on center. The location for the protection fencing should be as close to the dripline as possible still allowing room for construction to safely continue. Signs should be placed on fencing signifying "Tree Protection Zone - Keep Out". No materials or equipment should be stored or cleaned inside the tree protection zones. For this site, tree protection fencing will need to be broken down into 2 phases. During construction of the homes and driveway tree protection fencing will need to be placed at the tree driplines where possible. Where driplines and proposed work overlap each other, fencing shall be placed as close as possible to the proposed work. All of the landscaping work including hardscapes are recommended to take place at the end of the project. During this phase of the project fencing will need to be modified for the work to take place.

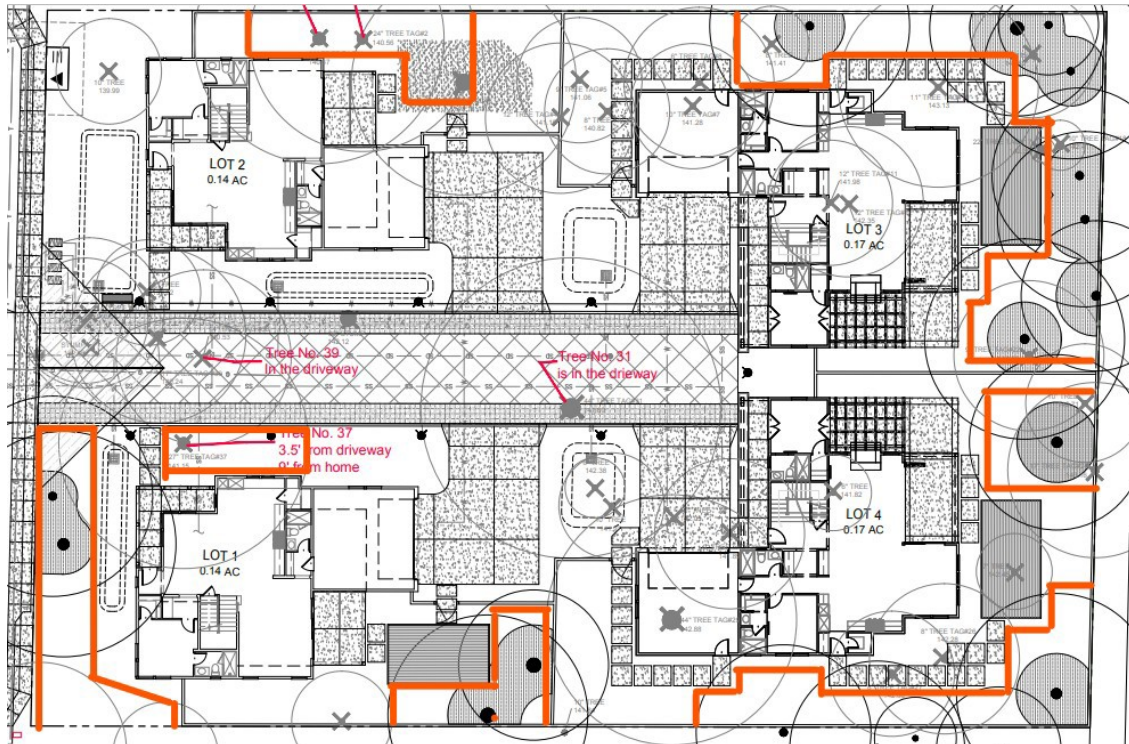
**Showing tree protection fencing for landscape construction**
