**MEMORANDUM**

**SUBJECT:** Heritage Tree Appeal – 1430 Mercy Street

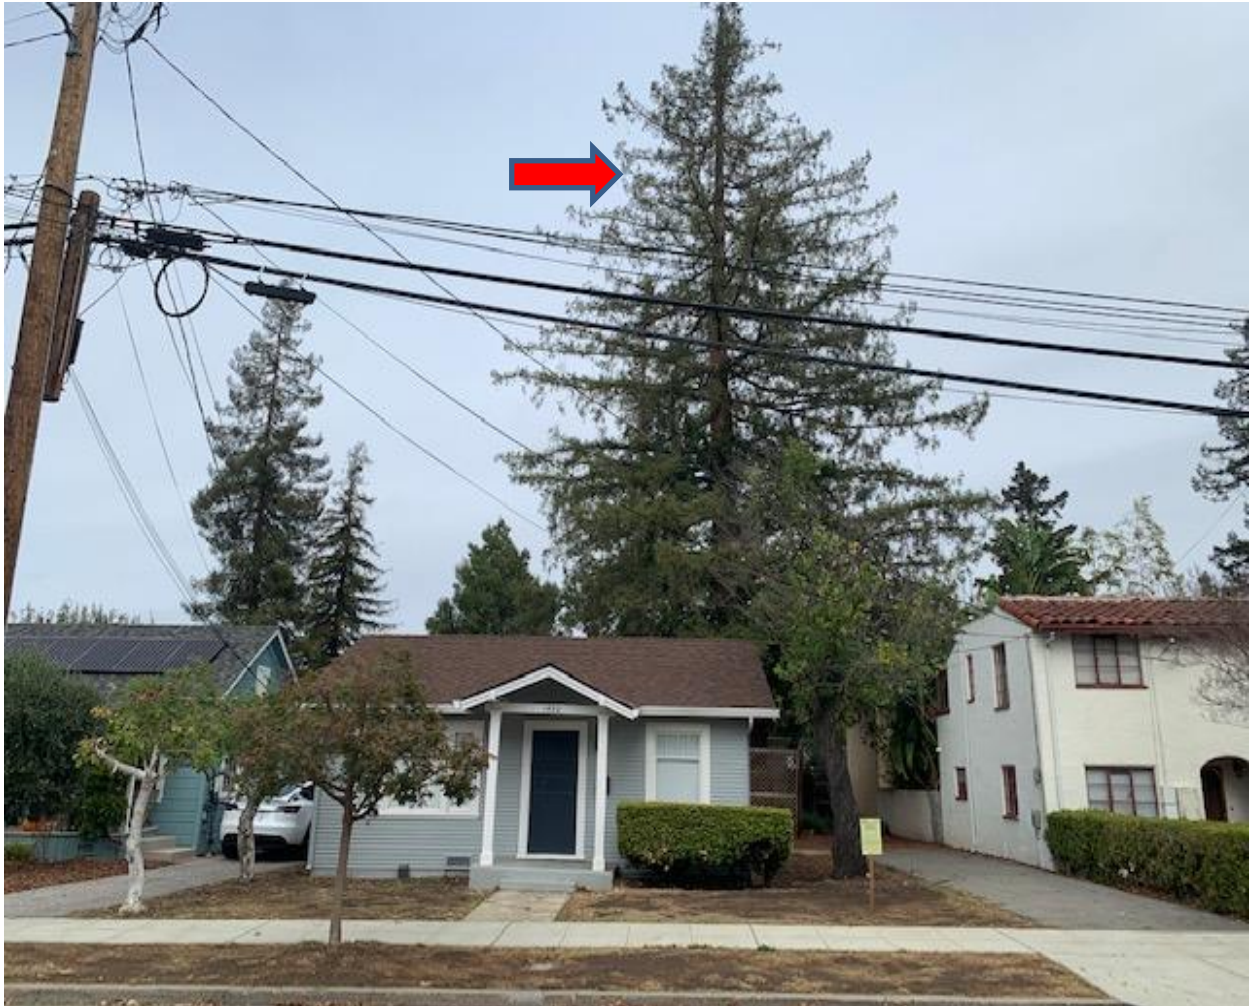
**Figure 1: Tree Under Review**

The Coast redwood is considered in good health with no signs of pest or disease issues. The tree is showing some signs of drought stress, which would be typical of the growing conditions (Figure 1).

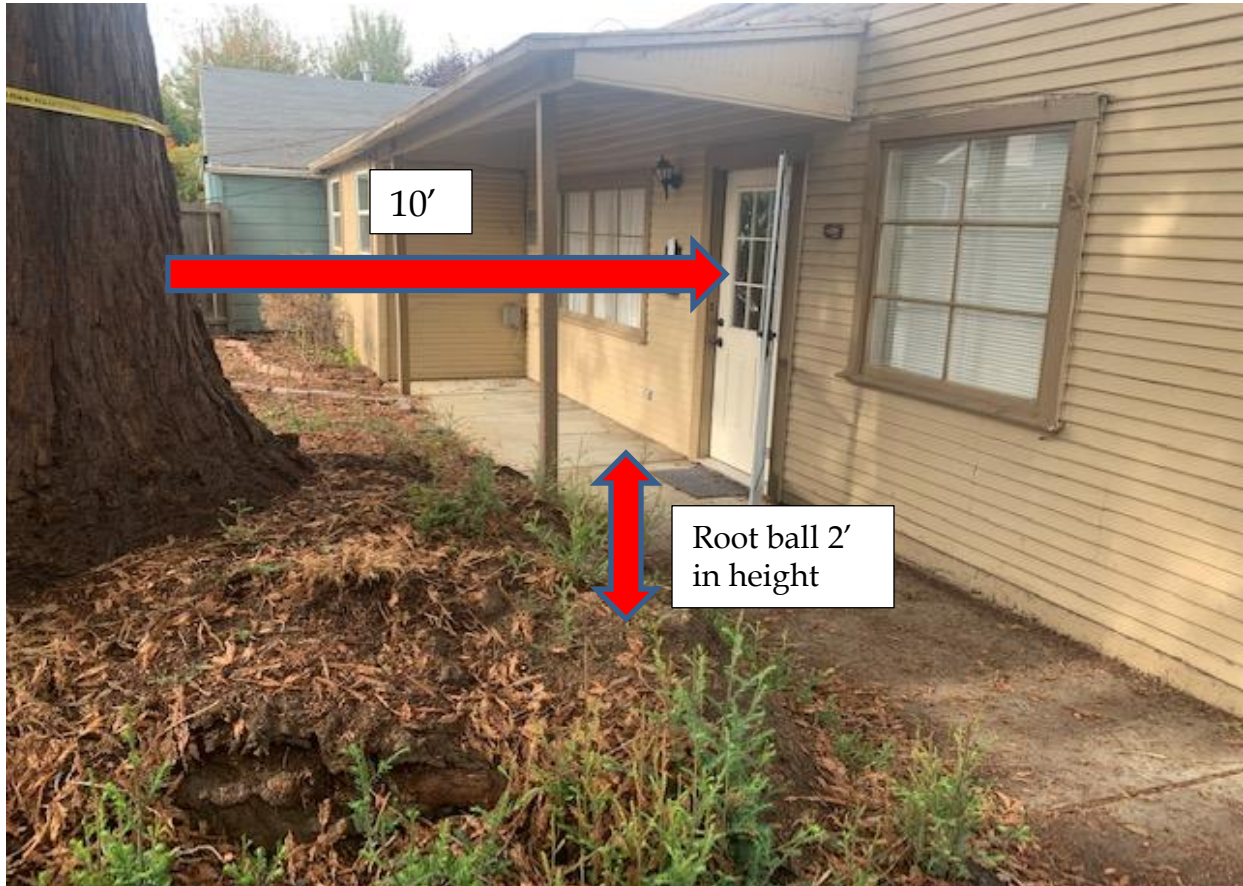
**Figure 2: Proximity of Tree to Home**

The Coast redwood tree trunk is located 10' from the rear structure (Figure 2). The tree is growing in a confined space, limited by a driveway to the east, the rear structure and concrete walkway to the north, and the front house to the south (Figure 3).

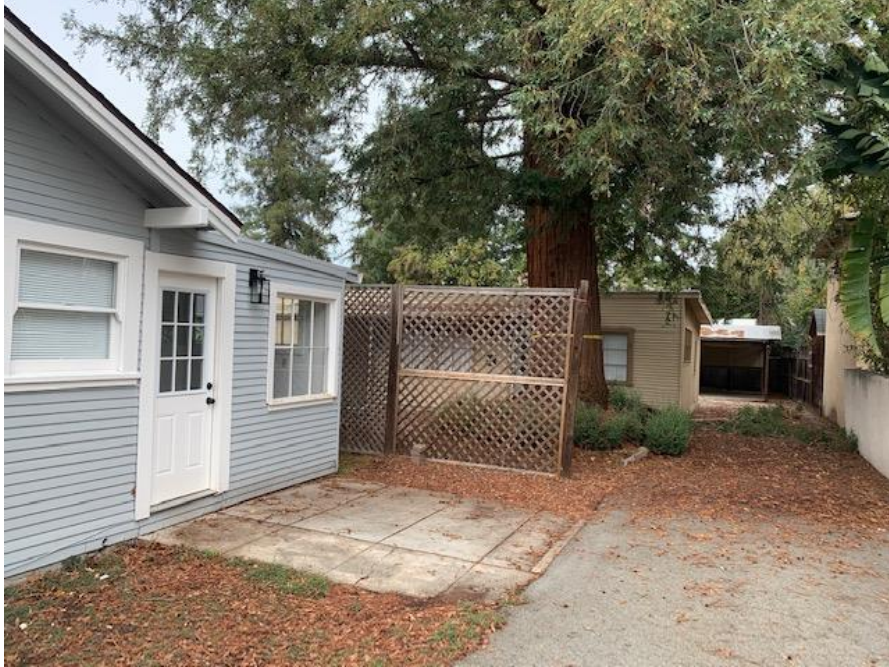
**Figure 3: Location of Tree**

The tree's roots are causing the concrete walkway around the rear home to slope in the direction of the home and impact the home with additional water during rain events. The only way to solve the drainage issue would be to remove the concrete walkway and replace it with a new concrete walkway. However, numerous roots would need to be cut to level the walkway, which then could cause concerning tree instability.

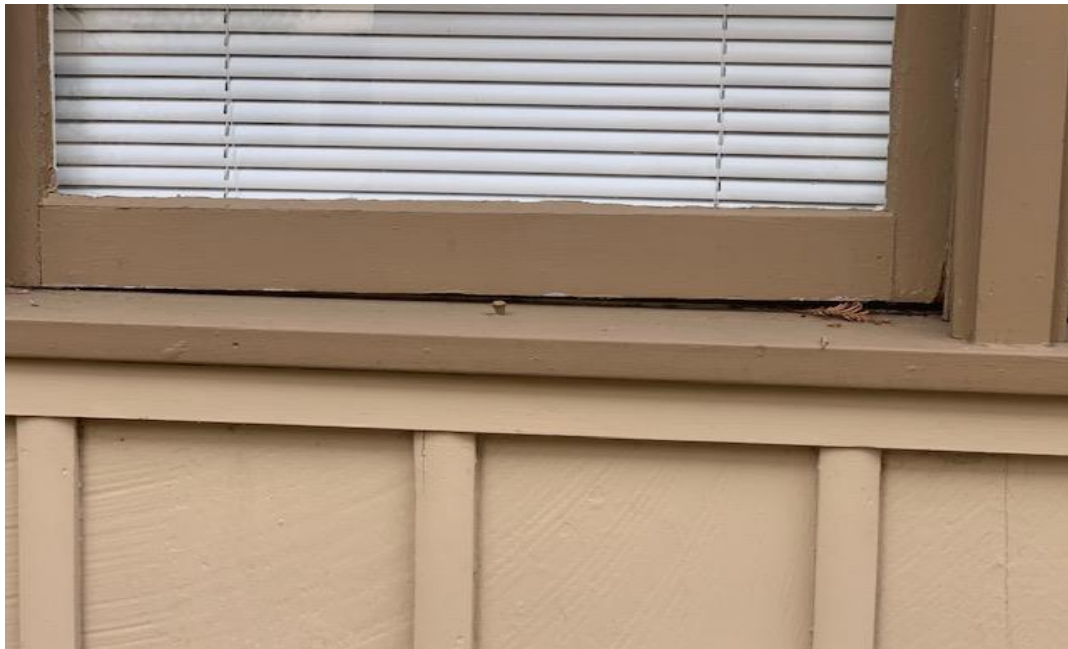
**Figure 4: Gap in Window Closing**

The window on the east side of the rear structure (Figure 4) does not close properly, and a clear gap is present on the section of the window away from the tree. This indicates the home foundation is likely lifted up from roots growing under the home.

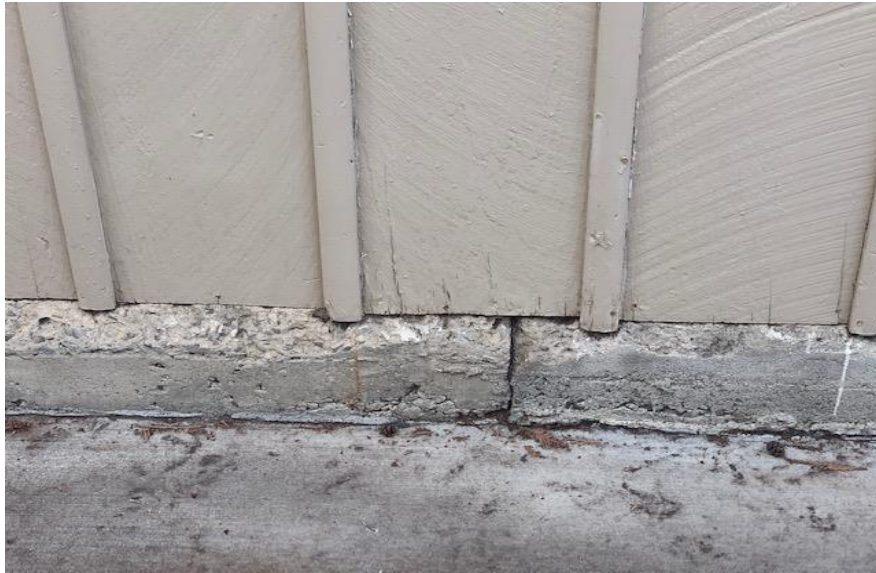
**Figure 5: Compromised Section Concrete Slab**

The concrete slab under the rear structure (Figure 5) has a section with a crack larger than a typical stress crack normally associated with slabs. This is likely caused by tree roots growing under the structure.

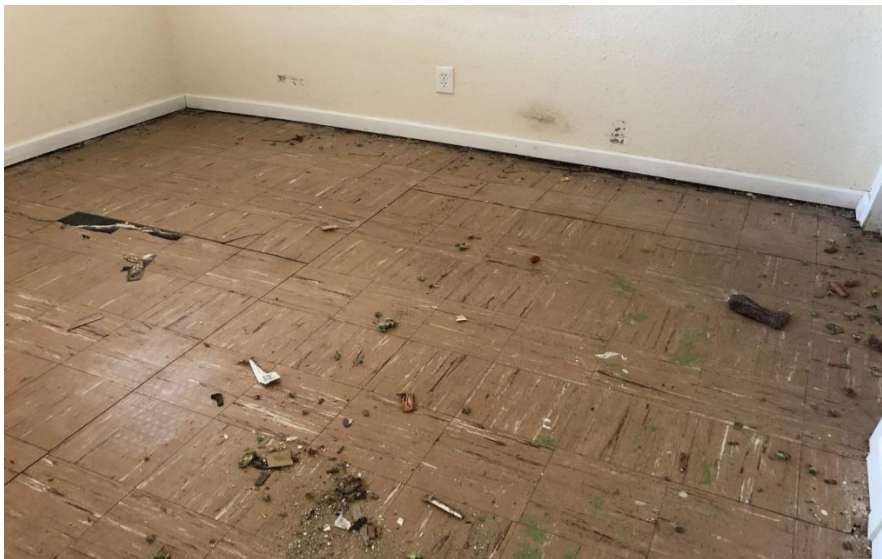
**Figure 6: Floorboard of Rear Structure**

The interior of the rear structure (Figure 6) shows size gaps under the baseboards. In addition to this evidence, a home inspection report included observations of sloping and lifting of the floors in the back unit.
