Arborist Report (revised 8/31/23)  
Tree identification and recommendations for  
194-198 Castro Street (APN: 158-15-013)  
construction project

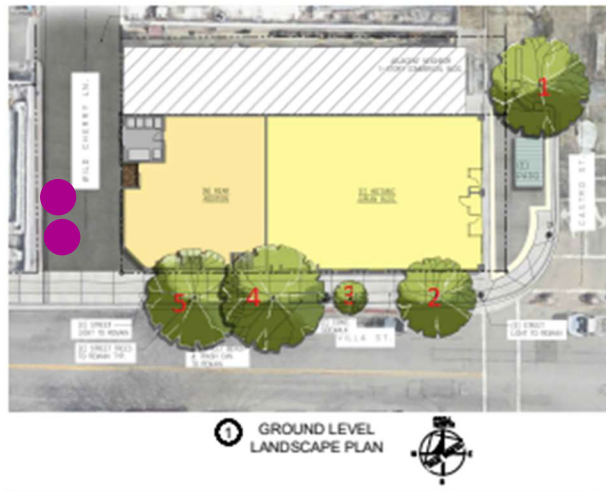
## Street Tree Identification

- Tree 1 – London plane (*Platanus acerifolia*), 18” DBH, condition good,  
Anticipated construction impact – none.
- Tree 2 – Tulip Poplar (*Liriodendron tulipifera*), 13” DBH, condition fair,  
Anticipated construction impact – low (canopy, stem).
- Tree 3 – Chinese Pistache (*Pistacia chinensis*), 8” DBH, condition fair,  
Anticipated construction impact – low (canopy, stem).
- Tree 4 – Chinese Pistache (*Pistacia chinensis*), 12” DBH, condition fair,  
Anticipated construction impact – moderate (canopy, stem,  
roots).
- Tree 5 - Chinese Pistache (*Pistacia chinensis*), 10” DBH, condition poor,  
Anticipated construction impact – moderate (canopy, stem  
roots).

- Flowering Plum (to be removed), 5” DBH, Condition good.

Pre-construction Maintenance (City)- Pruning for adequate building clearance, post construction building clearance and canopy balance. Due to its poor condition, Tree #5 should be removed before construction. After construction, a new 24" box tree of the same species should be planted in the same general location.
