report # 2639 (3 pages)

RE: Arborist report - 1851 Appletree Lane, Mountain View

Brief description of work - Addition to the single family residence. Three trees qualifying as Heritage trees (per Mountain View tree ordinance) are marked on the following site drawing. Two Liquidambar trees are being requested for removal. One Cedrus on the neighboring property to the south is to be protected.

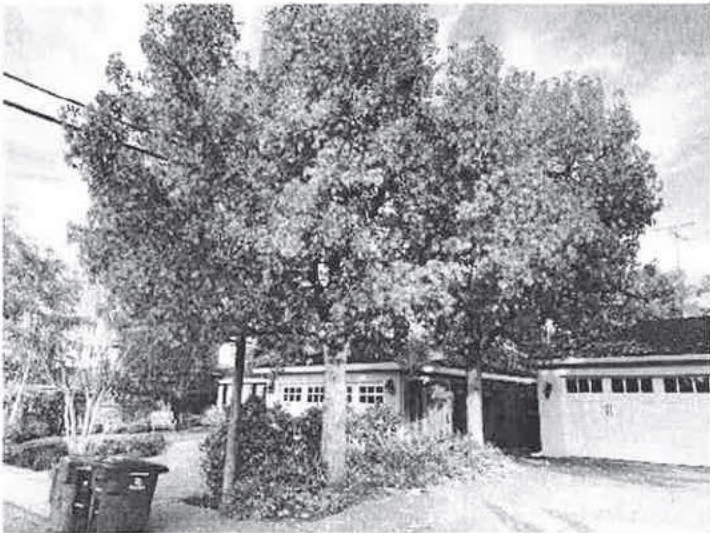
Trees #1 and #2 (both Liquidambar)

tree condition	Trunk circumference at 54" from grade	reason for removal
tree #1 (Liquidambar styraciflua)	good	52"	Tree roots are damaging driveway and sidewalk hardscape. This situation is expected to worsen with time. Tree is in a location which is in conflict with driveway improvement.
tree #2 (Liquidambar styraciflua)	good	50"	Tree roots are damaging driveway and sidewalk hardscape. This situation is expected to worsen with time. Tree is in a location which is in conflict with driveway improvement.

Tree replacement is required as a condition for removal of two Heritage Liquidambar trees. There is not ample enough space on this residential lot for the replacements to be placed there. I understand there is an option for the homeowner to pay to have replacement trees planted elsewhere in Mountain View in order to maintain the city's overall tree canopy. I don't know what that cost is, but I believe that to be the best option for you and for the successful tree canopy goals of Mountain View.

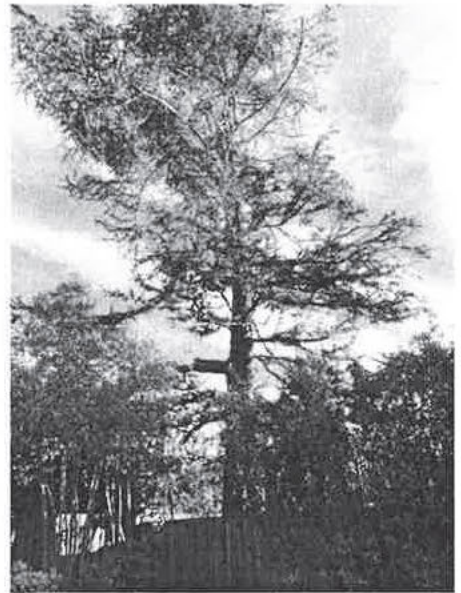
Tree # 3 (Cedrus deodara)

tree condition	Trunk circumference at 54" from grade	method of critical root zone protection
tree #3 (Cedrus deodara)	fair	122.5"	5' high chain link fence at drip line

The footprint of the home addition approaches the root zone of Tree #3 in the back yard. An appropriate tree protection measure is to fence off an area around the tree to prohibit the movement of heavy equipment over the critical root zone or the storage of construction materials on top of the critical root zone. In this case, I believe a reasonable definition of the critical root zone is the drip line of the tree (the edge of the leafy canopy). The distance from the trunk in this case is a radius of approximately 15'. The fence shall be 5' in height, made of chain link. It must be installed prior to any construction activity. It is reasonably unlikely that very many roots outside this defined area will be larger than 2" in diameter. However, in the process of constructing the foundation for the addition, roots of this size may be encountered. It may be difficult to determine if the roots are from the Cedar or other shrubby vegetation that is nearby. In any case, roots that need to be cut, should be cut cleanly with well sharpened tools.
