## Arborist Report

749 West El Camino Real

**April 22, 2021**  
**Revised April 2022**  
**& September 2022**

**Arborist Report  
749 W El Camino Real  
Mountain View, CA**

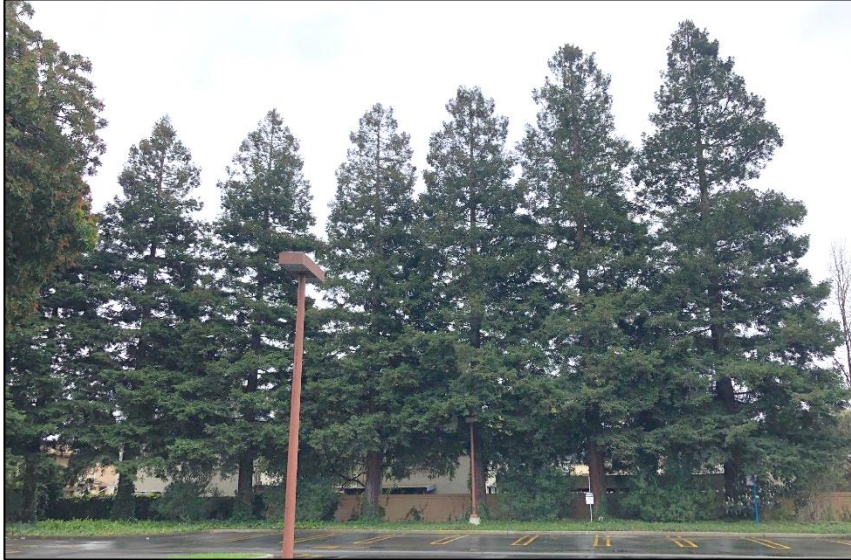
Coast redwood was the second most populous species with 14 trees assessed (4 off site). The 10 on site redwoods were in good condition (Photo 1) while the four off-site coast redwoods were in poor condition. The on-site coast redwoods (#32 – 41) varied in diameter from 21 to 34 inches

**Photo 1 (left):**  
Coast redwoods  
#37-42 along the  
eastern parking  
lot were in good  
condition.

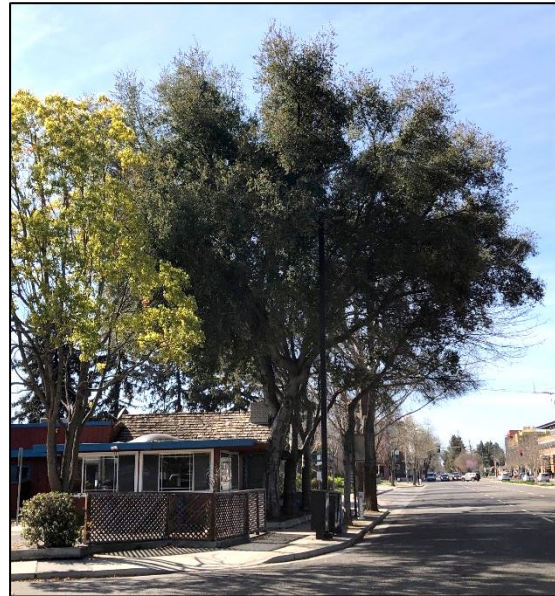
**Photo 3 (right):** Coast live oak #111 on El Camino Real was in good condition.
