MACNAIR
&
ASSOCIATES
CONSULTING ARBORISTS AND HORTICULTURISTS

August 22, 2024

RE: Magnussen's Toyota Auto Dealership Mountain View- Arborist Report and Tree Protection Specifications

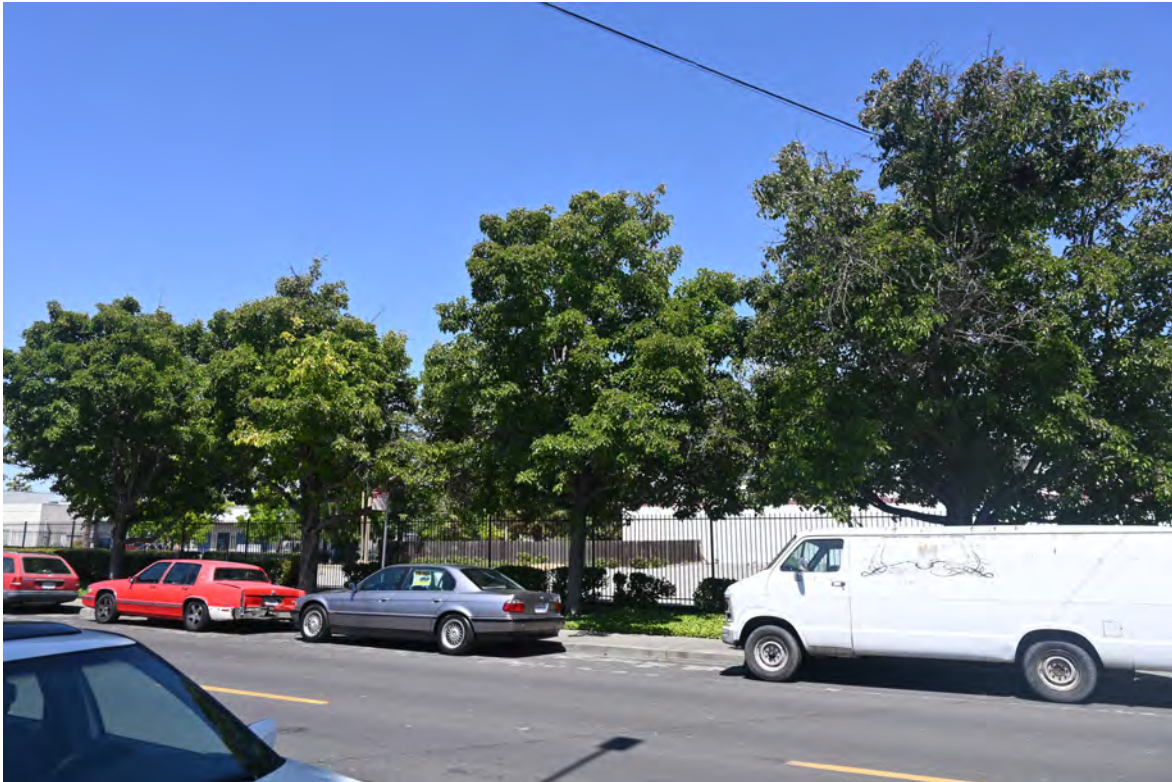
Bradford pear street trees growing along Independence Avenue.

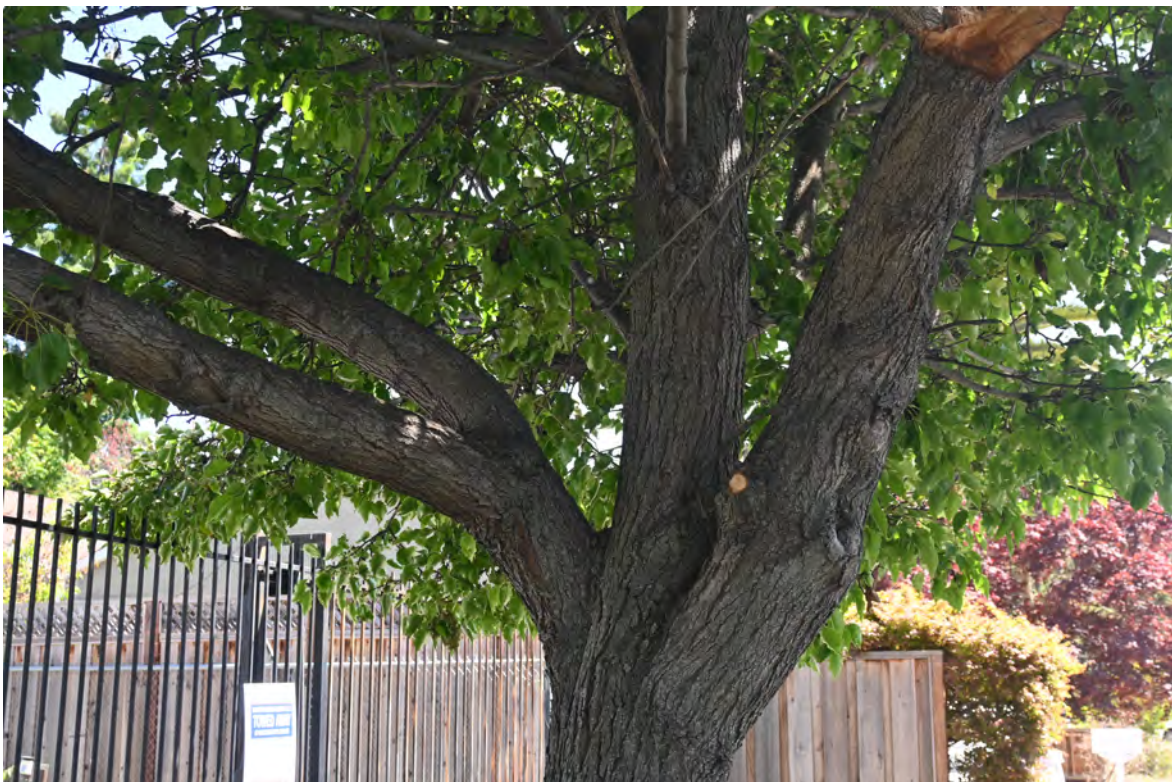
Closely spaced limbs are characteristic of Bradford pears and are prone to failure.

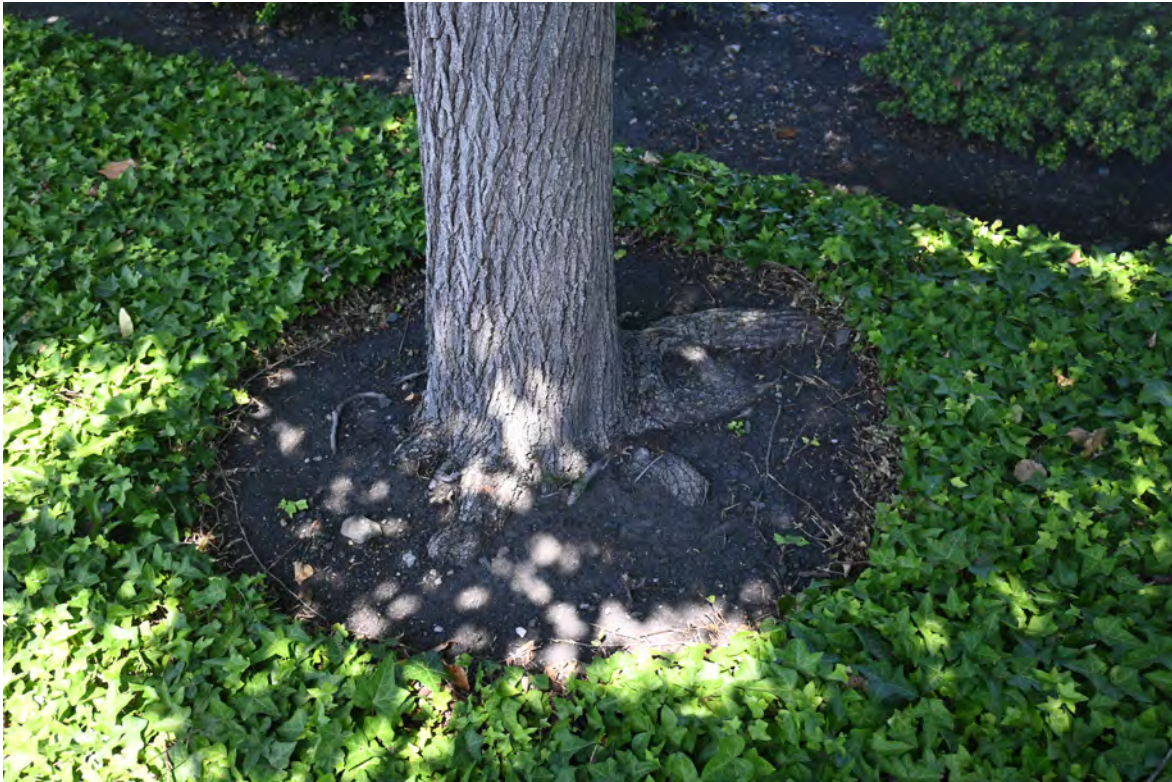
The asymmetrical root system of a Bradford pear. This defect does not appear to be affecting the health or stability of these trees.

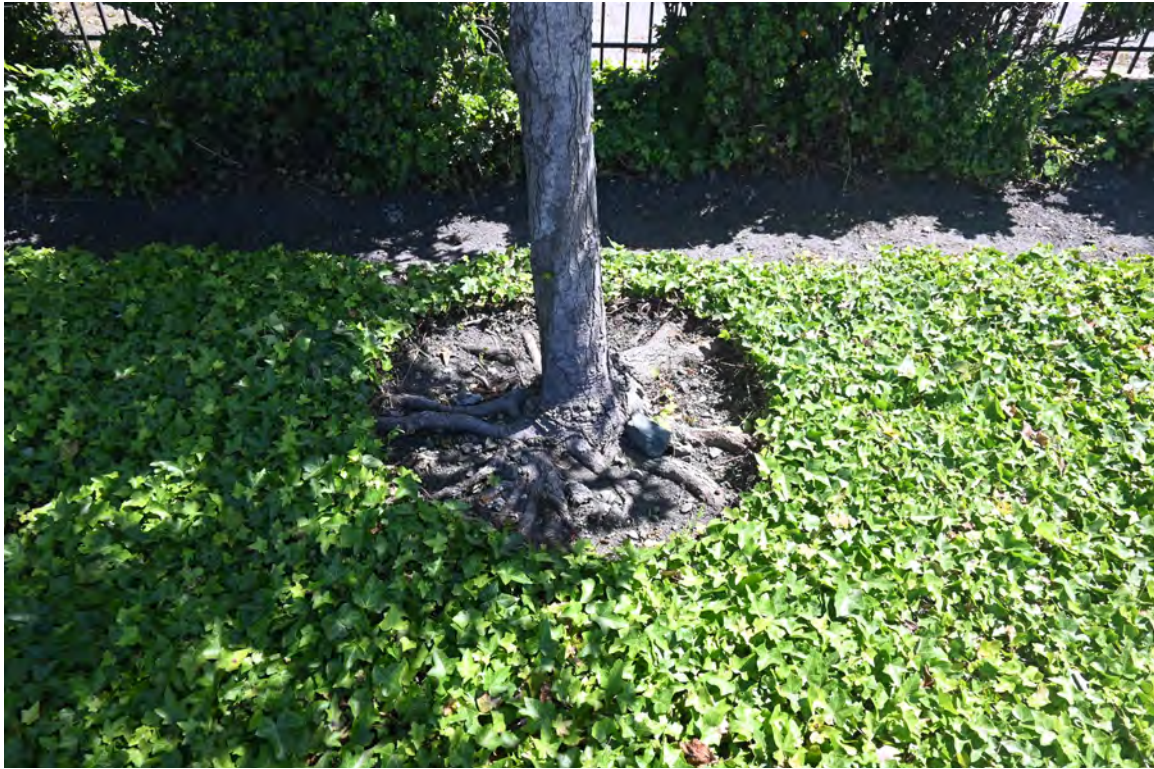
The surface rooting typical of liquidambar often causes pavement displacement.

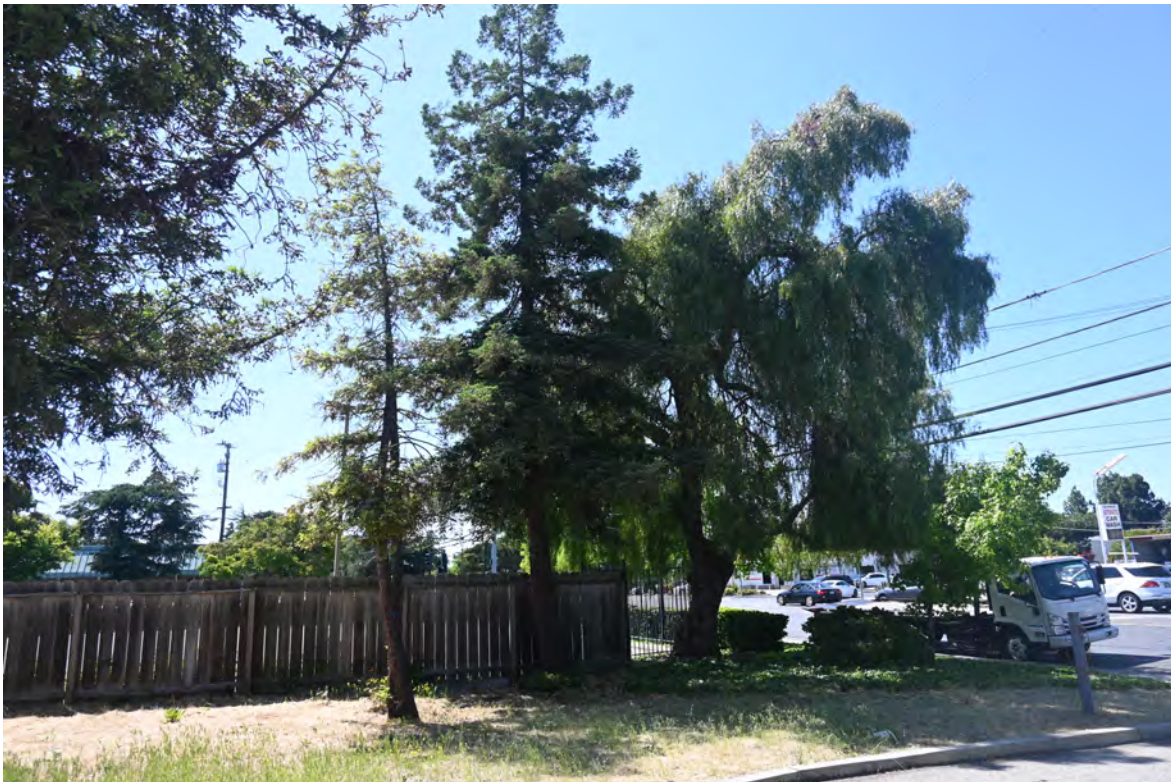
Peruvian pepper, tree #9., and coast redwoods #10 and #11.

8	liquidambar	2	3.0	9	1.5	2.5	10±	10±	3.0	1.5	Leaning tree with defective root system. Located adjacent to the pepper tree.	Poor	No (Street Tree)	Located in project grading limits. Removal required.	RC	1
9	Peruvian pepper tree (<i>Schinus molle</i>)	1	27.0	85	27.0		35'-40'±	25'-30'±	3.0	3.0	Mature tree with an extended second trunk. Lower trunk wounds and galls. Wound on southwest limb in mid-crown. Vigor and foliage density are moderate.	Moderate	Yes	Located in project grading limits. Removal required.	RC	2
10	coast redwood (<i>Sequoia sempervirens</i>)	1	16.0	50	16.0		45'-50'±	22±	3.0	3.0	Semi-mature tree with single trunk structure and no significant structural defects. Vigor and foliage density are moderate.	Moderate	Yes	Located in project grading limits. Removal required.	RC	2
11	coast redwood	2	10.7	26	6.5	8.5	20±	8±	1.5	2.0	Low two-trunk twisted structure. Vigor is low with significant branch dieback occurring.	Poor	Yes	Located in project grading limits. Removal required.	RC	2

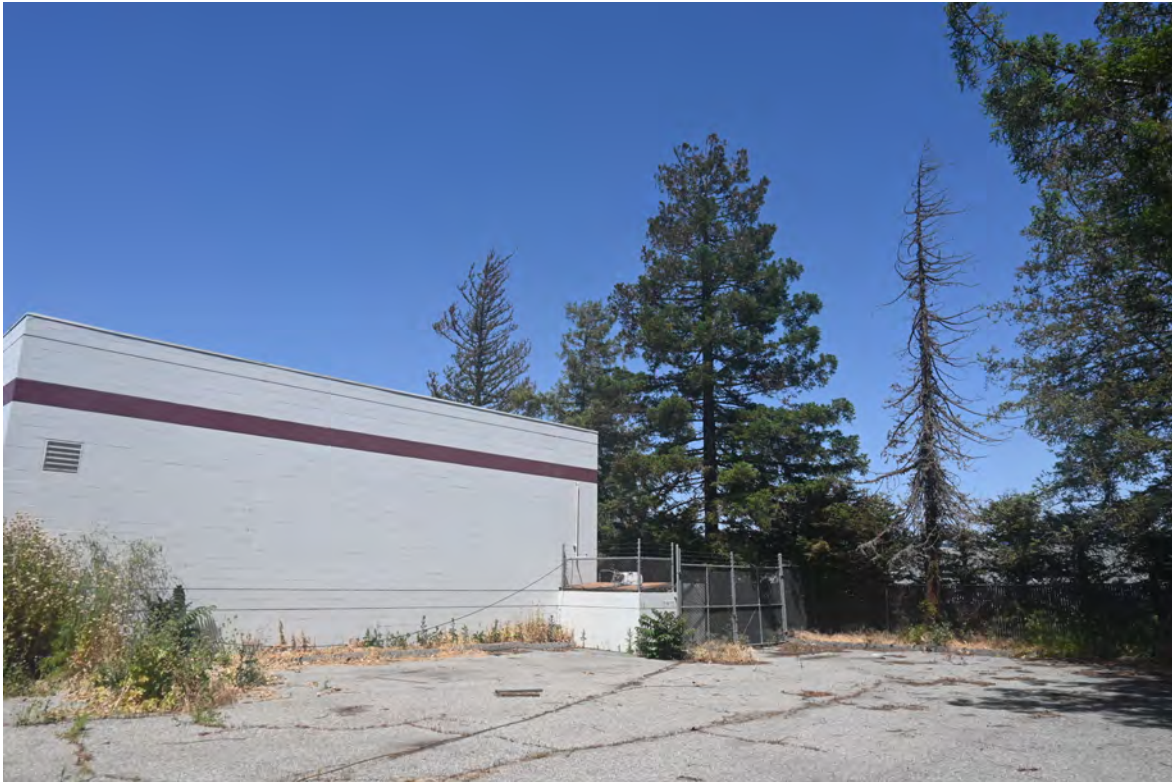
Redwoods, #21, #22, #22A, and #23.

23	coast redwood	1	15.0	47	15.0		55'-60'±	25'-30'±	0.0	0.0	Tree is mostly dead.	NA	Yes	Located in project grading limits. Removal required.	RC	2
24	coast redwood	1	25.0	79	25.0		60±	30±	2.0	3.0	Mature tree with single trunk structure. No significant structural issues. Vigor and foliage density are low. History of drought stress.	Poor to Fair	Yes	Located in project grading limits. Removal required.	RC	2
25	coast redwood	1	20.0	63	20.0		65±	30±	3.0	1.5	Semi-mature tree with single trunk structure and no significant structural defects. Vigor and foliage density are moderate. Extensive ivy on trunk. Probable significant damage to root system from adjacent property construction.	Poor to Fair	Yes	Located 21' to bio-retention and 24' to driveway. Masonry wall required next to trunk. Potential for cumulative root impacts.	MI	0

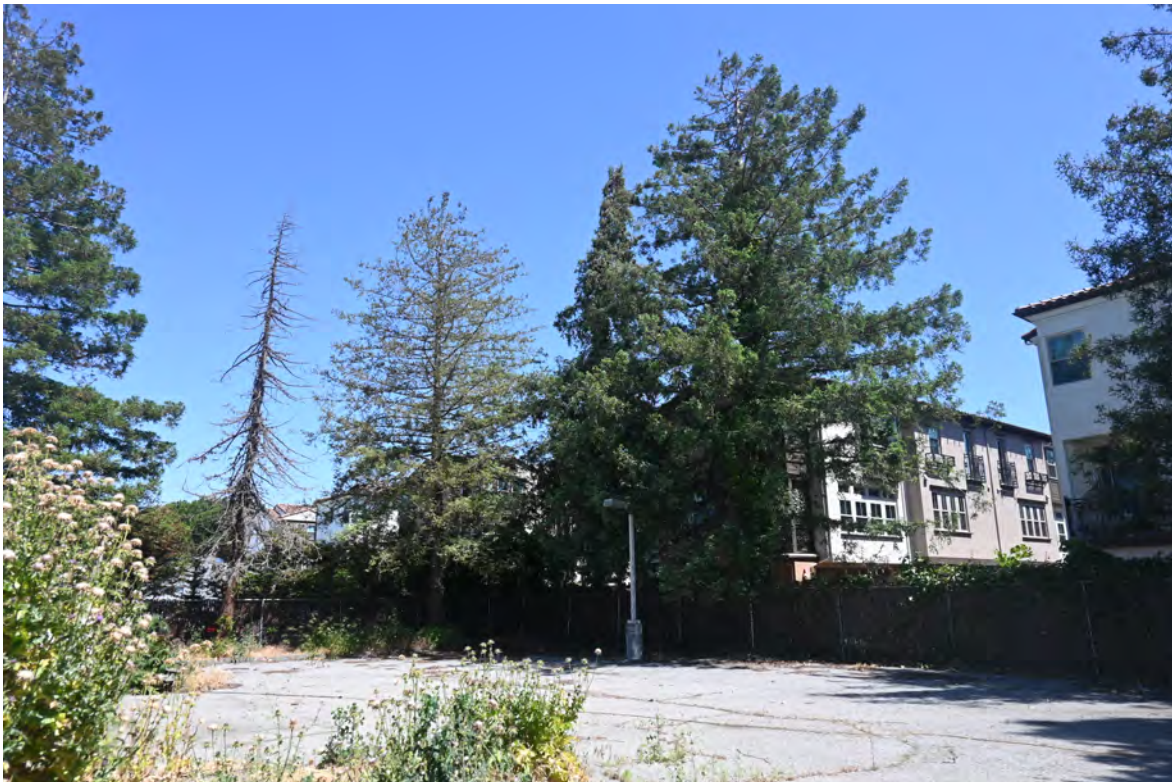
Redwoods along the south perimeter. Trees #23,#24, #25, and #26.

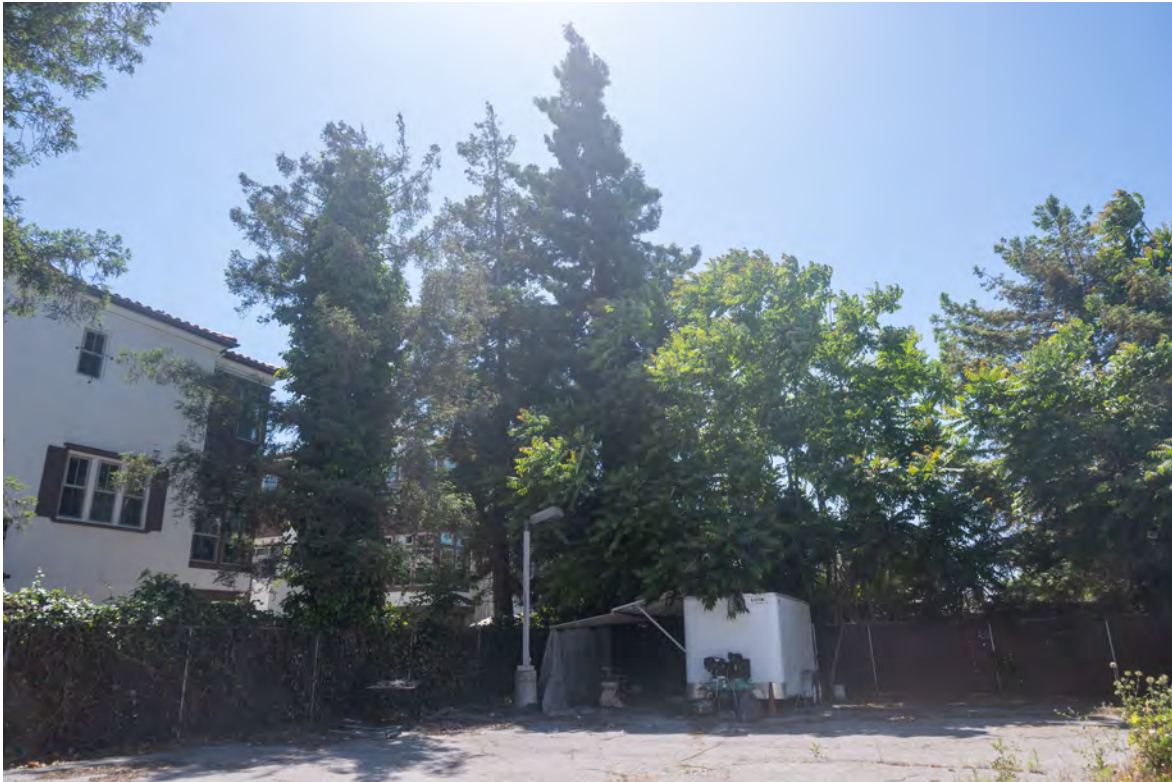
Redwoods and tree-of-heaven are growing on the adjacent property in the south portion of the project site. Trees #28- # 32.

28	coast redwood	1	24.0	75	24.0		50'±	25'-30'±	3.0	1.5	Mature tree with single trunk structure. No significant structural issues. Vigor and foliage density are moderate. Probable significant damage to root system from adjacent property construction.	Poor to Fair	Yes	Located in grading limits including bio retention area.	MI	0
29	coast redwood	1	32.0	100	32.0		60'±	30'±	3.0	3.0	Mature tree with single trunk structure. No significant structural issues. Vigor and foliage density are moderate. Located on adjacent property at fence line. Possible root loss from adjacent construction on south side.	Moderate	Yes	22' to parking area. Masonry wall required next to trunk.	MI	0
30	tree-of-heaven (<i>Ailanthus altissima</i>)	20±	2"-10"				40'-45'±	30'-35'±	3.0	2.0	Dense cluster of 20 or more stems surrounding original tree. Appears healthy. Located on adjacent property at fence line. Overhangs fence 30'.	Poor (Invasive)	Yes	Located in grading limits with significant grading cuts required and the construction of a masonry wall.	RC	1

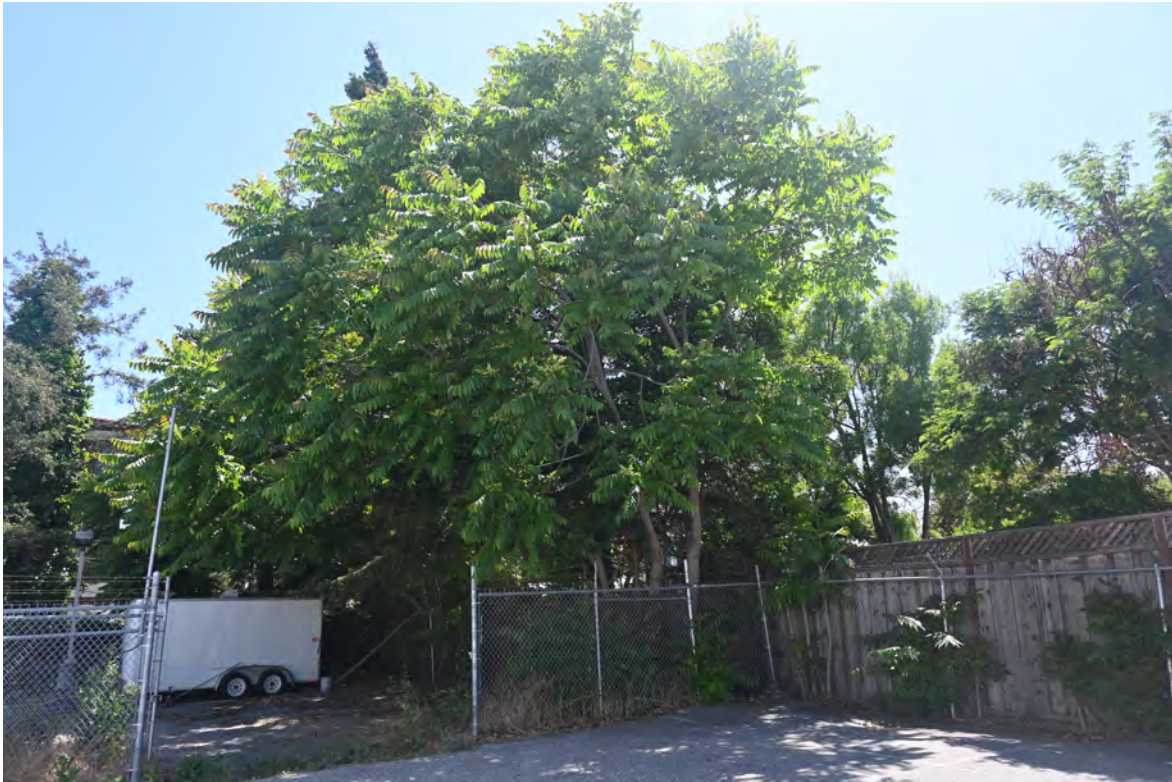
Tree-of-heaven cluster on adjacent property. (#32)

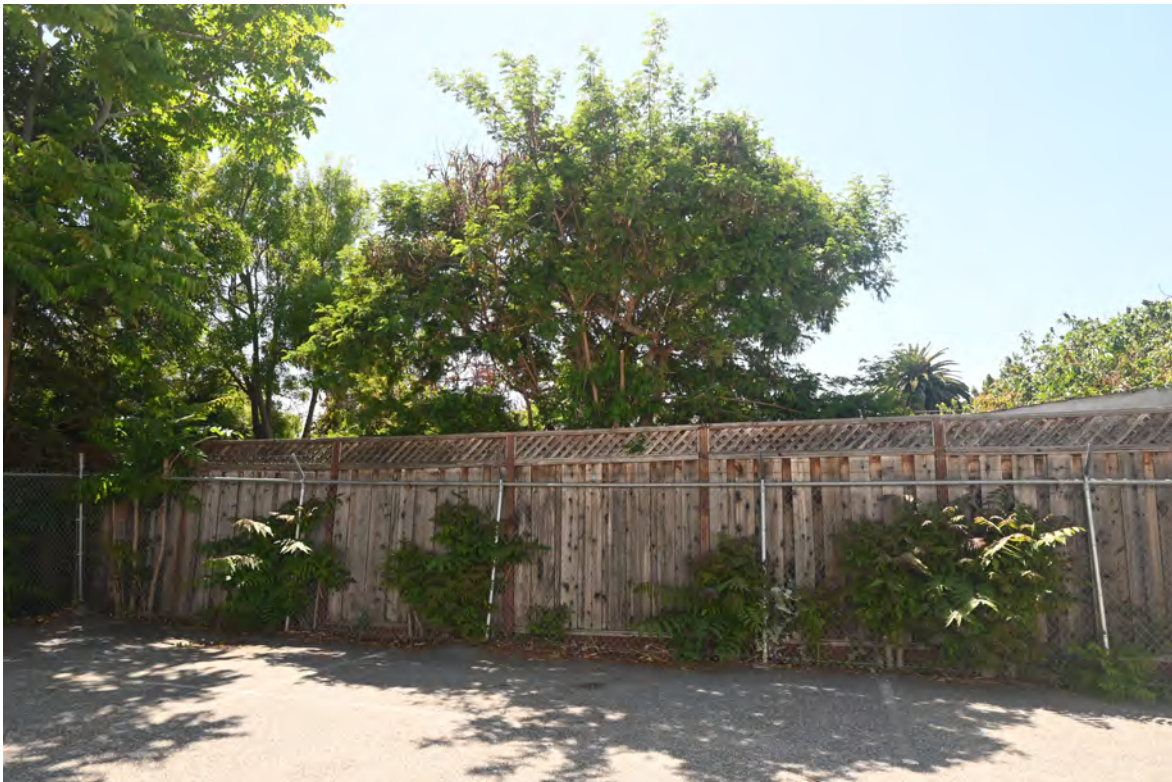
A white lead tree is growing on the adjacent property. (Tree #33)

33	white lead tree (Leucaena sp.)	multi	?		Moderate	Yes	Located on adjacent property adjacent to new masonry wall. Moderate impact likely.	LI	18'	4'	Located on the adjacent property. A root pruning trench is required at the property line.
34	crape myrtle (Lagerstroemia indica x fauriei)	1	6.5	20	Moderate to Good	No (Street Tree)	Currently designated for transplanting.	MI	NA	NA	Designated for transplanting.
35	crape myrtle	1	8.0	25	Moderate to Good	No (Street Tree)	Currently designated for transplanting.	MI	NA	NA	Designated for transplanting.

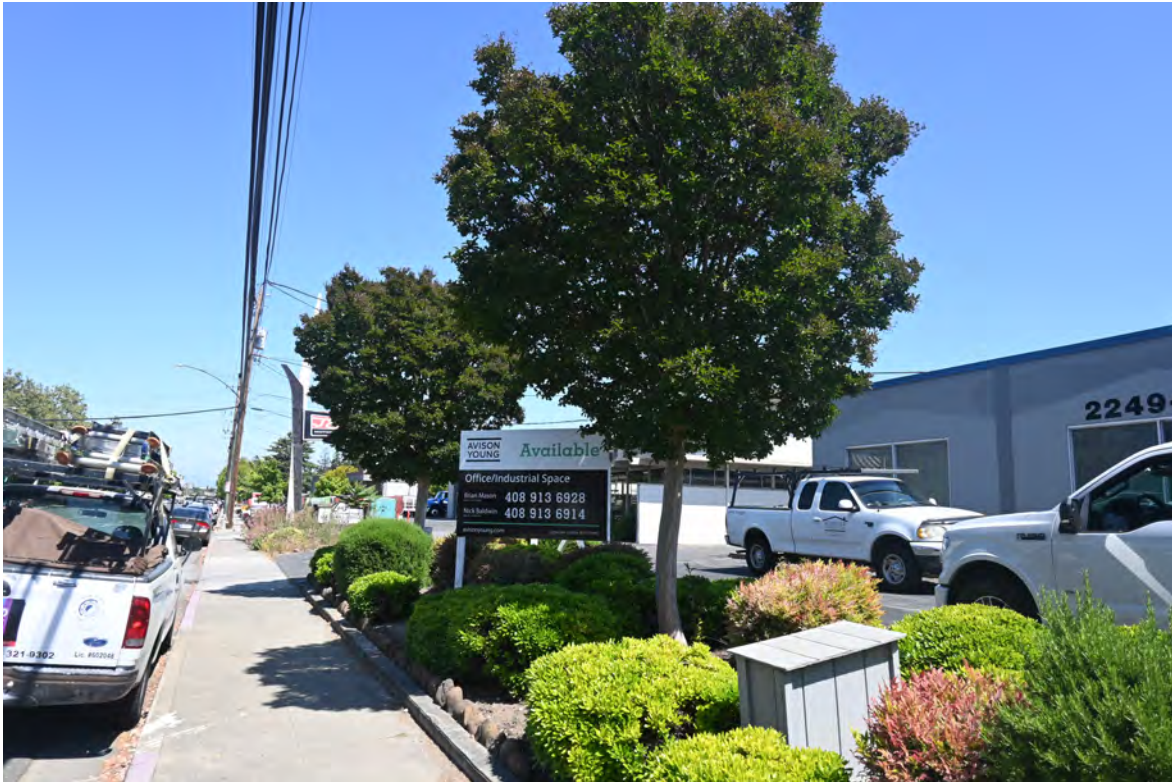
Crape myrtle street trees. (Trees #34 and #35)

34	crape myrtle (Lagerstroemia indica x fauriei)	1	6.5	20	6.5		18±	14±	3.0	3.0	Street tree. Semi-mature tree with single trunk structure and no significant structural defects. Vigor and foliage density are moderate.	Moderate to Good	No (Street Tree)	Currently designated for transplanting.	MI	0
35	crape myrtle	1	8.0	25	8.0		18±	14±	3.0	3.0	Street tree. Semi-mature tree with single trunk structure and no significant structural defects. Vigor and foliage density are moderate.	Moderate to Good	No (Street Tree)	Currently designated for transplanting.	MI	0
36	coast redwood	61	4" +				12'	4'	3.0	2.0	Hedge of coast redwood planted 5' o.c. Topped at approximately 12'. Generally moderate health. 79 trees along the west and south sides of the Parcel 1 parking lot.	Fair	Yes	Located in project grading limits. Removal required.	RC	122
37	coast redwood	18	4" +				12'	4'	3.0	2.0	18 of the hedged redwood are now retained.	Fair	Yes	Now retained.	LI	0

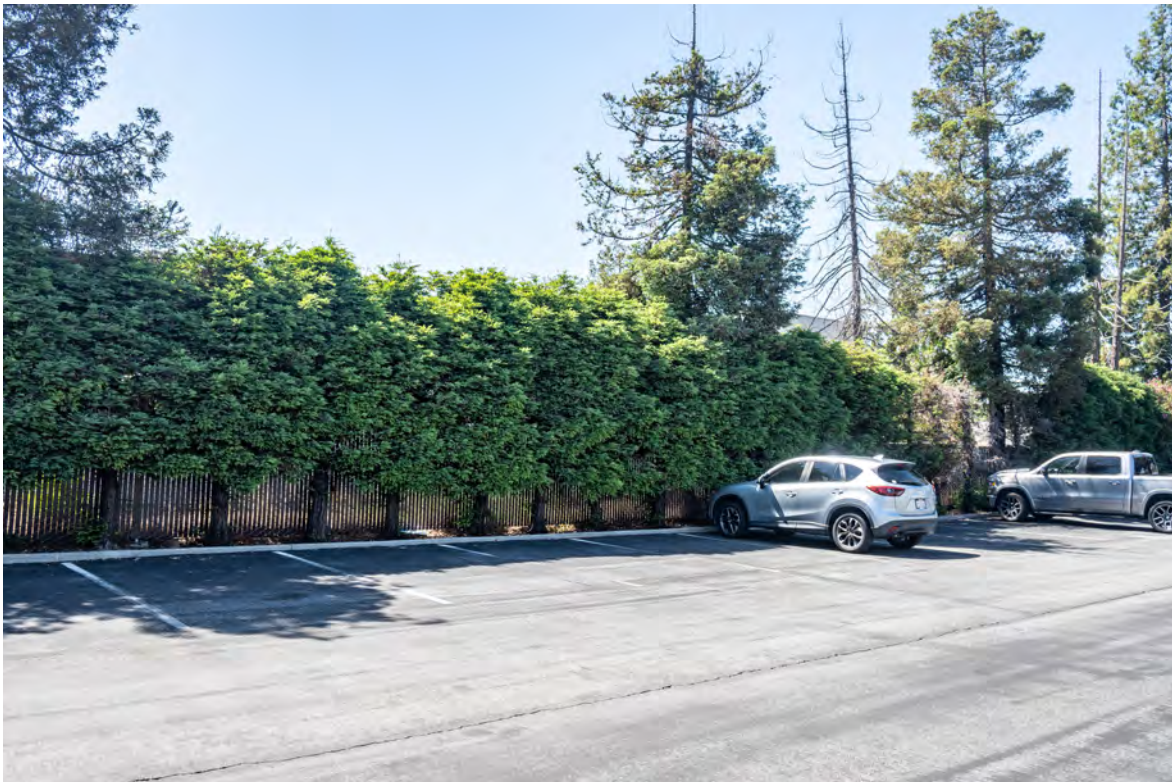
A unique aspect of the landscape plantings is the planting of 79 coast redwoods as a hedge bordering the Parcel 1 interior parking lot. The trees have been topped at 12 feet and were planted on five-foot centers. With the high water and frequent pruning requirements, the hedge is inefficient and a questionable screening strategy.

A hedge of redwoods borders the parking lot.
