Revised April 18, 2024

Site: 294 & 296 Tyrella Avenue, Mountain View, CA

As requested on Thursday, December 28, 2023, Kielty Arborist Services LLC visited the above site for the purpose of inspecting and commenting on the trees. Construction is planned for this site and your concern as to the future health and safety of the trees has prompted this visit.

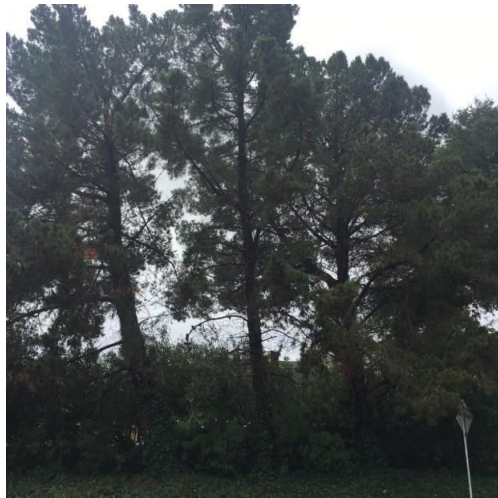
Trees #4-6 consist of Monterey pine trees. These trees are proposed for removal to facilitate the construction of the units and a storm drain line. The proposed storm drain line and building locations would require excavation at a very close proximity to the trees and impacts would be expected to be high. It should be known that Monterey pine trees in the landscape are short lived trees. Monterey pine trees throughout the Bay Area have been suffering from the prolonged period of drought. Monterey pine trees are a poor species selection. Pine trees #4-6 fall within the city of Mountain View's criteria for tree removal states the following:

Showing pines #4-6

In alignment with our commitment to sustainable urban development and tree preservation, a detailed assessment was conducted to evaluate the feasibility of retaining Trees #4H, #5H, and #6H within the proposed construction plan. The evaluation was grounded in the principles of arboricultural science and urban planning, with a focus on the long-term health and viability of these trees. Trees #4H, #5H, and #6H were also evaluated for transplanting. All three Monterey pine trees are only in fair condition. The deep tap root and widespread lateral root structure render them poor candidates for transplanting. It is highly likely the root system will be damaged during extraction, greatly decreasing survivability after transplantation. Deterioration in the canopy structure will occur as a result of damage to the root system, creating future hazards.

Tree #4H: To ensure the preservation of Tree #4H, it is necessary to adjust the building footprint and the area of the lot occupied by the building, resulting in a reduction of 382 square feet. This modification is based on the establishment of a tree protection zone, meticulously calculated to provide a critical root zone that extends to ten times the diameter at breast height (DBH) of the tree. This protective measure is crucial to safeguard the root system, which is vital for the tree's stability and health.

Tree #5H: Similarly, for the preservation of Tree #5H, a reduction of 260 square feet in the building's footprint and the area of the lot is required. This adjustment ensures the establishment of a tree protection zone encompassing a critical root zone of ten times the tree's DBH. This consideration is fundamental in preventing root damage and stress, thereby contributing to the tree's overall well-being.

Tree #6H: Preserving Tree #6H necessitates a more substantial reduction in the building's footprint and occupied area, amounting to 687 square feet. This area corresponds to a tree protection zone tailored to accommodate a critical root zone of ten times the tree's DBH. Such a protective zone is essential to maintain the integrity of the tree's root system, which is indispensable for its nourishment and structural support.

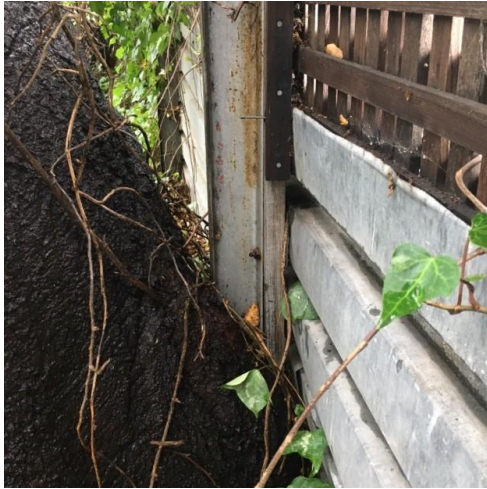
Showing metal post

Coast live oak trees #7-9 are in fair condition. Coast live oak tree #7 is codominant at 4 feet with a poor crotch formation. A seam is visible from the poor union that runs down to the base of the tree. This tree has also grown around a large metal post that supports the property fence. No maintenance has taken place to this tree for an unknown length of time. Coast live oak tree #8 is heavily suppressed by oak trees #7 and #9. Coast live oak tree #9 is heavy to the west. At this time, Coast Live Oaks # 7, #8, and #9 are all proposed for removal. The storm drain line and proposed building would require excavation on three sides of the oak tree's root zones. High impacts would be expected and would likely impact the tree's structural stability. Removal and replacement are recommended.
