Walter Levison
CONSULTING ARBORIST

**Assessment of sixteen (16) trees
at
858 Sierra Vista
Mountain View, CA**

4/26/2012

4/30/2012

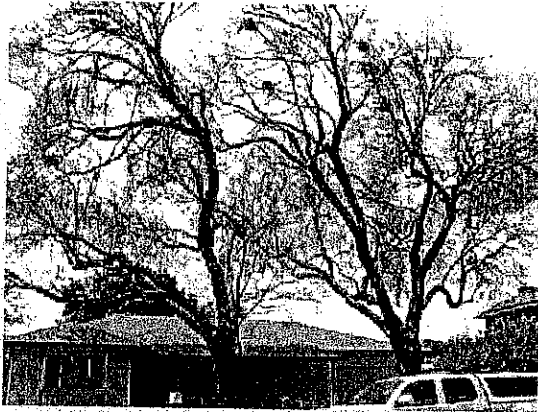
- a) Protected Trees: Trees #1 and #2 are the only heritage trees on the site. These are American elms (*Ulmus Americana*): a species which has been decimated for decades and is practically an extinct species in its straight, non-hybridized form. These two specimens are in poor overall condition (40 out of 100% overall condition ratings), and exhibit various structural defects such as narrow mainstem forks with included bark, and heavy branch endweight that in the case of these two trees is difficult to mitigate due to the lack of inner canopy live wood or foliage. The lack of inner live wood/foliage is a result both of natural shading and limb growth, and of past heavy pruning to remove this inner wood.

The canopies of the two trees are lopsided west toward the existing residence to be demolished.

In the long term, these two trees are poorly suited to preservation due to the species susceptibility to Dutch elm disease (DED), and due to the structural issues noted above. Their remaining safe and useful lifespan (SULE) is estimated to be 5 to 10 years at best, less if DED comes into play (note that foliar condition was not assessed due to the trees' being out of leaf at the time of survey. Overall tree condition may be worse than that stated here).

Right to Left: Trees #1 and #2

Per the above definition, American elms #1 and #2 are protected as heritage trees, and cannot be removed without first obtaining a formal tree removal permit from the City of Mountain View. Mitigation may or may not be required.

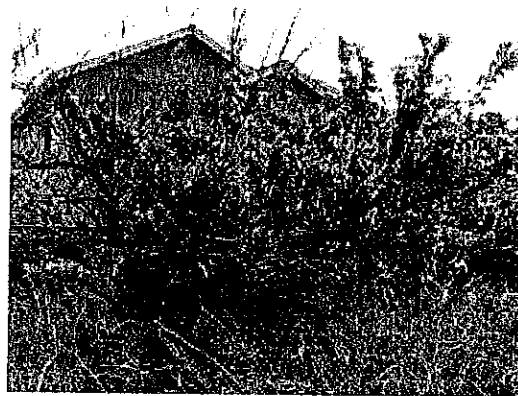
Apricot #13 with *P. syringae* infection.

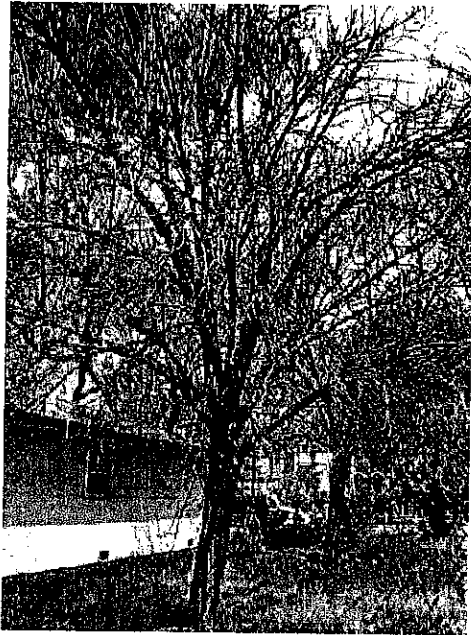
- c) Raywood ash: Trees #14 and 15 are Raywood ash: a cultivar of *Fraxinus oxycarpa* that has been declining for about a decade due to "Raywood ash decline": a fungal disease consisting mainly of *Botryosphaeria stevensii* (source: Tom Gordon, UC Davis researcher). Dieback consists of cankers on branches which eventually kills large portions of the canopy which then need to be pruned out, leaving a remnant tree of little or no value.

The two specimens on this site are currently in fair overall condition, with vigor (foliar density, twig extension, etc.) being estimated due to the trees being out of leaf on the date of my survey.

Left to Right: Raywood ash specimens
#14 and #15

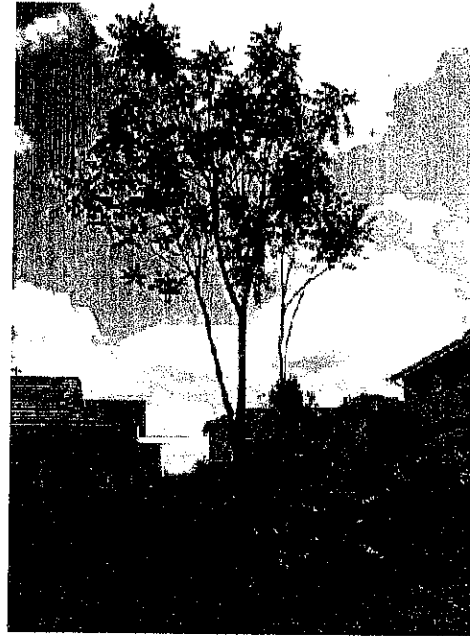
- d) Tree of Heaven: Tree #16 is an *Ailanthus altissima*: a species considered by many to be an invasive pest plant that is categorically eradicated. The tree may have been a volunteer started by a fertile seed dropped by a bird in its feces while sitting on the property boundary fence. These trees are very fast growing and weak wooded.

Tree of Heaven (volunteer tree) #16.
