Tree Inventory of
500/550 Ellis St
Mountain View, CA 94043

Prepared by
Urban Tree Management, Inc.
Inspection Date: November 4, 2019
Revised: October 12, 2023

TREE DISPOSITION & PROTECTION PLAN

Date: 08/04/2023
Scale: 24x36; 11x17;
Sheet: **L0.04**

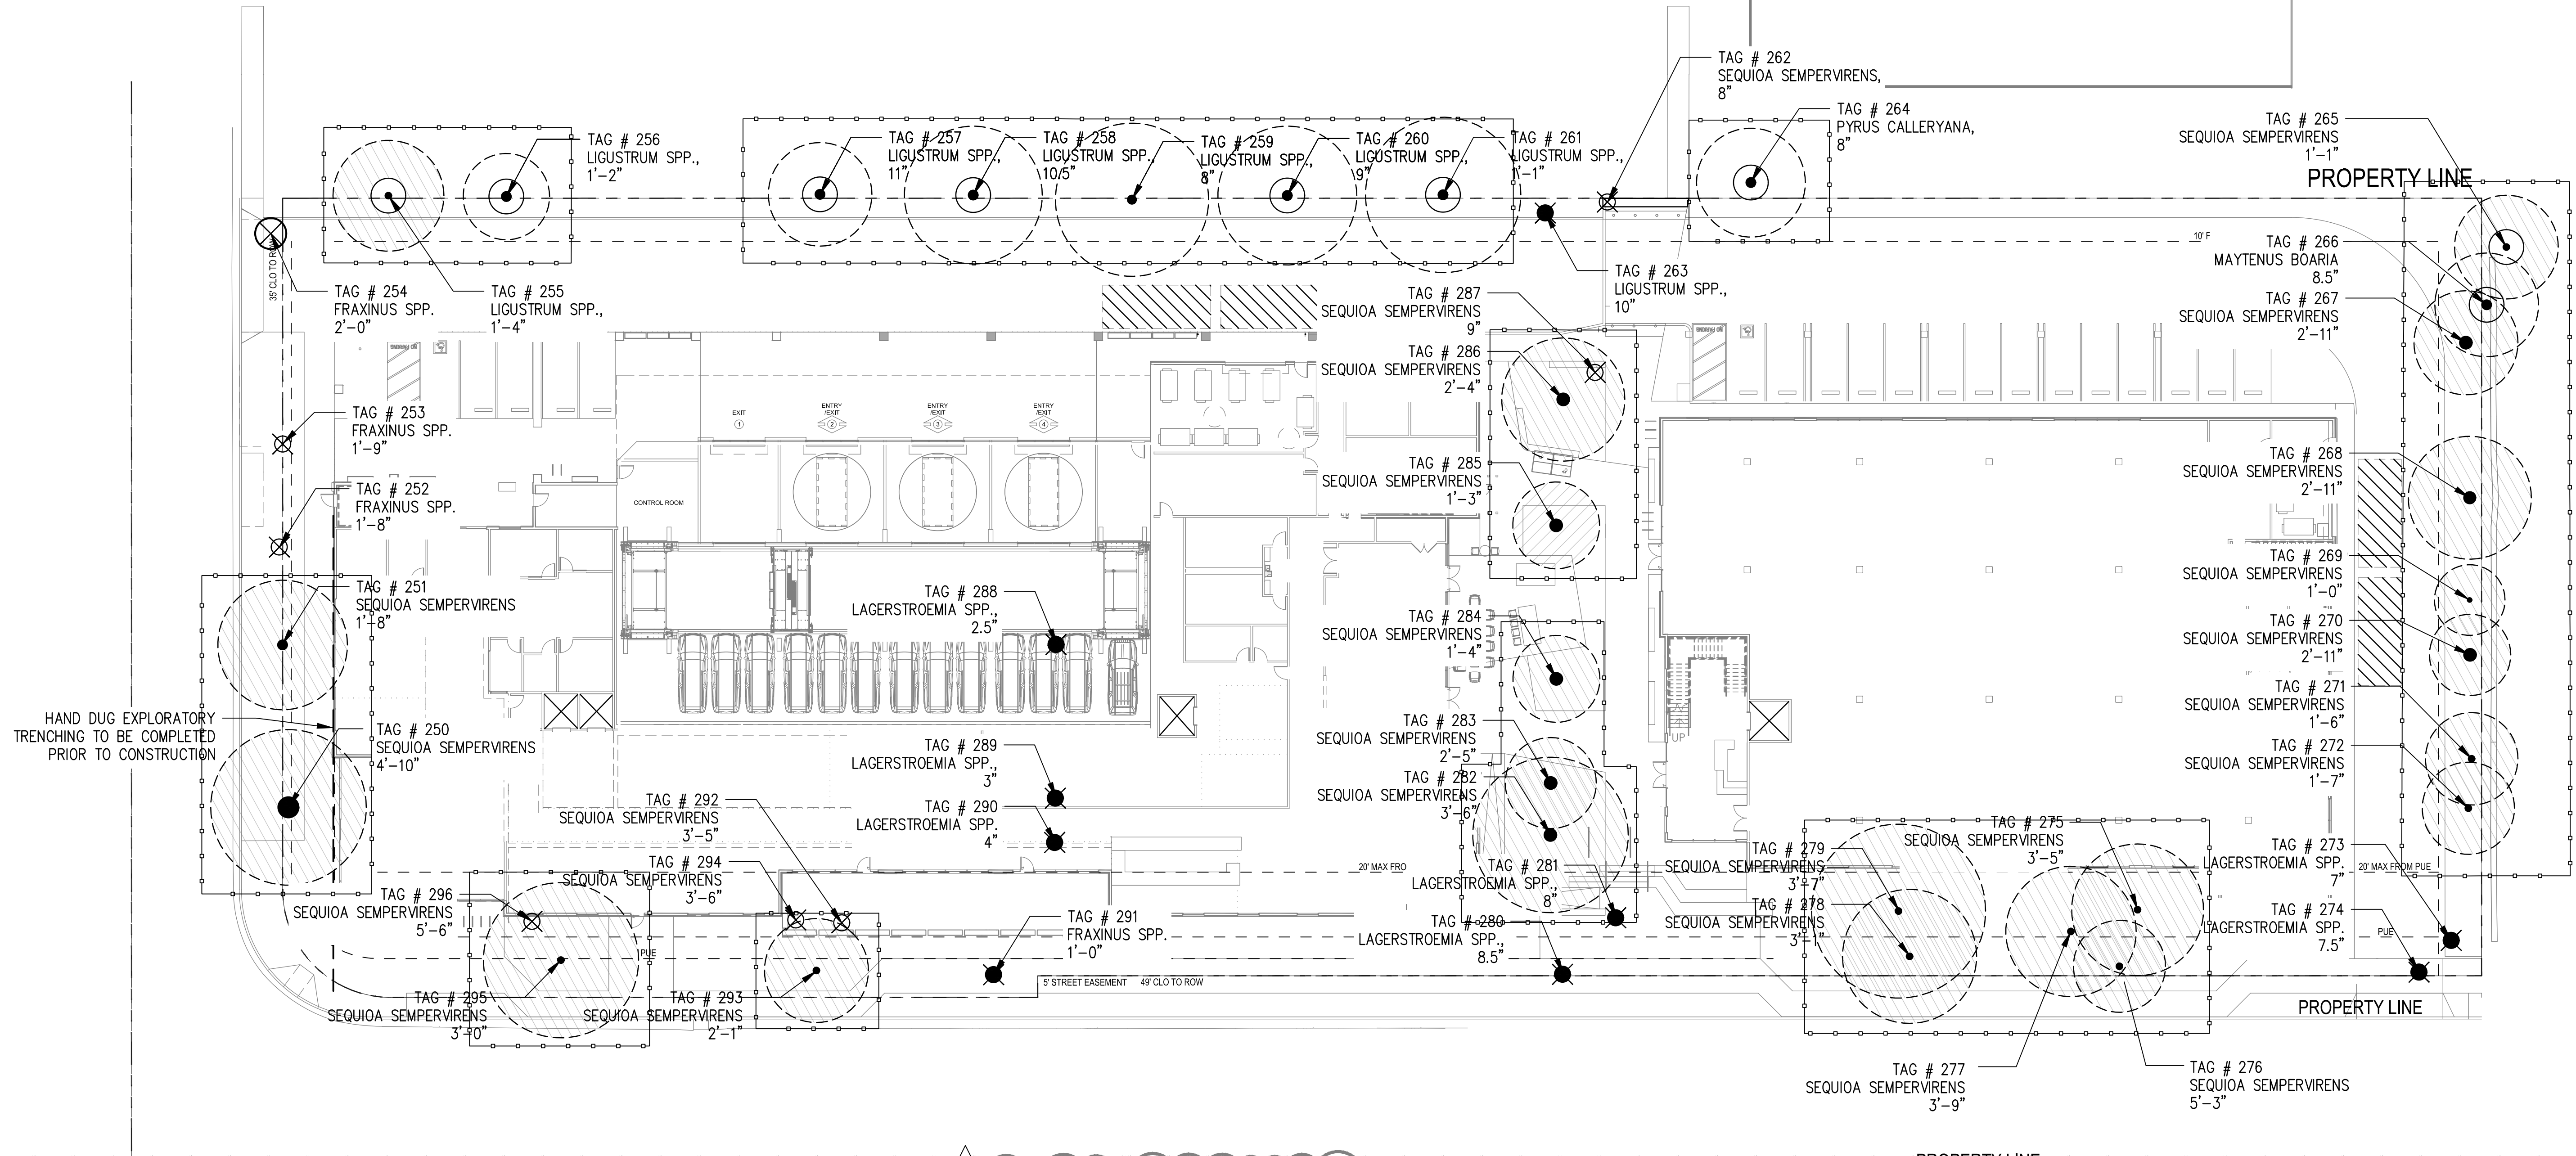
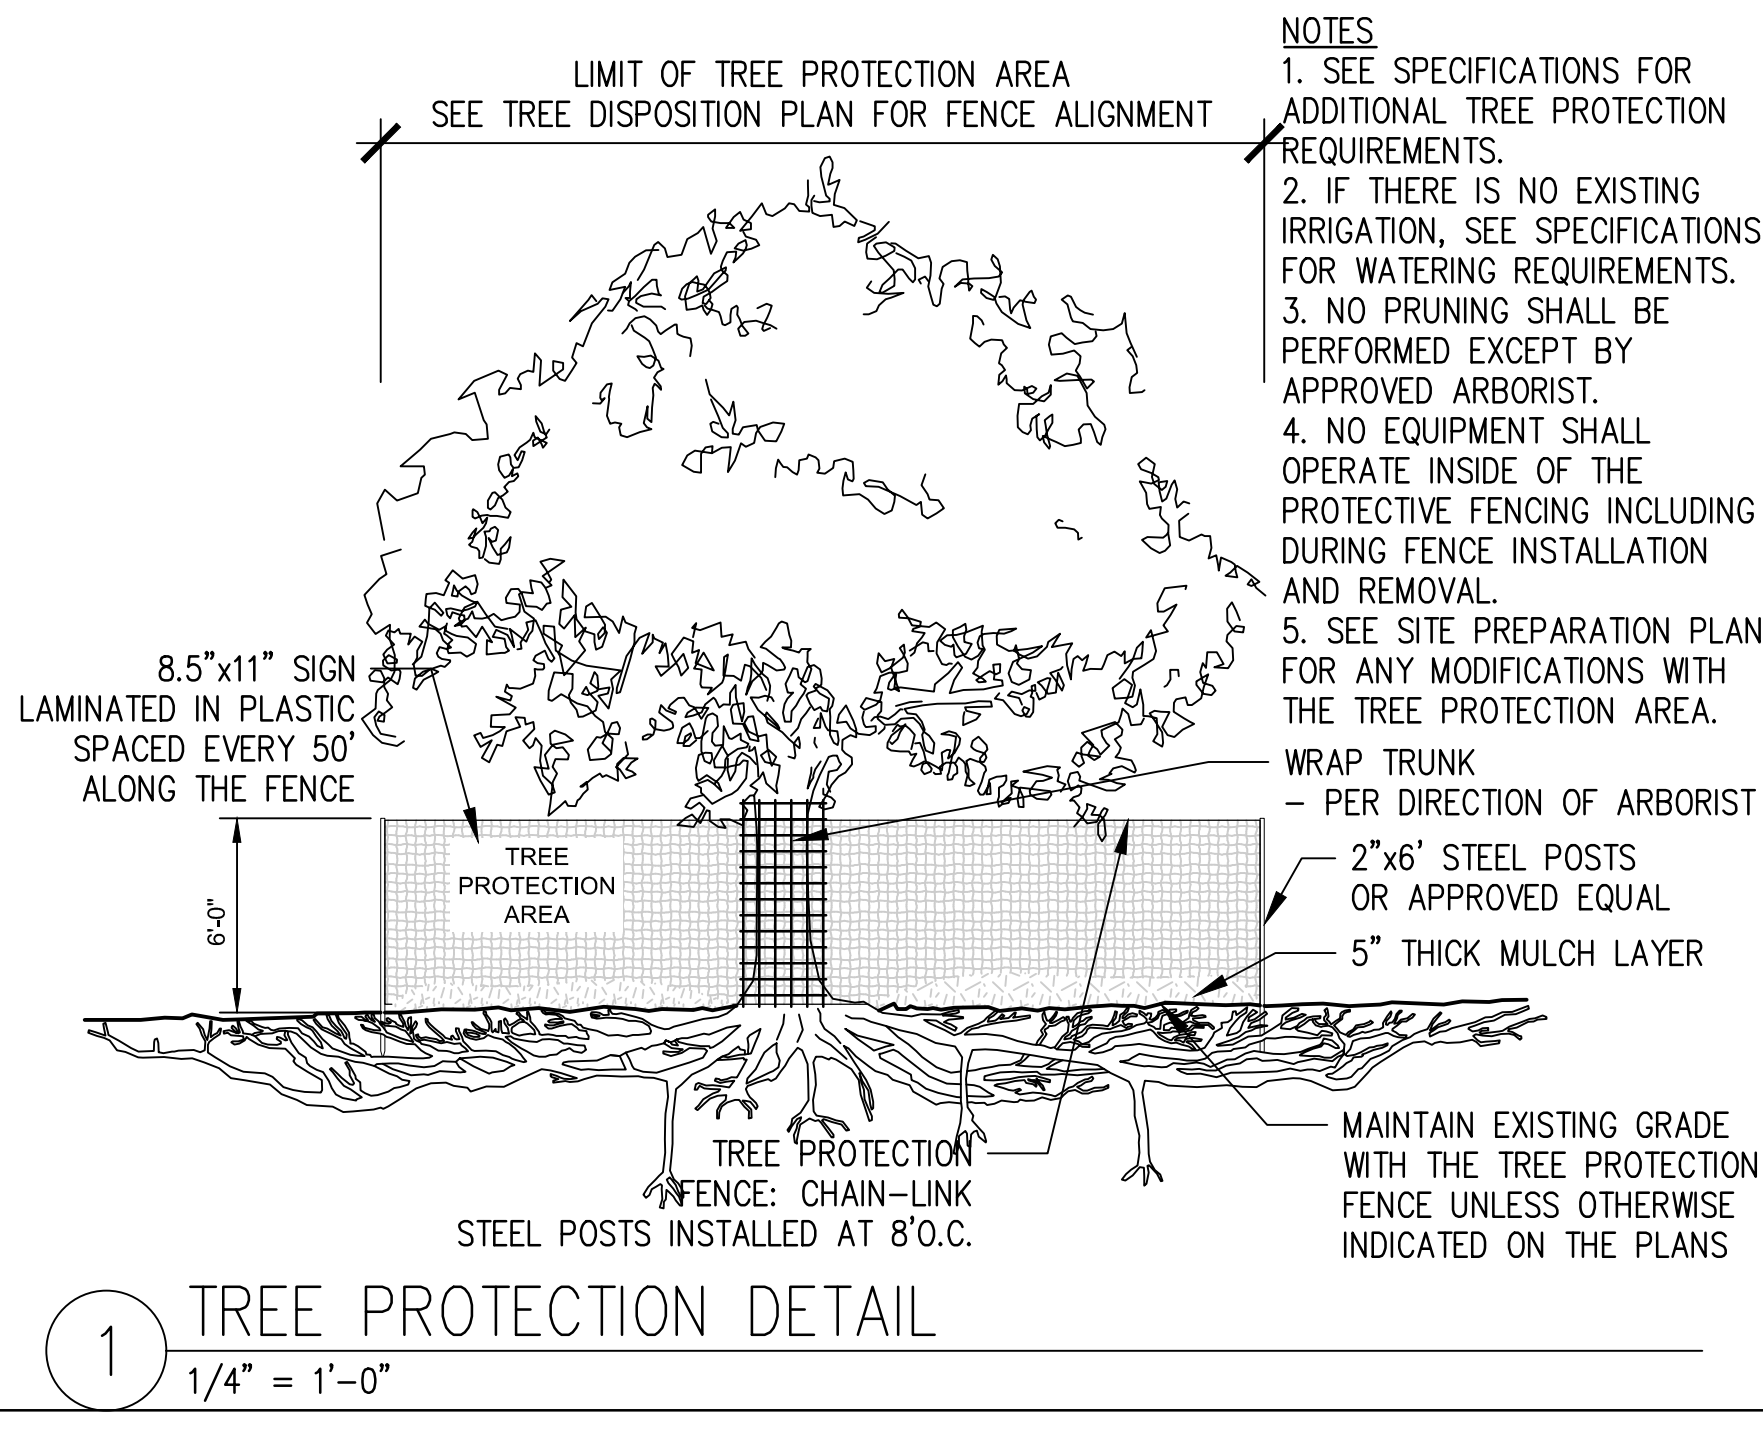
HAND DUG EXPLORATORY TRENCHING TO BE COMPLETED PRIOR TO CONSTRUCTION
