## Mayne Tree Expert Company, Inc.

December 4, 2024

RE: 5 FOREST GLEN ST., MOUNTAIN VIEW (ARBORIST REPORT)

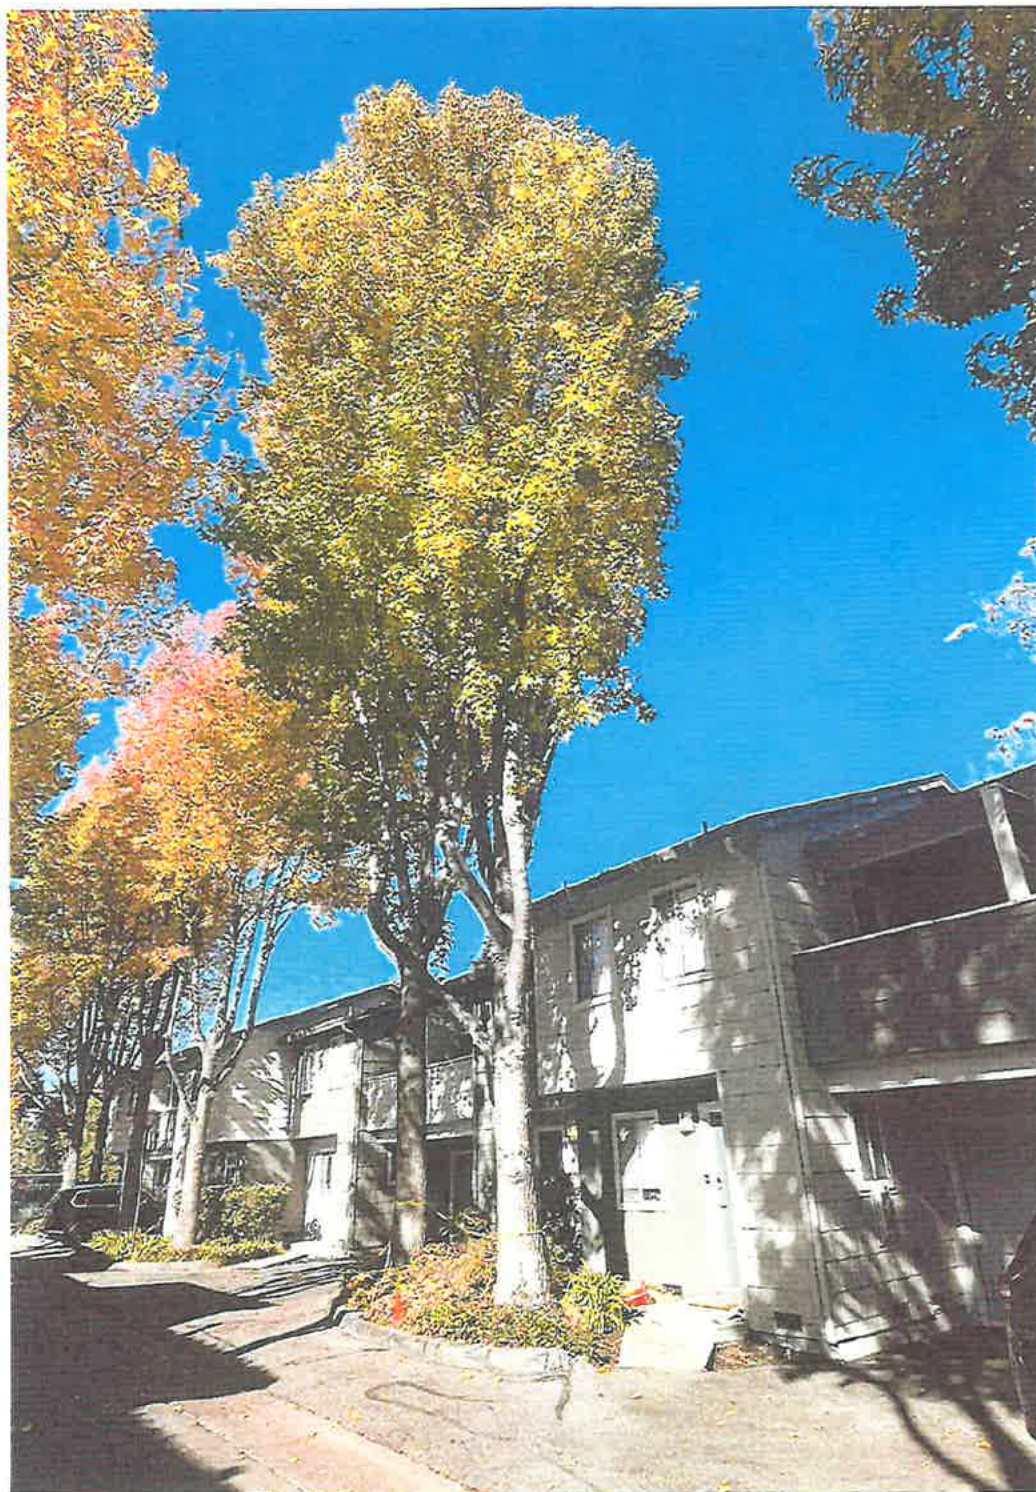
Picture #1

This liquidambar tree grows in a planter bed along the front of the home near the street (Picture #1). The roots of this tree have caused substantial damage to the irrigation system (Picture #2). An irrigation geyser in front of the home found this damage, which led to the discovery that the rotors had caused the damage. The roots have also damaged the curb and street, creating an uneven front walkway (Pictures #3 through #6). This tree has a five-stem attachment 20 feet (Pictures #7, #8, and #9). This location appears to be where the trees were topped in the past, which is consistent with the other multi-stem attachments in the Liquidambar trees lining the private street. Overall, this tree has good vigor and poor form.

This tree has caused extensive damage to the road, the irrigation, the walkway, and the street. It has poor form and is growing over a high target high traffic area, which puts everyone who uses the street at risk. No mitigation will counteract the root growth of these trees nor eliminate the hazard this tree presents. For these reasons, I believe this tree poses a significant hazard to the home, the occupants of the home, and the public. I strongly recommend removing this tree as soon as possible.
