## **Preliminary Arborist Report**

**555 Middlefield Road  
Mountain View, CA**

**October 14, 2016**

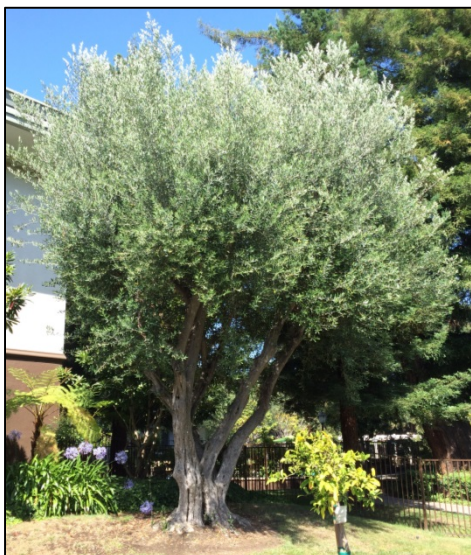
**Photo 1** (far left): Olive #318 had been previously topped at 15', but had a full, dense crown and was in good condition.

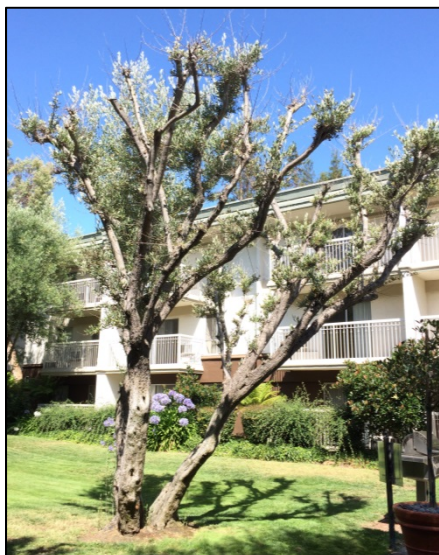
**Photo 2** (left): Tree #319 was in poor condition with very little live foliage.

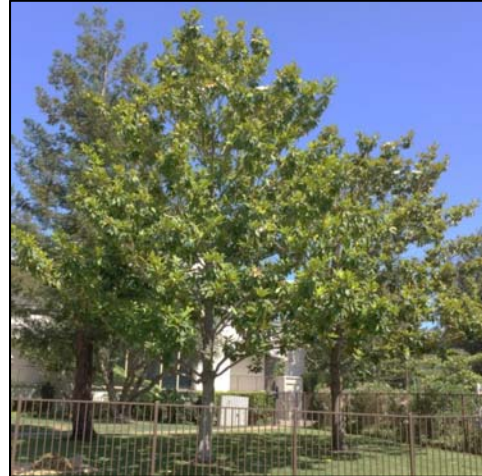
**Photo 4:** Southern magnolia #174 was in good condition with good form and structure.
