APPLICATION FOR HERITAGE TREE REMOVAL PERMIT

The undersigned owner of the property at 575 Sierra Ave, Mountain View

Kielty Arborist Services

Site: 591 Sierra Avenue, and adjacent parcel, Mountain View, CA

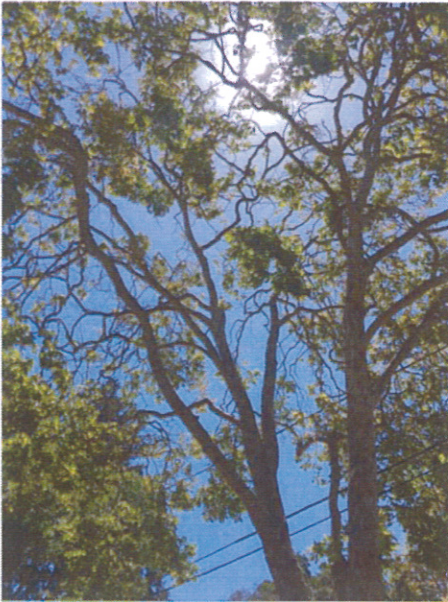
Tree#	Species	DBH	CON	HT/SP	Comments
1H	Sycamore (<i>Platanus x hispanica</i>)	20.9	50	50/40	Fair to poor vigor, fair form, codominant at 10 feet, abundance of die back in canopy.

**Summary:**

The majority of the trees surveyed are in fair to good condition. Sycamore street tree #1 is in fair condition. An abundance of dead wood was observed in the tree's canopy during my site visit. This could be a sign of anthracnose causing leaf drop. It is recommended to provide supplemental irrigation to this tree where possible to increase its health. Sycamore tree #1 was the only tree located on the property at 591 Sierra Avenue. This tree will need to be protected during the entire length of construction. The street tree's entire planting pit must be fenced off by tree protection fencing.

Showing abundance of dead wood in canopy**Remaining trees are all on the adjacent parcel next to 591 Sierra :**

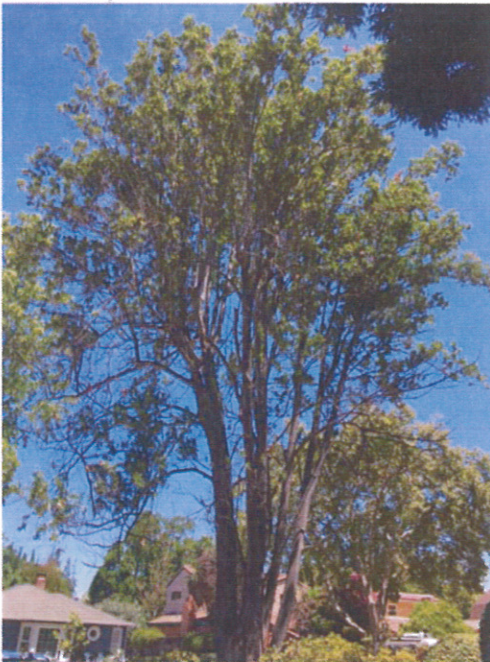
2H	Bay (<i>Umbellularia californica</i>)	41.6	40	65/40	Poor vigor, poor form, topped at 30 feet in the past, codominant at 8 feet, abundance of dead wood, large sprouts now leaders, hazardous.
3H	Redwood (<i>Sequoia sempervirens</i>)	48.2	80	120/35	Good vigor, good form, in grove.
4H	Redwood (<i>Sequoia sempervirens</i>)	24.1	80	110/35	Good vigor, good form, in grove.
5H	Redwood (<i>Sequoia sempervirens</i>)	28.1	70	65/20	Good vigor, fair form, suppressed, top not visible, in grove.
6H	Redwood (<i>Sequoia sempervirens</i>)	27.4	80	100/25	Good vigor, good form, in grove.
7H	Redwood (<i>Sequoia sempervirens</i>)	44.7	80	130/35	Good vigor, good form, in grove.
8H	Redwood (<i>Sequoia sempervirens</i>)	32.6	80	100/35	Good vigor, good form, in grove.
9H	Douglas fir (<i>Pseudotsuga menziesii</i>)	35.1	80	100/30	Good vigor, good form, in grove.
10H	Redwood (<i>Sequoia sempervirens</i>)	12.5	50	35/12	Fair vigor, poor form, suppressed.

Bay tree #2 is the only tree on site in poor condition. This tree has poor vigor with an abundance of dead wood, and poor form, as the tree has been topped in the past at 30 feet. Topping trees is never recommended as it leads to a high risk of future limb failure. New limbs that form after a topping cut has been made do not develop proper branch to trunk unions and as a result are prone to failure during normal weather patterns. These new limbs with poor unions now account for 35 feet of the tree's height. Limb failure is at high risk with this tree as a result of the poor past maintenance. Removal of this tree is recommended as a limb failure is imminent, making the tree a hazard to the property.

Showing bay tree #2**Kielty Arborist Services**

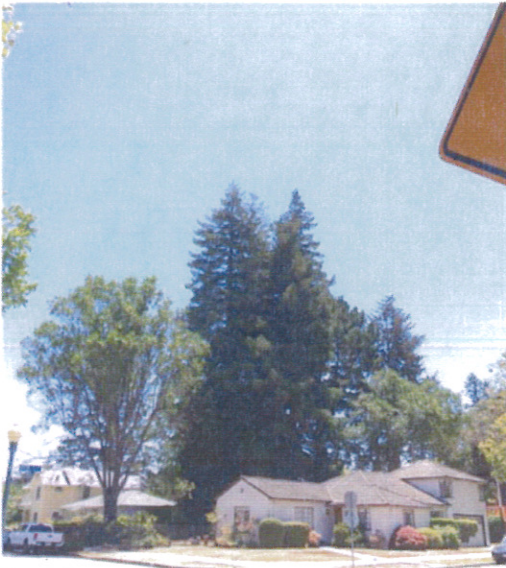
Redwood trees #3-8, #10 and Douglas fir #9 make up a large grove on the adjacent parcel next to 591 Sierra Avenue. These trees are all located in the southern corner of the property. Because a new home is proposed on this empty parcel, these trees are recommended for removal as they take up the majority of the buildable area on this site. Without these trees removed the site is virtually unbuildable. Large 4-6 inch diameter roots were observed at 29 feet from the large grove. At 29 feet from the grove is the center of the property. Cutting large 4-6 inch diameter roots would likely have a high impact on the health of these trees as well as the structural integrity, therefore these trees are proposed for removal.

Showing grove of redwood trees

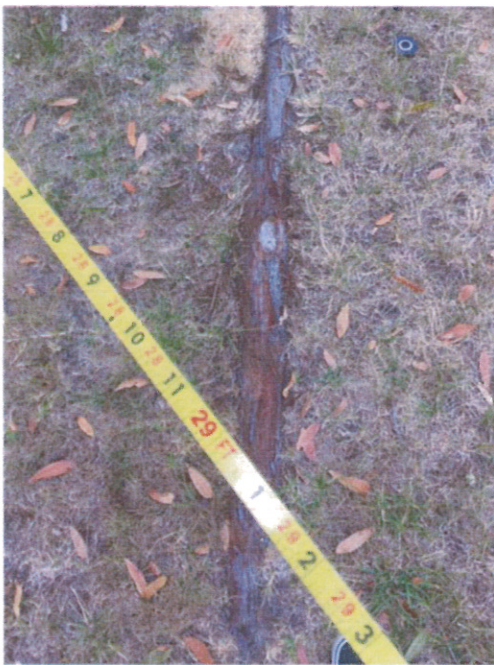
Showing large root at 29 feet from grove

Redwood trees are not native to this area of Mountain View as this area is primarily an oak woodland habitat(dry). Redwood trees in their native habitat receive water through means of coastal fog and summer rainfall. That said in order to keep redwood trees healthy in this area human intervention by mean of heavy irrigation is a must. A mature redwood is capable of using 500 gallons of water in one day. The irrigation needs for these trees is too large for the restrictions put on conservation of water. Redwoods that grow outside of their native habitats tend to develop shallow root systems that can extend 100 feet away from a mature tree. This root system can cause significant damage to nearby foundations or hardscapes. Redwood trees are not practical on such a small lot. The following tree protection plan will help to insure the future health of the retained tree on site.
