**Tree Inventory of**  
**500/550 Ellis St**  
**Mountain View, CA 94043**

**Prepared by**  
**Urban Tree Management, Inc.**  
**Inspection Date: November 4, 2019**  
**Revised: September 11, 2023**

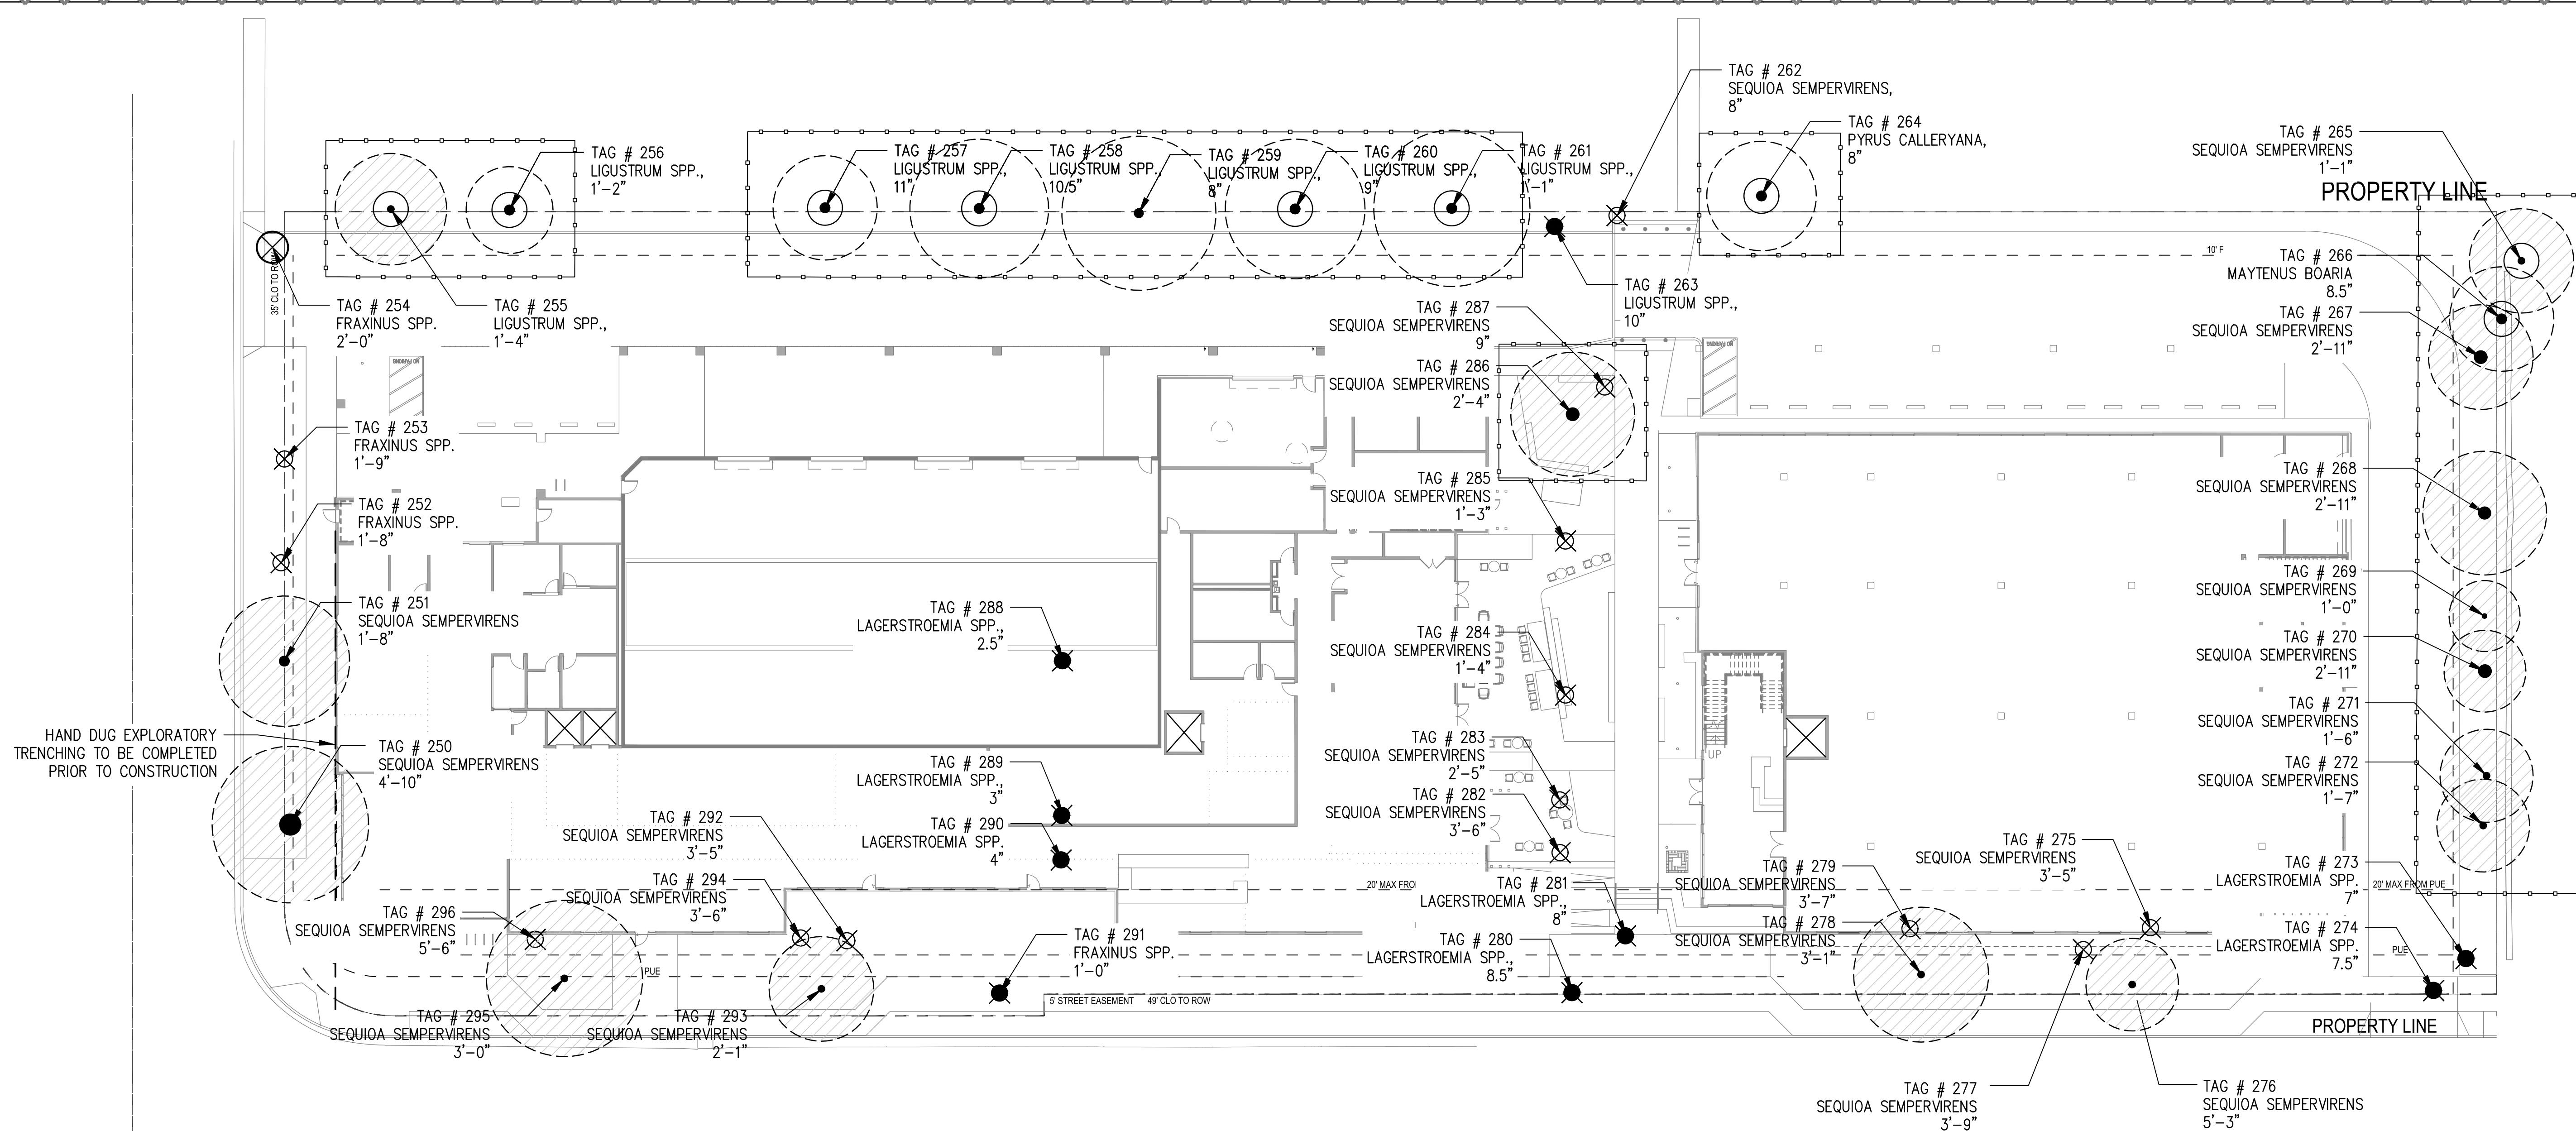
Date: 08/04/2023  
 Scale: 24x36;  
 11x17;  
 Sheet: **L0.04**

HAND DUG EXPLORATORY TRENCHING TO BE COMPLETED PRIOR TO CONSTRUCTION
