# 266 & 272 Tyrella Ave Mountain View, CA Arborist Report 2024

Date: May 30th, 2024

Subject: Tree protection plan for 266 & 272 Tyrella Ave, Mountain View, CA 94043

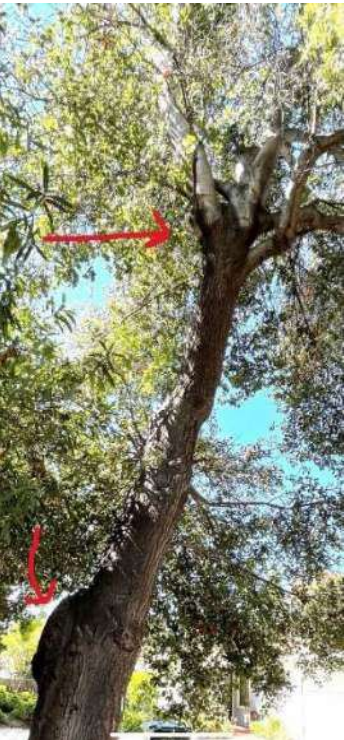
Coast Live Oak tree #3 is in poor condition. The health of the tree is fair, but its form and structure are poor. The tree has been pruned on one side of its canopy for utility line clearance pruning. The tree also leans heavily into the property. The tree is not allowed to balance itself out and will always have an unbalanced canopy due to the overhead utility line location and the constant pruning needed. A large limb at 6' on the trunk has been removed in the past and some associated decay was observed. The tree has also been topped in the past, creating risk of limb failures due to the poor structure of the tree. Topping trees weakens trees. Topping cuts lead to decay as the wounds made are too large for the tree to compartmentalize the wound. This gives decay organisms a free path to move down through the branches, often resulting in an unacceptable level of risk. After a tree is topped, the tree's survival mechanism causes a tree to produce multiple shoots below each topping cut often referred to as "water sprout growth." The new shoots develop from latent buds hidden underneath the surface of old branches. These new shoots are not anchored into the tree like normal branches that develop in a socket of overlapping wood tissues. The new shoots are weakly attached as they are only anchored in the outermost layers of the parent branches. These sprouts grow very quickly as a survival mechanism and are prone to failure in normal weather conditions due to the limbs being weakly attached. Limb failure risk also increased as decay is likely to be found from the past topping cut. The new limbs are also at risk of developing included bark. Crown restoration and crown reduction pruning is recommended. This tree will need annual monitoring due to the tree's poor structure.

Oak trees #3 and #6 are shown in close proximity to the ADA ramp (4'1" from #3 & 2'11" from #6). The ramp is to be supported entirely on top of the existing grade using individual wooden posts. No continuous cut shall be used as a foundation for the ramp, as this would lead to higher impacts than necessary. All post holes when working within the tree driplines shall be excavated by hand under the project arborist's supervision. The plan shall maintain flexibility in post-hole locations. If roots measuring 2" in diameter or larger are encountered, the posts are recommended to be moved to retain a root of this size. Impacts are expected to be minor. The trees are recommended to be deep water fertilized using Nutriroot as a mitigation measure in the early spring. Mulch is proposed within the tree protection zones of trees #3, 4, and 6 as seen in the landscape plans for the site. The mulch should be installed within the tree protection zone before the start of construction as an additional tree protection measure.

The proposed underground parking and first-floor foundation are shown 11' from oak tree #3 and 16' from oak tree #6. The basement is recommended to be built using vertical shoring where oak tree #3 and #6 are located to reduce potential impacts to the trees as using a standard OSHA overcut would have higher impacts on the tree than necessary. The Project Arborist is recommended to be on-site to inspect the basement cut for the underground garage. All exposed roots at the basement cut are recommended to be cleanly cut back to the basement wall. Roots exposed measuring 1.5" in diameter or larger are recommended to be covered by layers of wetted-down burlap to help avoid root desiccation. Roots encountered are recommended to be documented by the Project Arborist. Impacts on the tree from the underground parking structure and foundations are expected to be minor. It is recommended to set up a series of soaker hoses at the basement cut and first-floor foundations once building materials have been allowed to dry and cure. Every other week during the dry season, the soaker hoses are recommended to be turned on until the top foot of the soil is saturated. Once a year following the construction of the foundations and underground basement cut, the irrigation can be permanently suspended. Deep water fertilizing the tree in early spring using Nutriroot is also recommended.

A pathway is proposed at 3' from oak tree #3. The pathway is recommended to be built up on top of grade and only require rough surface grading not to exceed more than 6" into grade when within the dripline of the tree. The rough surface grading will need to be done by hand when within the dripline of the tree. The entire pathway construction when within the dripline of the tree, will be required to be constructed by hand in combination with an air spade while under the supervision of the Project Arborist. Any roots encountered within the minor surface grading measuring 1.5" in diameter or larger are recommended to be retained by raising the grade of the pathway to keep the tree roots or packing the required base rock around the tree roots. All exposed roots during this process are recommended to be kept moist by wrapping/covering roots in layers of wetted down burlap to help avoid root desiccation. Impacts from the pathway

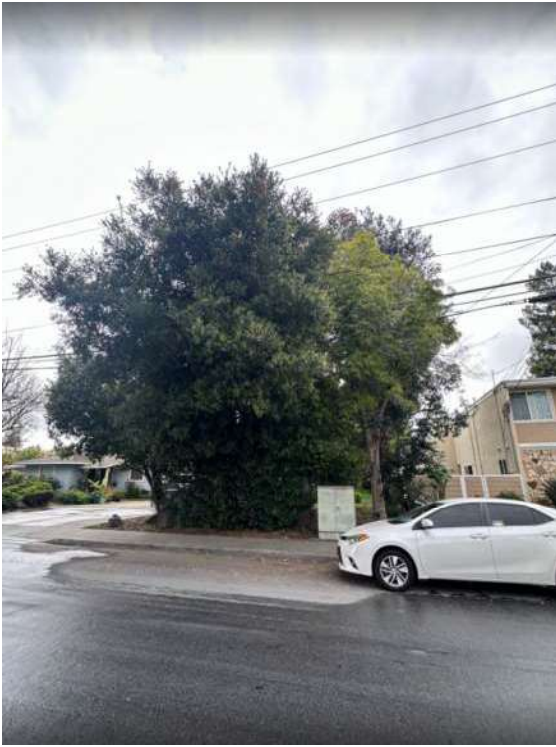
**Showing oak tree #4 under utility lines**

Coast live oak tree #4 is in fair condition (lower end). The health of the tree is good, but its structure and form are poor due to utility line clearance pruning and growing in suppressed conditions. The tree grows at a lean towards the street. This tree will need crown reduction pruning to reduce the risk of limb failure over the street.

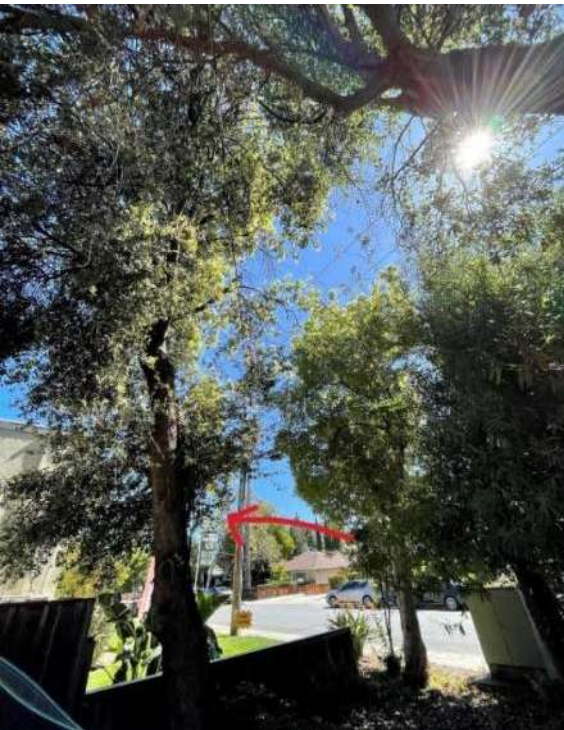
**Showing Holly Oak #6**

Holly Oak tree #6 is in fair condition. The tree has a slight lean into the property and has been pruned in the past on only one side of the canopy for line clearance. Future crown reduction pruning in the direction of the lean is recommended to balance the canopy.

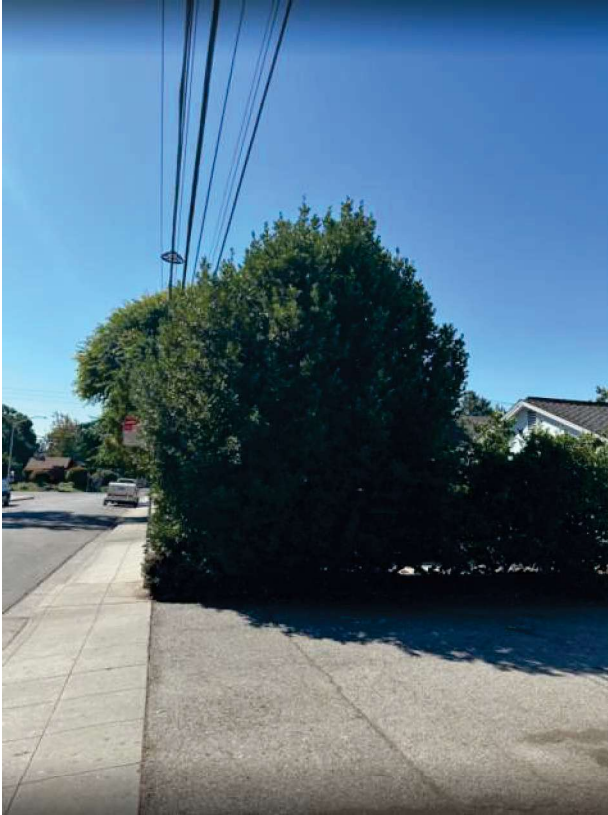
**Showing sweet bay #12**

Sweet Bay tree #12 is located on the neighboring property to the south. In the past the tree has been cut down and allowed to re-sprout. Hedge type tree maintenance is recommended to continue for this tree.

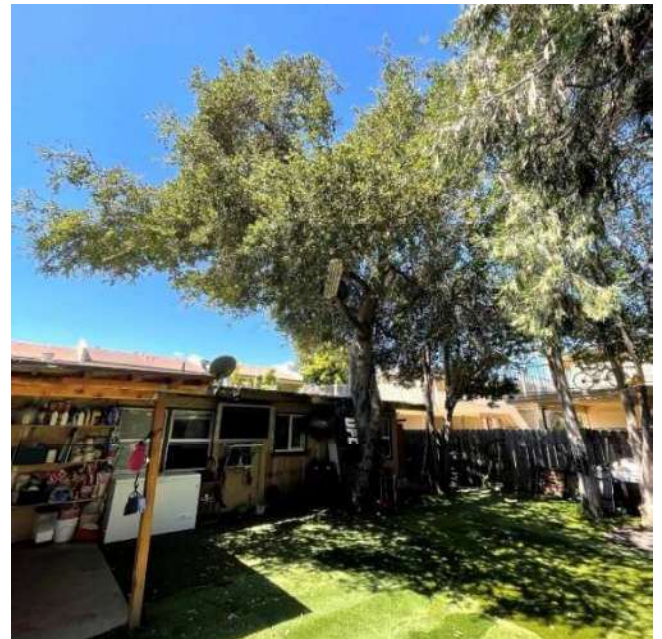
**Showing Oak tree #16**

Coast Live Oak tree #16 is in fair condition. This tree is to be retained for the project. Minor crown reduction pruning where over-stretched limbs are observed is recommended. Bleeding cankers were observed on the trunk. To treat an oak tree suffering from bleeding canker, it is recommended to apply Agrifos (a phosphonate fungicide) to manage the disease. Agrifos works by enhancing the tree's natural defense mechanisms, stimulating resistance to the pathogen that causes the canker. It is typically applied via injection or bark spray to ensure effective absorption. This treatment can help slow the progression of the disease, limiting further damage to the vascular system and preserving the overall health of the tree. Regular monitoring and timely applications are key to managing bleeding cankers effectively. The tree is close to the existing structure and has been growing in suppressed conditions.

The proposed underground parking and first floor foundation is shown at 9 feet to the south of Oak tree #16. The existing building to the south of the oak tree is only 5 feet from the tree. The existing building has likely acted as a root barrier from the tree and little to no roots are expected underneath the existing structure foundation. The basement to the east is shown at 16 feet 11 inches from the tree. This distance equals approximately 8 times the diameter of the tree and is considered within a tolerable distance, where impacts to the tree are expected to be minimal.

The potential for tree failure of Coast Live Oak #16 following construction has been evaluated, including the consideration that a portion of the root system on the southern side of the tree may be affected by excavation for the proposed underground garage. Based on the project layout, the garage wall is located 9 feet from the tree, within an area currently occupied by an existing structure that has likely functioned as a physical root barrier for many years. As previously stated, little to no significant rooting is expected on the southern side beneath the existing building footprint. Additionally, the proposed eastern basement wall lies approximately 16 feet 11 inches from the tree, or 8 times the tree's diameter, which is within a tolerable threshold for protected trees.

With vertical shoring to minimize over-excavation and arborist-supervised excavation practices, expected root loss will be limited to non-structural fine roots. The main structural roots supporting the tree are likely to remain intact, particularly on the north and west sides, which are undisturbed. Given the tree's current good health, structural form, and adaptive capacity, and considering the conservative construction methods proposed, the risk of structural failure post-construction is considered low. Ongoing annual inspections are recommended to monitor the tree's health and stability, particularly during the first few years following construction, to ensure any early signs of stress or imbalance are addressed promptly.

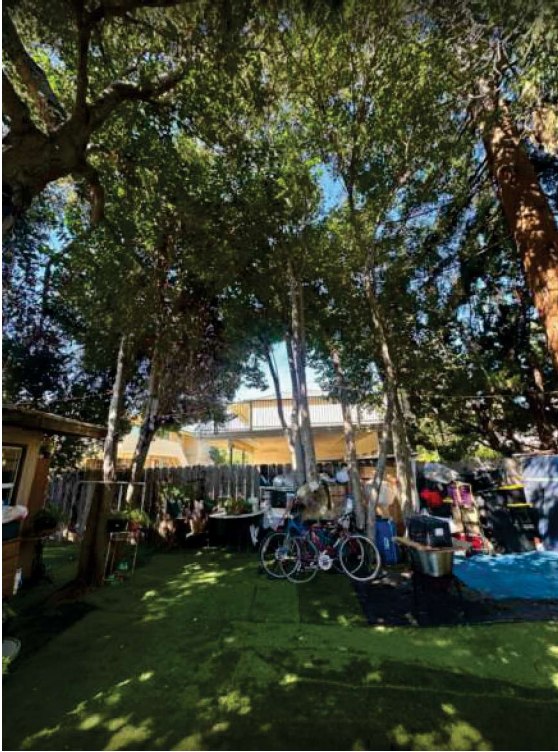
**Showing privet trees #14, #17 and #18**

Privet trees #14, #17 and #18 are in poor condition due to their poor structure and form ratings. The trees are codominant at 1-2', and dead wood was observed in the canopies. The trees do provide privacy screening and are to be retained for this purpose.

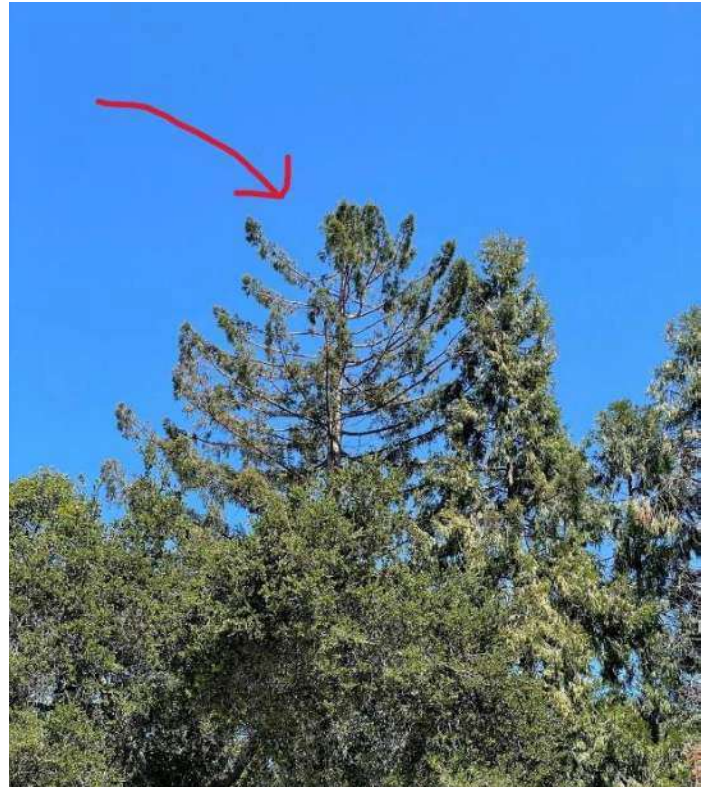
Redwood tree #21 is in fair condition (lower end). The tree is under a significant amount of drought stress causing the tree to decline in vigor. It is recommended to deep water fertilize the tree with 300 gallons of water mixed with Nutriroot fertilizer. This tree will need to be heavily irrigated with 50 gallons of clean water every 2 weeks during the dry season. The irrigation will hopefully improve the tree's condition rating. It is recommended to continue to monitor the tree.

**Showing top of  
Redwood tree #21 looking thin**

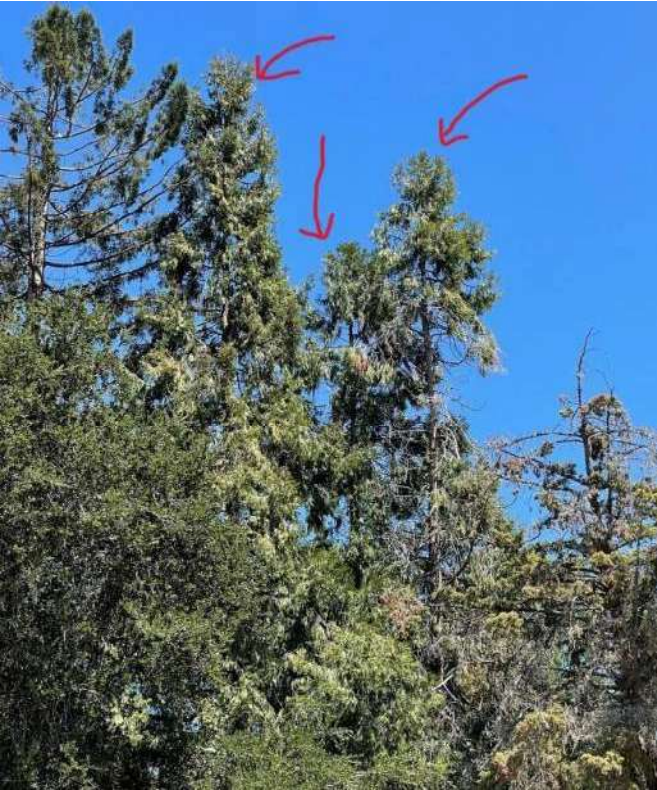
**Showing tops of Cedar trees #22-24 with areas of die back.**

Incense Cedar trees #22-24 are in fair to poor condition. Areas of *Coryneum canker* (caused by the fungus *Seiridium cardinale*) caused dieback were observed. The disease likely came from adjacent Monterey Cypress tree #15 that is in very poor condition due to the same disease. Treatment for *Coryneum canker* in incense cedar, caused by *Seiridium cardinale*, focuses on cultural practices aimed at reducing tree stress and promoting overall health, as no consistently effective fungicide treatment exists. Pruning infected branches during dry weather is essential to prevent the spread of spores; it's important to cut well below the cankered areas and disinfect tools between cuts. Proper irrigation, with deep and infrequent watering, helps reduce drought stress, a key factor that makes trees more susceptible to infection. Mulching with organic material around the base of the tree can aid in moisture retention and minimize root competition. Additionally, sanitation practices such as removing and disposing of fallen infected branches and needles can help limit the spread of the disease. While chemical treatments are generally ineffective, maintaining tree health and reducing environmental stress can significantly mitigate the impact of *Coryneum canker*. Regular monitoring is critical.

Maintaining irrigation for these trees is recommended to keep the retained trees healthy during construction. To irrigate trees effectively, deep but infrequent watering is essential, particularly during the dry season. Watering every other week is recommended to ensure moisture penetrates to a depth of 12 to 18 inches, encouraging deep root growth. This method helps trees access water from deeper soil layers, enhancing their resilience during periods of drought. Frequent, shallow watering should be avoided, as it promotes shallow roots, leaving trees more susceptible to stress.

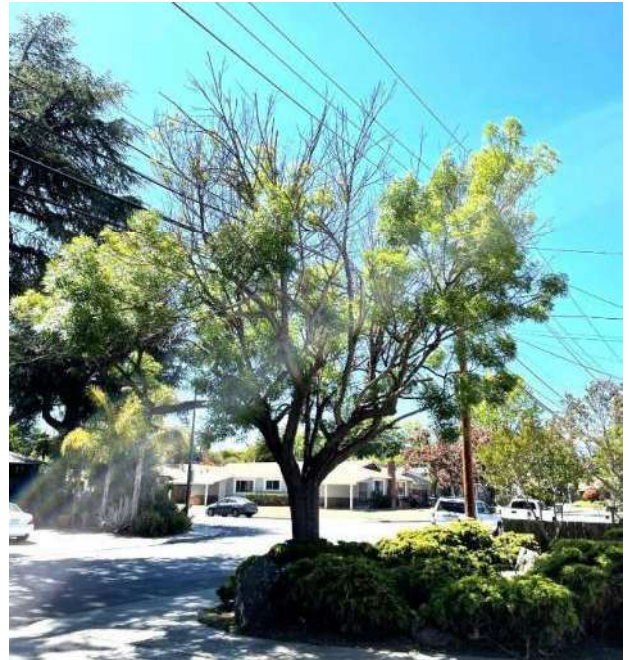
Showing Ash tree #1

Raywood Ash street tree #1 is in poor condition due to Verticillium, a common fungal disease for the species. The disease has caused large areas of die back in the canopy leading to an overall decline in health. This tree is not well suited for preservation withing the new landscape. The condition of the tree is poor due to disease and not expected to improve with any mitigation measures. This tree meets the following tree removal criteria as set forth in the Heritage Tree Ordinance of Mountain View: *1. The condition of the tree with respect to disease, infestation, general health, damage, public nuisance, danger of falling, proximity to existing or proposed structures, and interference with utility service.*

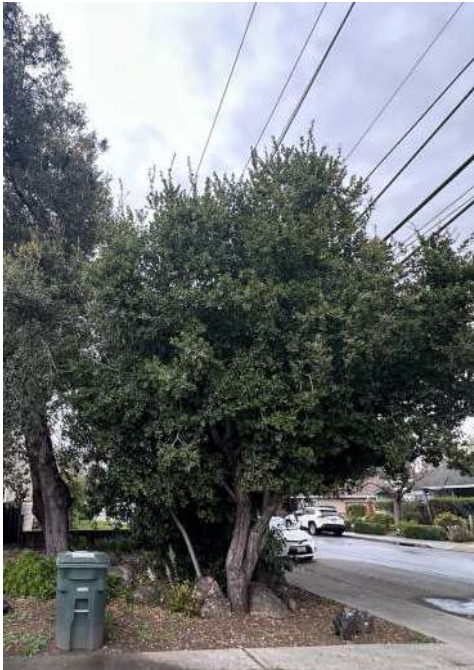
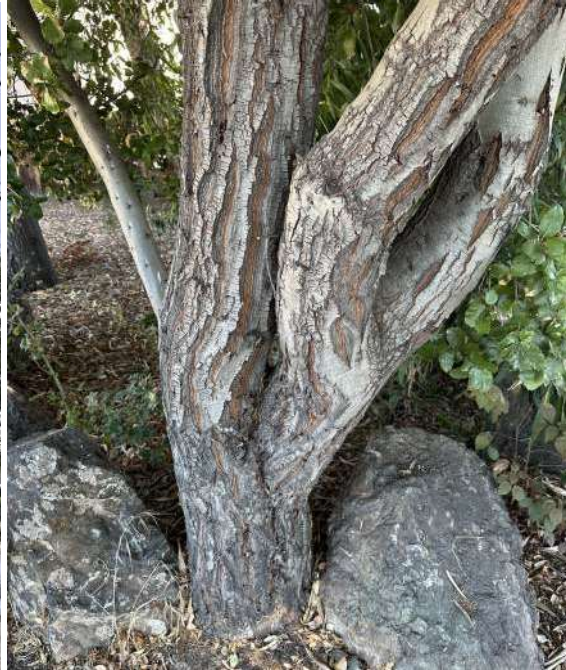
Coast live oak tree #2 is in fair condition. The tree is growing in suppressed conditions. The tree is codominant at 2' with included bark. Included bark often raises risk of large leader failures. The tree is proposed for removal to facilitate the construction of a pedestrian entry plaza. This tree meets the following tree removal criteria as set forth in the Heritage Tree Ordinance of Mountain View: *1. The condition of the tree with respect to age of the tree relative to the life span of that particular species, disease, infestation, general health, damage, public nuisance, danger of falling, proximity to existing or proposed structures, and interference with utility services. 2. The necessity of the removal of the heritage tree in order to construct improvements and/or allow reasonable and conforming use of the property when compared to other similarly situated properties.*

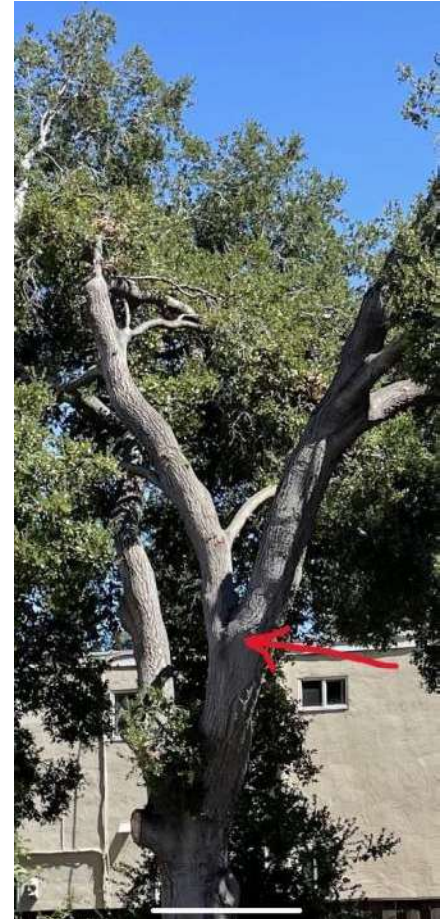
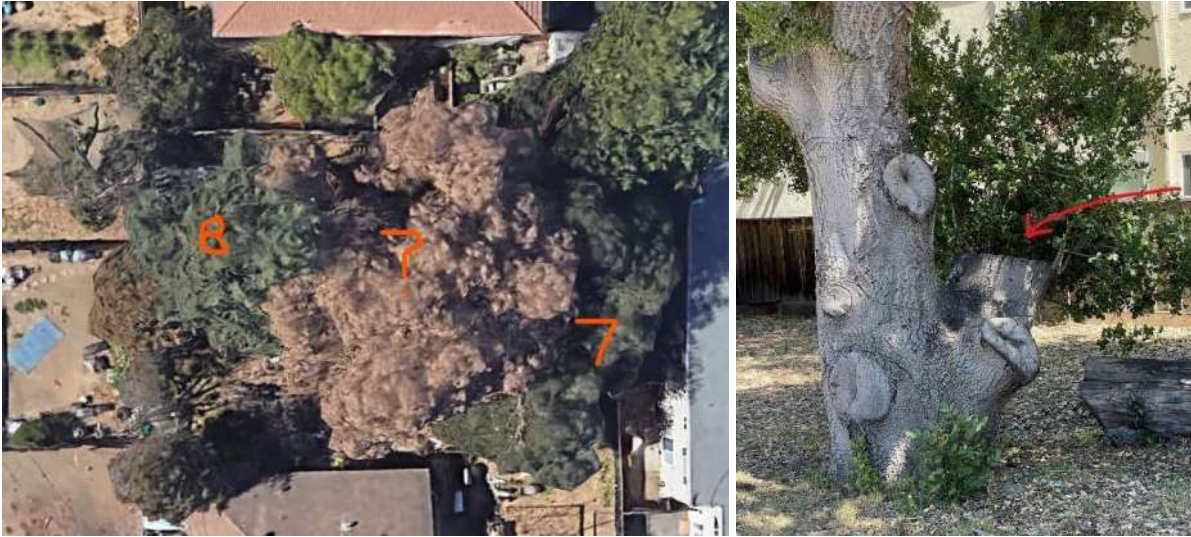
Coast Live Oak tree #7 was given a poor condition rating. Another tree, in the past, was located between oak tree #7 and Deodar Cedar tree #8. This tree was removed for unknown reasons. Looking at old Google Earth images, it looks like the tree was a large dead Monterey Pine judging by the color and shape of the canopy. The removed tree looked to have been the dominant tree in the backyard causing trees #7 and #8 to grow heavy away from the center of the property. Now that the tree has been removed, the oak tree #7 is subjected to windthrow with an increased likelihood of failure due to having an off-balanced canopy. The canopy as a standalone tree is very unbalanced. The tree is also codominant at 15' with included bark observed. Included bark significantly raises risk of a large leader failure. The risk of a codominant leader failure is high due to windthrow in combination with having an unbalanced canopy and included bark observed at 15'. The large codominant leader that was removed in the past at 5' will likely decay as the pruning cut is large and will not compartmentalize leading to an increased risk of a total tree failure at the lower trunk of the tree. The city of Mountain View has asked for risk assessment on the tree. Below you will find a completed tree risk assessment. **Picture showing codominant leaders with included bark (MORE PHOTOS ON NEXT PAGE)**

Showing trees #7 and #8 with past removed tree    Showing decay at 5'

Tree removal is recommended due to a moderate to high risk of failure in the crown or branches. The tree is very unbalanced with over-extended limbs. Once the load on the limbs exceeds the strength of the wood, large limb failures will take place. Pruning mitigations within ANSI standards would only delay the failure of large limbs. It is my professional opinion that this tree should be removed due to the risk of a large limb failure. The canopy is very unbalanced. This tree meets the following tree removal criteria: *1. The condition of the tree with respect to age of the tree relative to the life span of that particular species, disease, infestation, general health, damage, public nuisance, **danger of falling, proximity to existing or proposed structures, and interference with utility services.*** The developer owner is not comfortable with the tree and its associated risk; therefore, tree removal is recommended as the tree is outside the tolerable risk level of the developer.

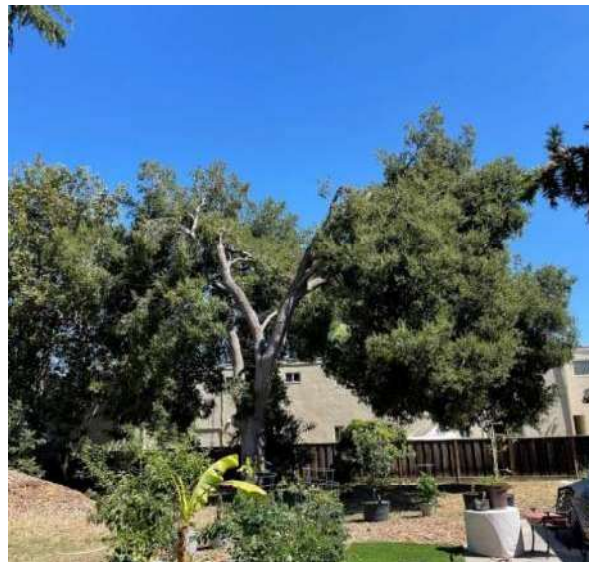
Showing an off balanced canopy subjected to wind throw

A basic level 2 tree risk assessment was conducted for oak tree #7. The tree parts of most concern are the crown/branches and trunk due to an unbalanced crown with over-extended branches and decay observed from a past large leader removal (conditions of concern). Load factors include strong winds and heavy rains which are normal for the area and come from the North West. The load on the crown and branches is significant while the load on the trunk is minor. The load is also increased due to the previous pine tree removal that took place. The likelihood of failure in the crown and branches is imminent (in my professional opinion) and the likelihood of failure of the trunk is possible. The targets looked at are people using the proposed courtyard (#1) and the proposed structure (#2). Both targets are within the tree's drip line. The structure has a constant occupancy rate while people in the courtyard have an occupancy rate of frequent. It is not practical to move the targets or to restrict access. The likelihood of failure is imminent in the crown and branches due to the unbalanced crown with over-extended branches observed. The likelihood of failure of the trunk is possible. The likelihood of impacting people in the courtyard is medium as they are not static targets, while the likelihood of impacting the proposed structure is high as it is a static target.

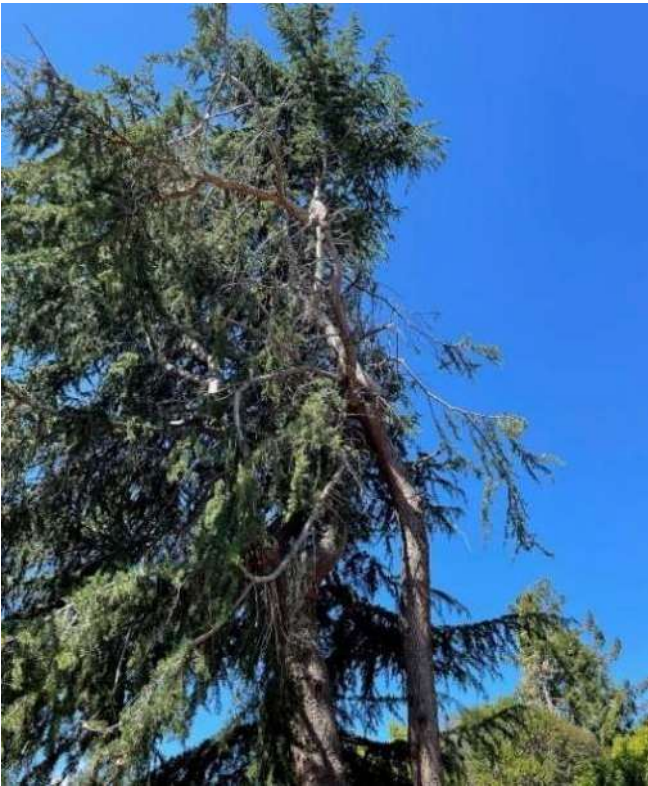
Deodar Cedar tree #8 was given a poor condition rating. An old mature Monterey Pine tree in the past was removed near the tree. The pine tree was removed for unknown reasons. The removed tree looked to have been the dominant tree in the backyard causing cedar tree #8 to grow heavy away from the center of the property. The large Cedar tree is now subjected to windthrow as the tree has lost its protection from prevailing winds. The canopy as a stand-alone tree is very unbalanced. Tree failure risk is high due to windthrow in combination with an unbalanced canopy. Poor codominant unions with included bark were also observed that further increase the risk of a large leader failure. A history of large limb failures was also observed. This tree meets the following tree removal criteria: *1. The condition of the tree with respect to age of the tree relative to the life span of that particular species, disease, infestation, general health, damage, public nuisance, **danger of falling, proximity to existing or proposed structures, and interference with utility services.** 2. **The necessity of the removal of the heritage tree in order to construct improvements and/or allow reasonable and conforming use of the property when compared to other similarly situated properties.*** (Photo showing off balanced canopies subjected to wind throw)

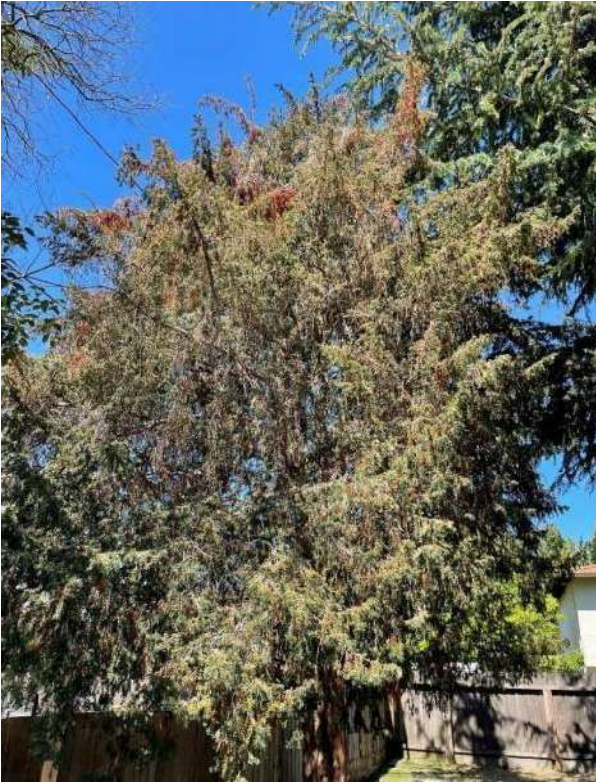
**Showing Yew tree #9 in decline**

Japanese Yew tree #9 is in poor condition and not expected to improve with any possible mitigation measures. Canker disease caused die back and drought stress have led to the tree into a state of decline. Tree removal is recommended. This tree meets the following tree removal criteria as set forth in the Heritage Tree Ordinance of Mountain View: *1. The **condition of the tree with respect to disease, infestation, general health, damage, public nuisance, danger of falling, proximity to existing or proposed structures, and interference with utility service.***

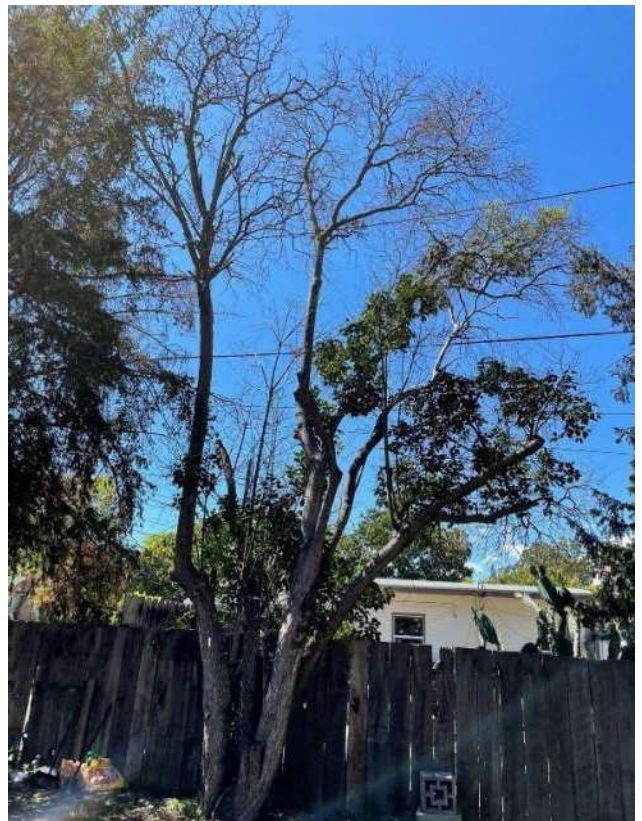
**Showing nearly dead privet tree #10**

Privet tree #10 is nearly dead and not expected to improve with any possible mitigation measures. Drought stress has led to the tree's decline. Tree removal is recommended. This tree meets the following tree removal criteria as set forth in the Heritage Tree Ordinance of Mountain View: *1. The **condition of the tree with respect to disease, infestation, general health, damage, public nuisance, danger of falling, proximity to existing or proposed structures, and interference with utility service.***

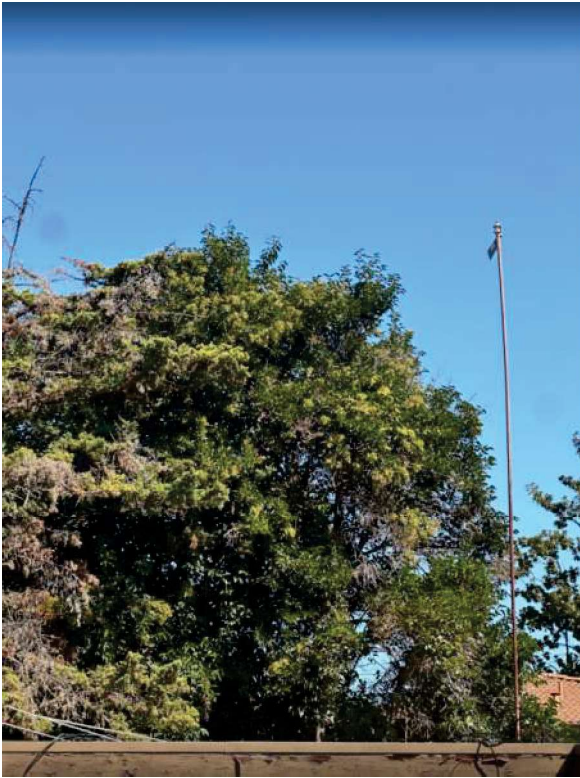
**Showing privet tree #13**

Privet tree #13 is in poor condition. The tree has not been well maintained in the past. The Privet tree is codominant with included bark. The Privet tree does offer some screening for the property but would easily be replaced by new screening material. This tree is not expected to improve. Privet tree #13 meets the following tree removal criteria as set forth in the Heritage Tree Ordinance of Mountain View: *1. The condition of the tree with respect to disease, infestation, general health, damage, public nuisance, danger of falling, proximity to existing or proposed structures, and interference with utility service.*

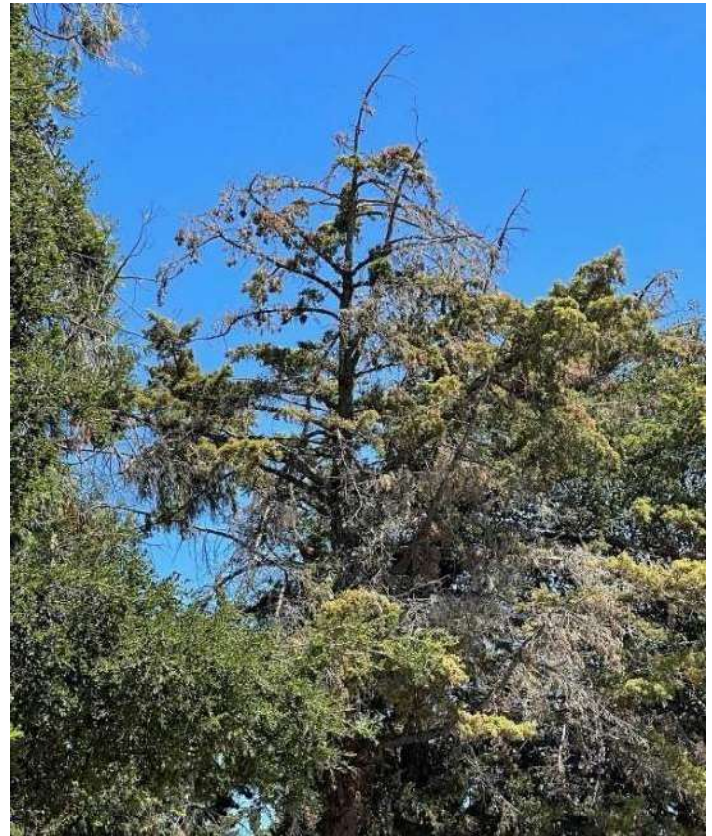
**Showing top of Monterey Cypress tree #15**

Monterey Cypress tree #15 is in very poor condition. Severe die back due to Cypress Canker Disease was observed. This tree is not expected to improve with any possible mitigation measures. Tree removal is recommended. This tree meets the following tree removal criteria as set forth in the Heritage Tree Ordinance of Mountain View: *1. The condition of the tree with respect to disease, infestation, general health, damage, public nuisance, danger of falling, proximity to existing or proposed structures, and interference with utility service.*
