961 EICHLER DR  
BLACK OAK

## HERITAGE TREE APPEAL NOTICE

**HERITAGE TREE APPEAL: 961 EICHLER DR/HTR-16164**

# Home Inspection Report

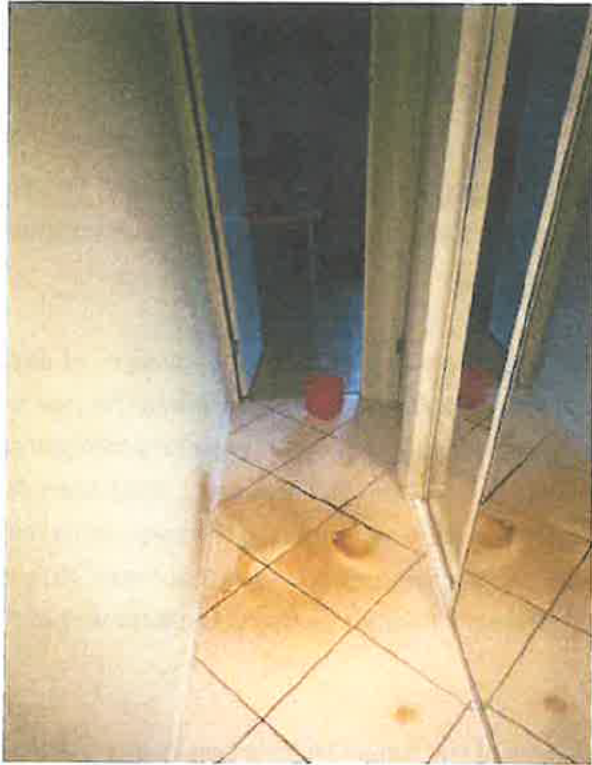
- d. Attachment E: Disclosures from home sale, page 6 roof leakage.
  - e. Homeowner Photo 1: interior view of roof leakage in southeast corner of home after rain.

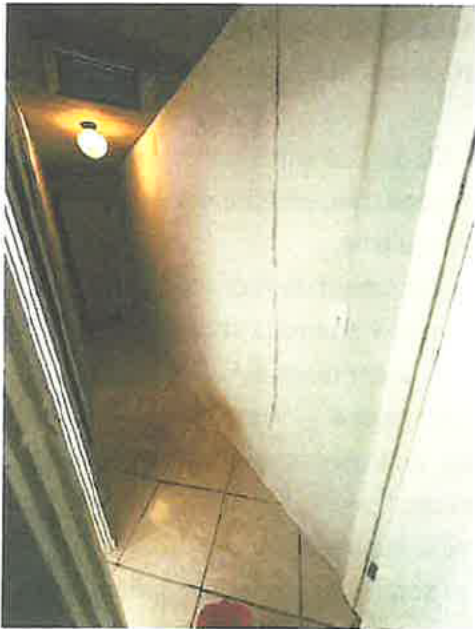
f. Homeowner Photo 2: interior view of roof leakage in southeast corner of home after rain. Please note the moldy skylight.

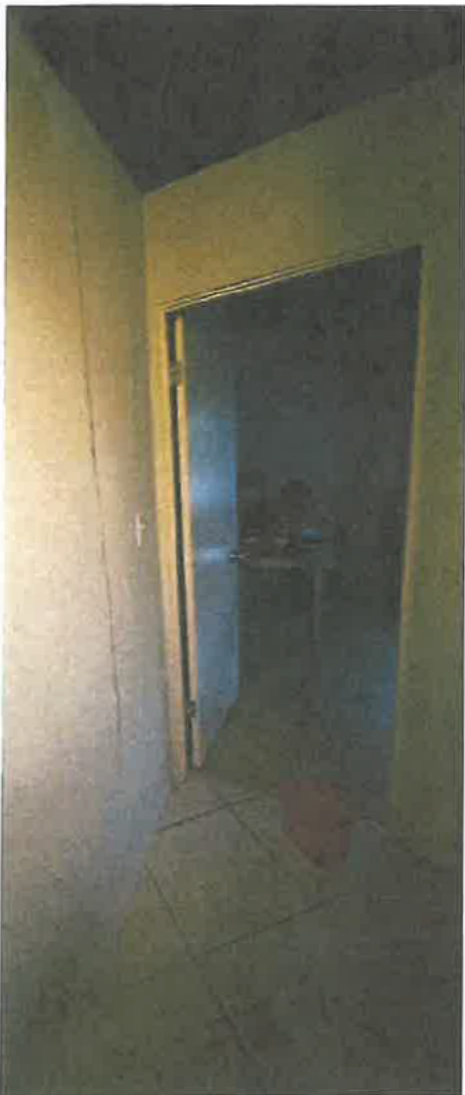
- g. Homeowner Photo 3: interior view of roof leakage in southeast corner of home after rain.

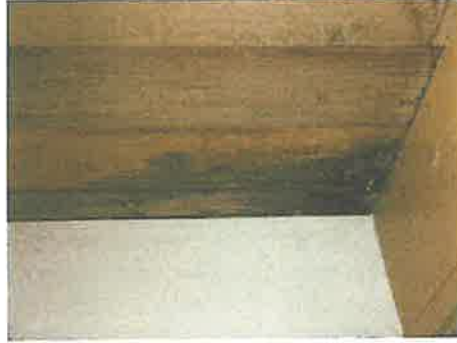
- 2

**FURTHER EVALUATION** Some moisture staining was noted on the underside of the roof sheathing in the south hallway, in the kitchen, in the bathrooms and in the bedrooms. Staining of this type is likely to be the result of past roof leakage and appeared to be dry at the time of the inspection. Consulting with the seller or current occupant for additional information on the history and performance of this system is suggested. (See the 'Roofing System' page for related information on this system.) (See the 'Interior Components' page for related information on this matter) Review of the roofing page in this report may provide additional information on the current condition of the roof covering. Review of a current pest control report is suggested and may provide additional information on this condition. Further evaluation of this area to verify current conditions is recommended.

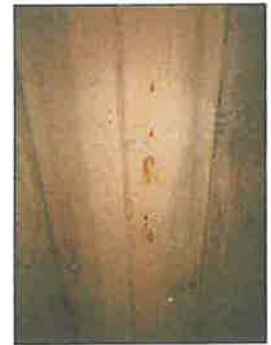
- 3

**REPAIR** Damage to the wood sheathing by wood boring insects was noted in the east bedroom at the ceiling. Treatment and repair of the affected wood sheathing is often needed to correct this condition. Review of a current pest control report is suggested and may provide additional information on this condition.

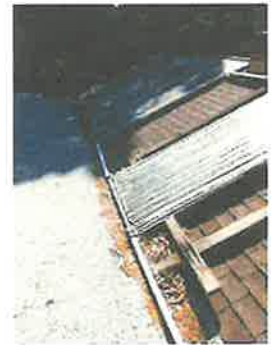
- 4

**CLIENT ADVISORY** A solar thermal (water heating) panel system has been installed on the roof and covers portions of the roofing material. As is common with systems of this type, the roofing material below the panel/s is not visible and could not be inspected. No conclusions are made or offered in inaccessible areas. We suggest further evaluation of this area when access can be provided. It should be noted that inspection and testing of the solar thermal system is beyond the scope of an industry standard home inspection and was not performed. Consulting with the seller or current occupant for additional information on this system is suggested. If additional information on this system is desired, consulting with a qualified specialist in the appropriate field is suggested. Review of the manufacturer's installation and operations guidelines for information on the operation and maintenance of this system is suggested.

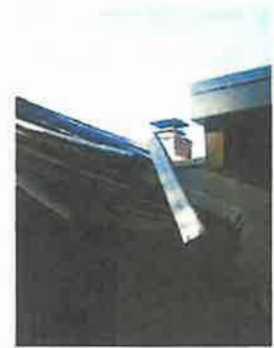
- 6

**SAFETY ISSUE** A loose metal component from the thermal heating panels was observed on the roof covering at the west side of the home. A loose or unsecured component can be blown or fall from the roof without warning and can be a risk of injury. *This condition presents a safety hazard and requires corrective action to reduce the potential for injury.* Removal of these items from the roof is strongly recommended.

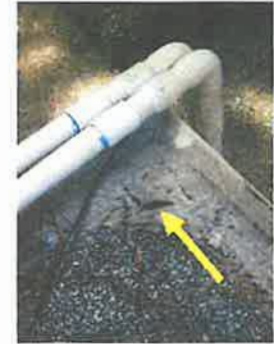
- 7

**REPAIR** The mastic sealed roof at the edge at the north/west corner was found to have voids or openings at the roof surface. Poorly sealed roof flashing is susceptible to leakage and resultant moisture damage. Improvement to seal the voids or opening is recommended. We suggest consulting with a qualified roofing contractor for further evaluation and repair as needed.

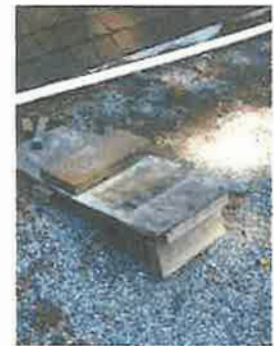
- 8

**MAINTENANCE** Store items and/or debris were observed on the roof covering at the north side of the home. Items placed on the roof can hold moisture in contact with the roof covering, can cause premature deterioration and/or damage of the roofing material and clog the roof drainage system. Removal of these items from the roof is recommended.

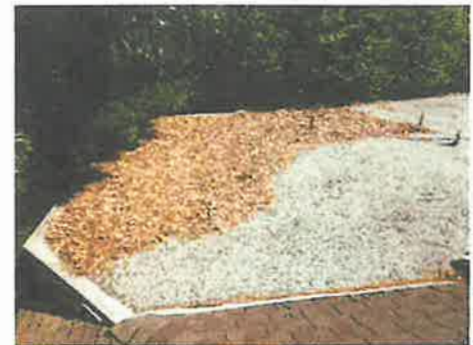
- 9

**MAINTENANCE** Tree droppings and/or debris were noted on the roof covering. Debris can clog downspouts and overflow the roof gutter/s and lead to moisture damage of the surrounding eave material below. Clearing the debris should be undertaken as soon as possible. Seasonal cleaning will be needed to maintain proper drainage of the gutter and downspout system.

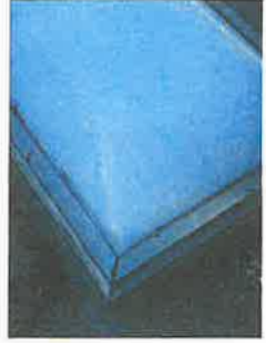
- 11

**REPAIR** The plastic dome on the skylight at the south/west corner has cracking damage on the surface visible. This condition should be evaluated further as leakage may develop over time. Budgeting to replace this plastic cover is advisable. Repairs to correct this condition are recommended.

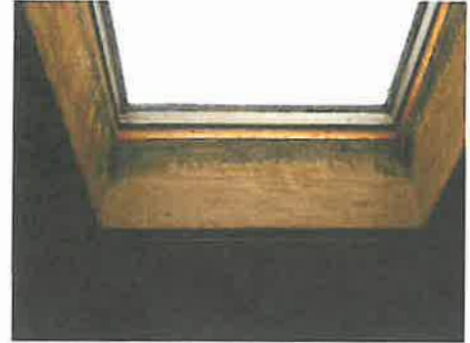
- 85   **FURTHER EVALUATION** Moisture staining was noted on the ceiling finish below each of the skylights. The surface was dry. Staining of this type is commonly an indication that some leakage or high moisture conditions have occurred at this location. (See related comments in this report) The moisture staining to date appears to be cosmetic, however, undetected moisture damage may be concealed and require repair. Further evaluation of this condition is needed. Review of a current pest control report may provide additional information.
