Certified Arborist's Pre-Construction Subpar Redwood Tree Status Report

Data Date: February 13, 2023

Site:
Residential Rebuild
333 Franklin St.
Mountain View, CA 94041

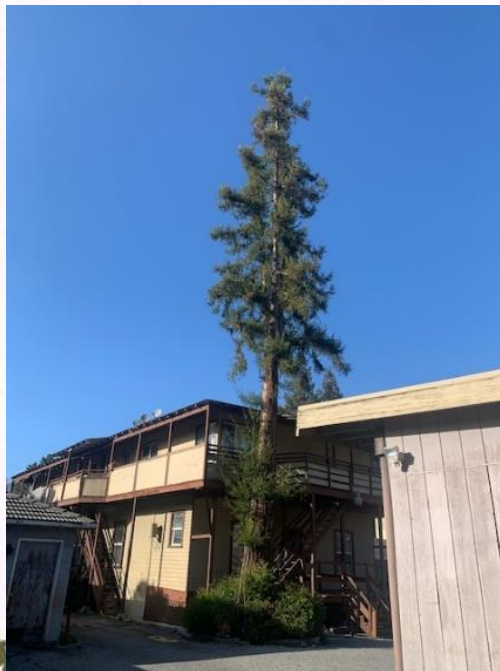
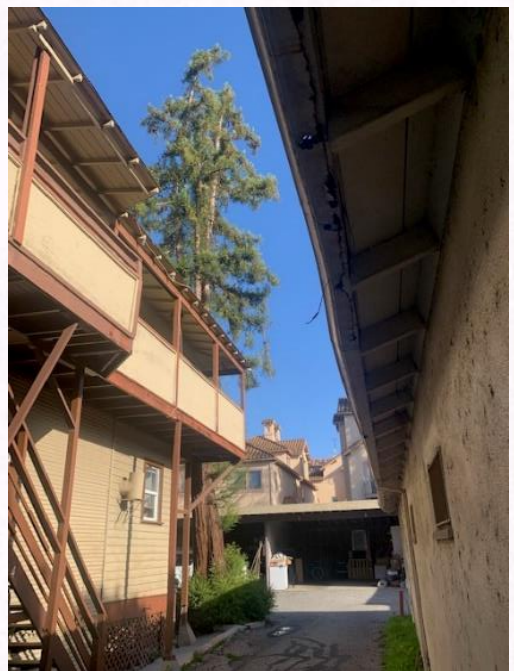
P-1 & P-2 (at right): Subject Redwood viewing from existing interior courtyard & from driveway looking in off of Franklin Street.

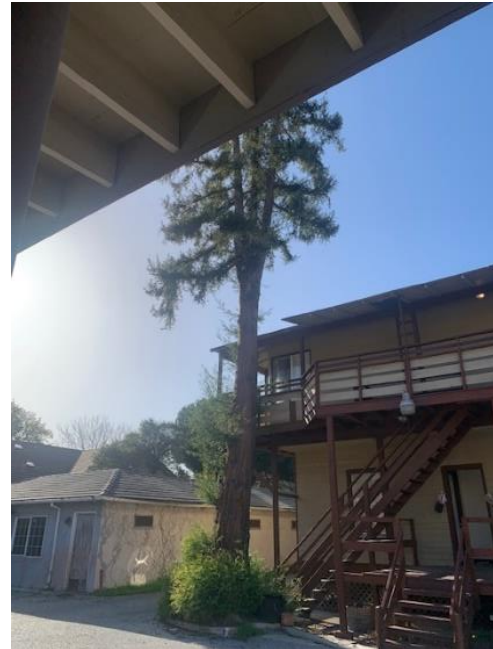
P-3 at right shows multiple leaders at lowest severe (topping) cut above roof level with all laterals (side branches) also severely truncated/stubbed.

The already hazardous condition of this tree would only be aggravated by new construction on these Franklin Street parcels ... the risk of failure of the v-crotches with narrow-angled trunk attachments and breakage of limbs due to foliage endweight accumulation will continue to overhang new homes and residents.

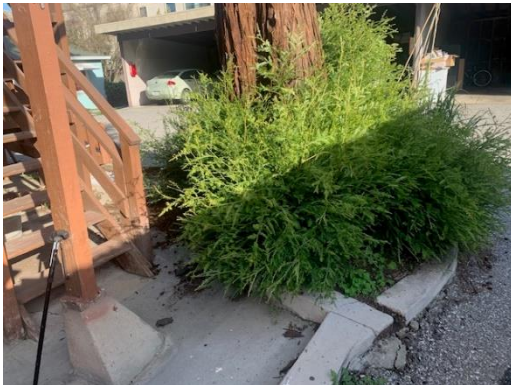
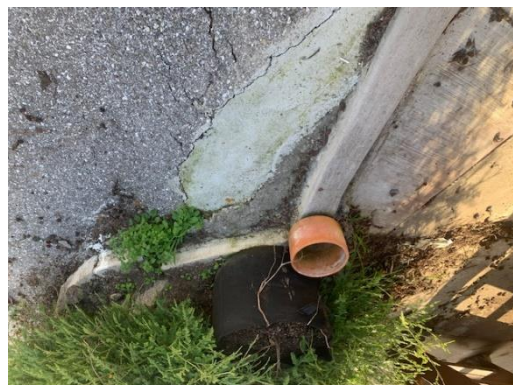
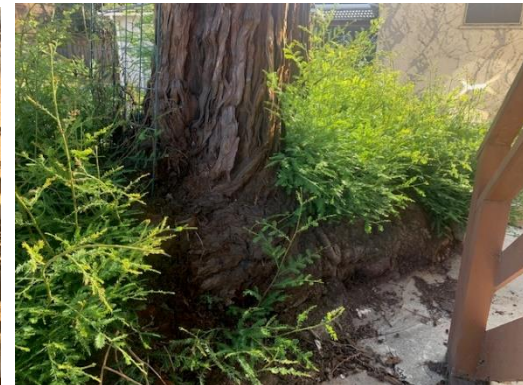
P-4, P-5, P-6 (below): Subject Redwood crowds existing building/stairs with root flare (burl) breaking concrete curb and driveway ... prior box form retained, adding to accumulated defects.

Two factors drive the requirement to remove this 37" Coastal Redwood ... current structural defects ... and stability and health after construction

Conclusion: A removal permit for this redwood should be granted by the City with no further delay.

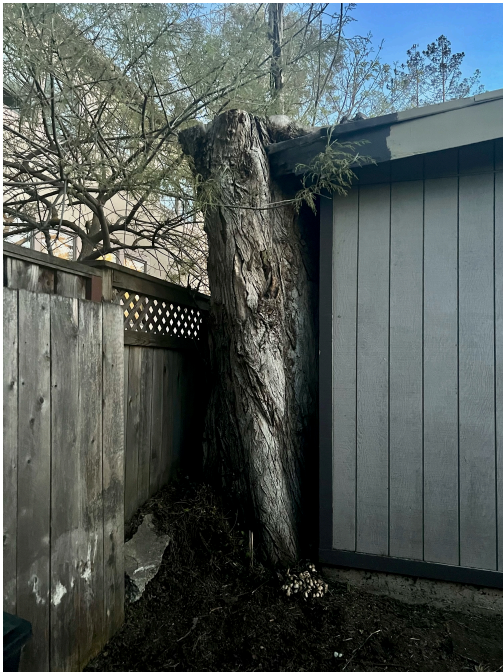
Tree No. 2

Re: **31" diameter (97" circumference) Acer saccharinum (Silver maple)** in rear yard

There is a large glowing mushroom mass where the trunk meets the soil ... https://ipm.ucanr.edu/legacy_assets/pdf/pestnotes/pnarmillariarootrot.pdf

This tree is irrecoverably dead ... those mushrooms are the fruiting bodies of oak root fungus.
