266 & 272 Tyrella Ave Mountain View, CA Arborist Report 2024

Site: 266 & 272 Tyrella Ave
Mountain View, CA 94043

Date: May 30th, 2024

Subject: Tree protection plan for 266 & 272 Tyrella Ave, Mountain View, CA 94043

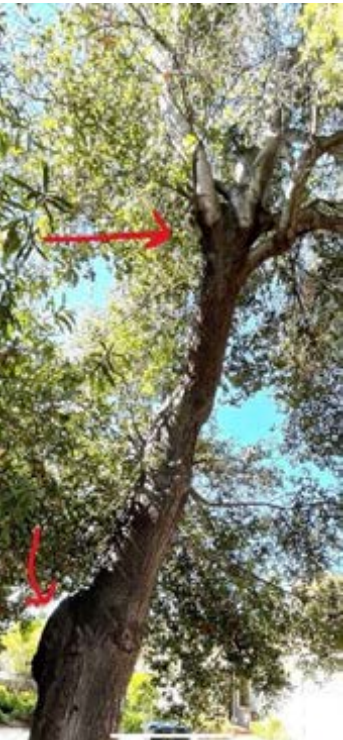
Coast Live Oak tree #3 is in poor condition. The health of the tree is fair, but its form and structure are poor. The tree has been pruned on one side of its canopy for utility line clearance pruning. The tree also leans heavily into the property. The tree is not allowed to balance itself out and will always have an unbalanced canopy due to the overhead utility line location and the constant pruning needed. A large limb at 6' on the trunk has been removed in the past and some associated decay was observed. The tree has also been topped in the past, creating risk of limb failures due to the poor structure of the tree. Topping trees weakens trees. Topping cuts lead to decay as the wounds made are too large for the tree to compartmentalize the wound. This gives decay organisms a free path to move down through the branches, often resulting in an unacceptable level of risk. After a tree is topped, the tree's survival mechanism causes a tree to produce multiple shoots below each topping cut often referred to as "water sprout growth." The new shoots develop from latent buds hidden underneath the surface of old branches. These new shoots are not anchored into the tree like normal branches that develop in a socket of overlapping wood tissues. The new shoots are weakly attached as they are only anchored in the outermost layers of the parent branches. These sprouts grow very quickly as a survival mechanism and are prone to failure in normal weather conditions due to the limbs being weakly attached. Limb failure risk also increased as decay is likely to be found from the past topping cut. The new limbs are also at risk of developing included bark. Crown restoration and crown reduction pruning is recommended. This tree will need annual monitoring due to the tree's poor structure.

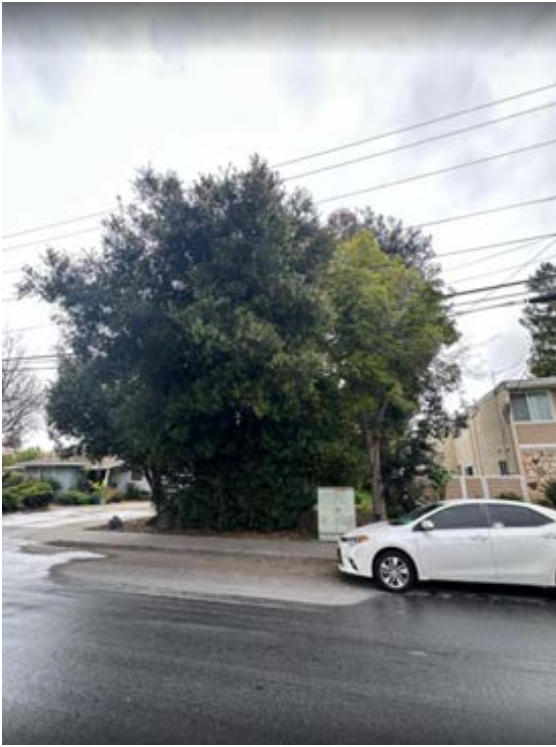
Coast live oak tree #4 is in fair condition (lower end). The health of the tree is good, but its structure and form are poor due to utility line clearance pruning and growing in suppressed conditions. The tree grows at a lean towards the street. This tree will need crown reduction pruning to reduce the risk of limb failure over the street.

Showing oak tree #4 under utility lines

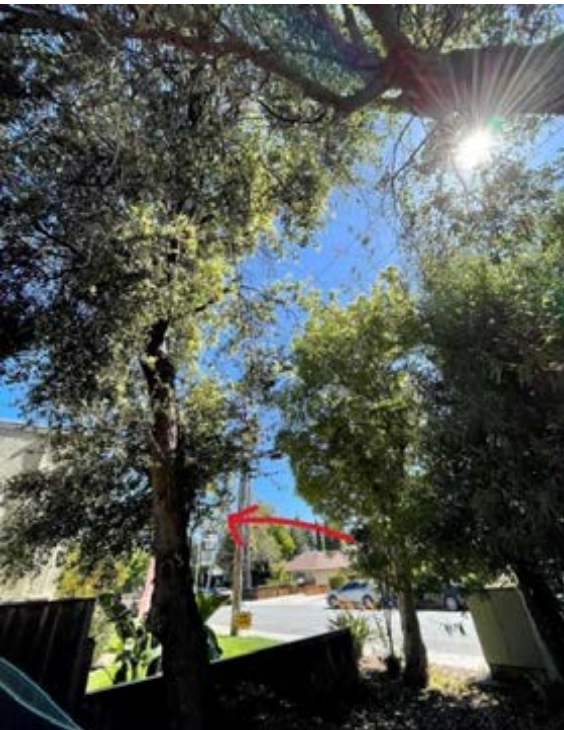
Holly Oak tree #6 is in fair condition. The tree has a slight lean into the property and has been pruned in the past on only one side of the canopy for line clearance. Future crown reduction pruning in the direction of the lean is recommended to balance the canopy.

Showing Holly Oak #6

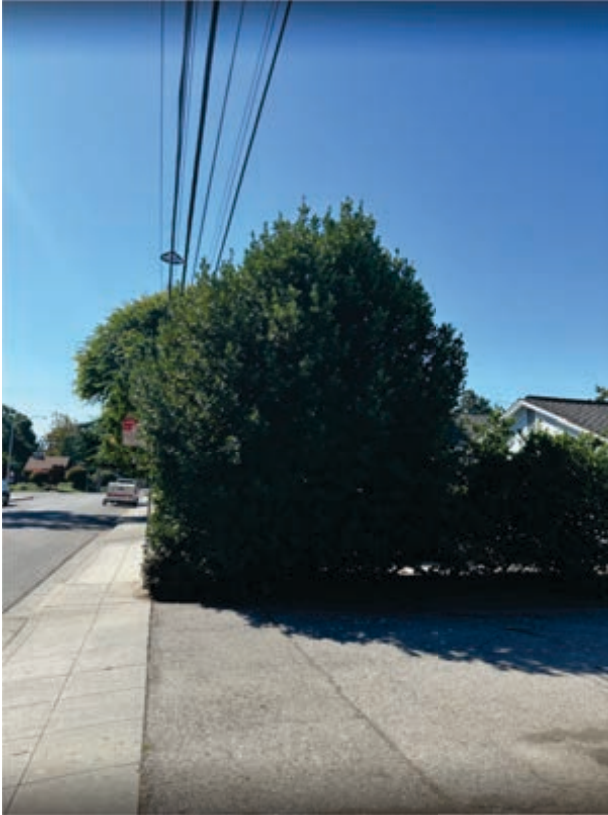
Sweet Bay tree #12 is located on the neighboring property to the south. In the past the tree has been cut down and allowed to re-sprout. Hedge type tree maintenance is recommended to continue for this tree.

Showing sweet bay #12

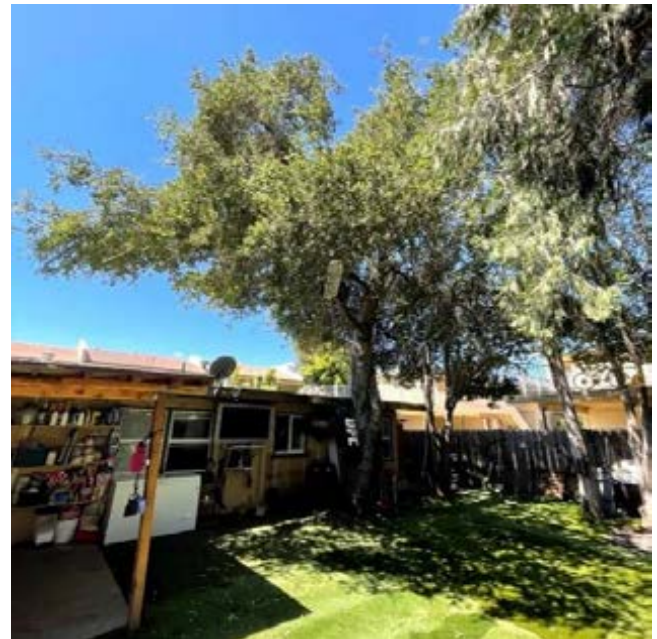
Coast Live Oak tree #16 is in fair condition. This tree is to be retained for the project. Minor crown reduction pruning where over-stretched limbs are observed is recommended. Bleeding cankers were observed on the trunk. To treat an oak tree suffering from bleeding canker, it is recommended to apply Agrifos (a phosphonate fungicide) to manage the disease. Agrifos works by enhancing the tree's natural defense mechanisms, stimulating resistance to the pathogen that causes the canker. It is typically applied via injection or bark spray to ensure effective absorption. This treatment can help slow the progression of the disease, limiting further damage to the vascular system and preserving the overall health of the tree. Regular monitoring and timely applications are key to managing bleeding cankers effectively. The tree is close to the existing structure and has been growing in suppressed conditions.

Showing Oak tree #16

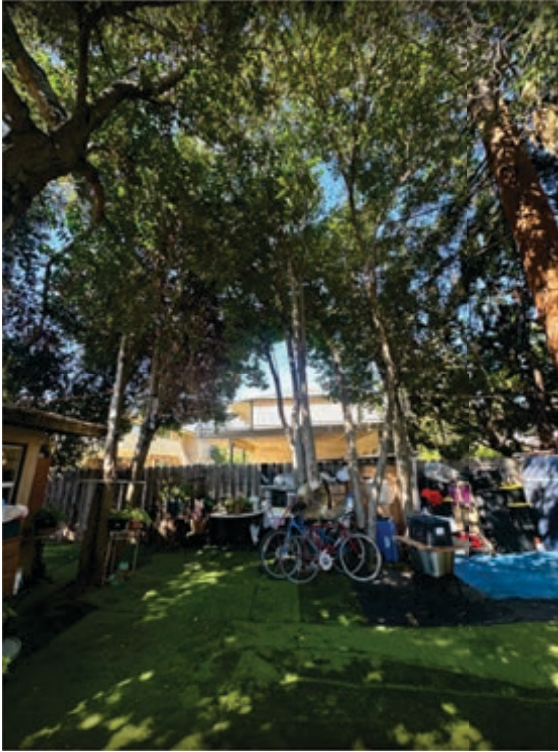
Privet trees #14, #17 and #18 are in poor condition due to their poor structure and form ratings. The trees are codominant at 1-2', and dead wood was observed in the canopies. The trees do provide privacy screening and are to be retained for this purpose.

Showing privet trees #14, #17 and #18

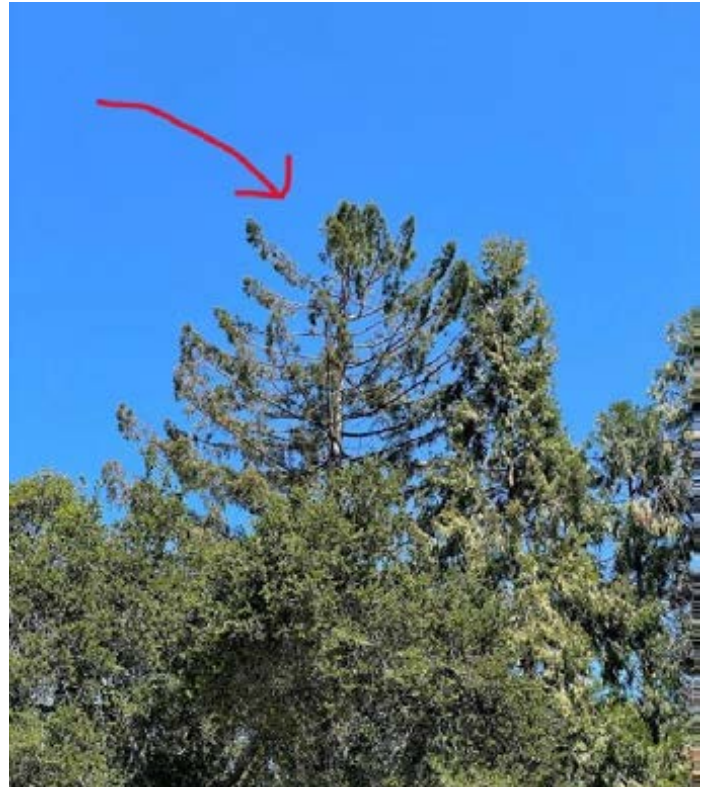
Redwood tree #21 is in fair condition (lower end). The tree is under a significant amount of drought stress causing the tree to decline in vigor. It is recommended to deep water fertilize the tree with 300 gallons of water mixed with Nutriroot fertilizer. This tree will need to be heavily irrigated with 50 gallons of clean water every 2 weeks during the dry season. The irrigation will hopefully improve the tree's condition rating. It is recommended to continue to monitor the tree.

**Showing top of
Redwood tree #21 looking thin**

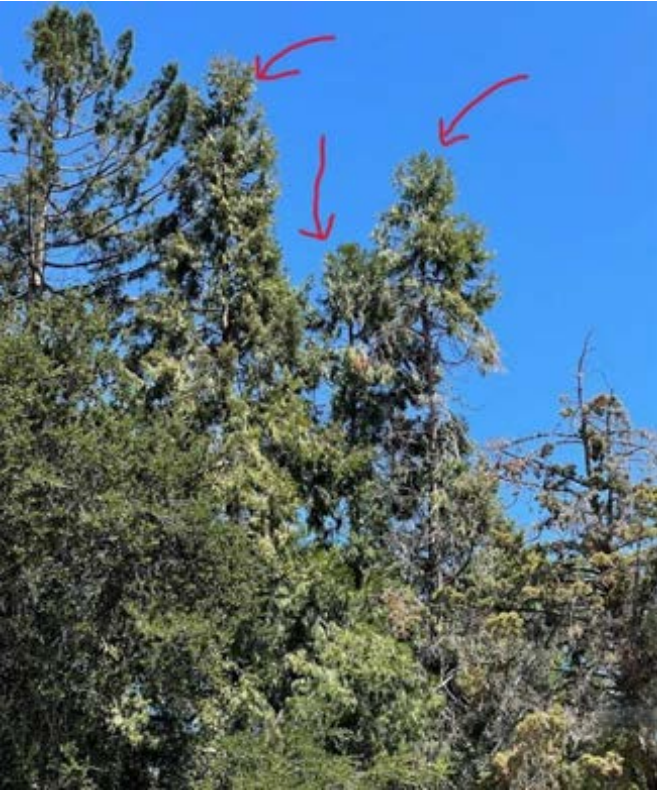
Showing tops of Cedar trees #22-24 with areas of die back.

Incense Cedar trees #22-24 are in fair to poor condition. Areas of *Coryneum canker* (caused by the fungus *Seiridium cardinale*) caused dieback were observed. The disease likely came from adjacent Monterey Cypress tree #15 that is in very poor condition due to the same disease. Treatment for *Coryneum canker* in incense cedar, caused by *Seiridium cardinale*, focuses on cultural practices aimed at reducing tree stress and promoting overall health, as no consistently effective fungicide treatment exists. Pruning infected branches during dry weather is essential to prevent the spread of spores; it's important to cut well below the cankered areas and disinfect tools between cuts. Proper irrigation, with deep and infrequent watering, helps reduce drought stress, a key factor that makes trees more susceptible to infection. Mulching with organic material around the base of the tree can aid in moisture retention and minimize root competition. Additionally, sanitation practices such as removing and disposing of fallen infected branches and needles can help limit the spread of the disease. While chemical treatments are generally ineffective, maintaining tree health and reducing environmental stress can significantly mitigate the impact of *Coryneum canker*. Regular monitoring is critical.

Maintaining irrigation for these trees is recommended to keep the retained trees healthy during construction. To irrigate trees effectively, deep but infrequent watering is essential, particularly during the dry season. Watering every other week is recommended to ensure moisture penetrates to a depth of 12 to 18 inches, encouraging deep root growth. This method helps trees access water from deeper soil layers, enhancing their resilience during periods of drought. Frequent, shallow watering should be avoided, as it promotes shallow roots, leaving trees more susceptible to stress.

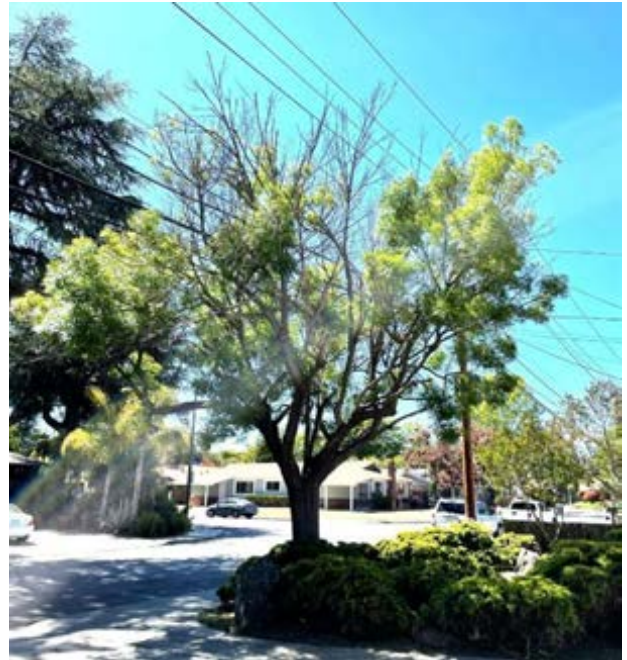
Raywood Ash street tree #1 is in poor condition due to Verticillium, a common fungal disease for the species. The disease has caused large areas of die back in the canopy leading to an overall decline in health. This tree is not well suited for preservation withing the new landscape. The condition of the tree is poor due to disease and not expected to improve with any mitigation measures. This tree meets the following tree removal criteria as set forth in the Heritage Tree Ordinance of Mountain View: *1. The **condition of the tree with respect to disease, infestation, general health, damage, public nuisance, danger of falling, proximity to existing or proposed structures, and interference with utility service.***

Showing Ash tree #1

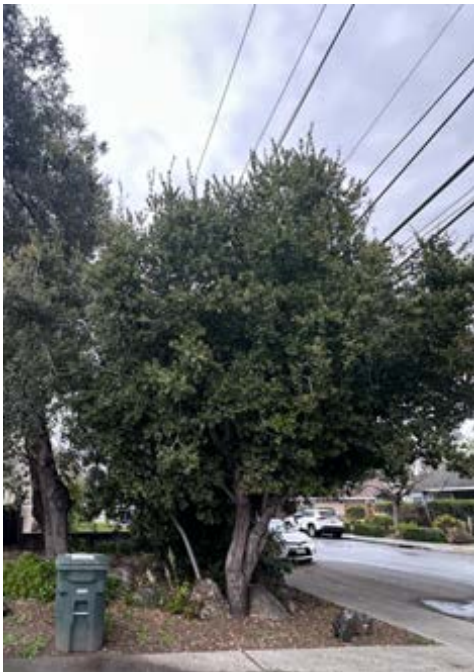
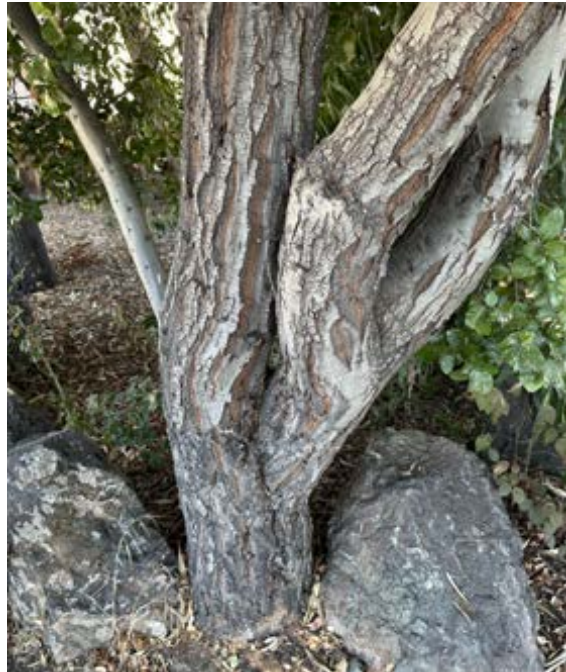
Coast live oak tree #2 is in fair condition. The tree is growing in suppressed conditions. The tree is codominant at 2' with included bark. Included bark often raises risk of large leader failures. The tree is proposed for removal to facilitate the construction of a pedestrian entry plaza. This tree meets the following tree removal criteria as set forth in the Heritage Tree Ordinance of Mountain View: *1. The **condition of the tree with respect to age of the tree relative to the life span of that particular species, disease, infestation, general health, damage, public nuisance, danger of falling, proximity to existing or proposed structures, and interference with utility services.*** *2. The **necessity of the removal of the heritage tree in order to construct improvements and/or allow reasonable and conforming use of the property when compared to other similarly situated properties.***

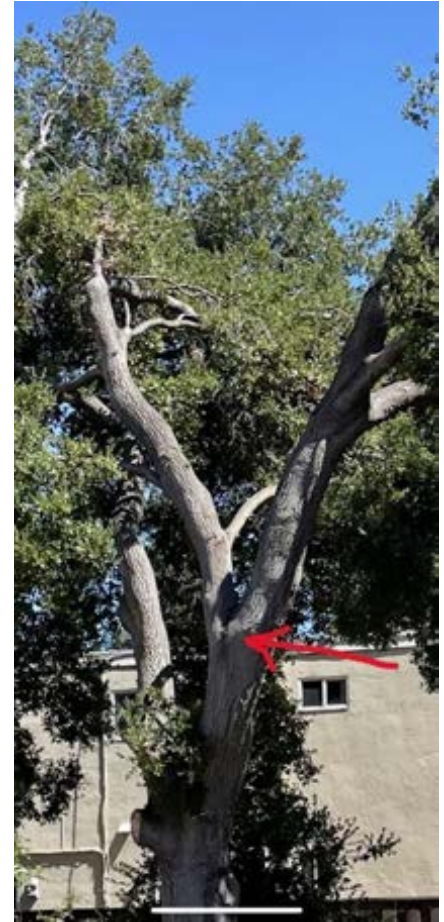
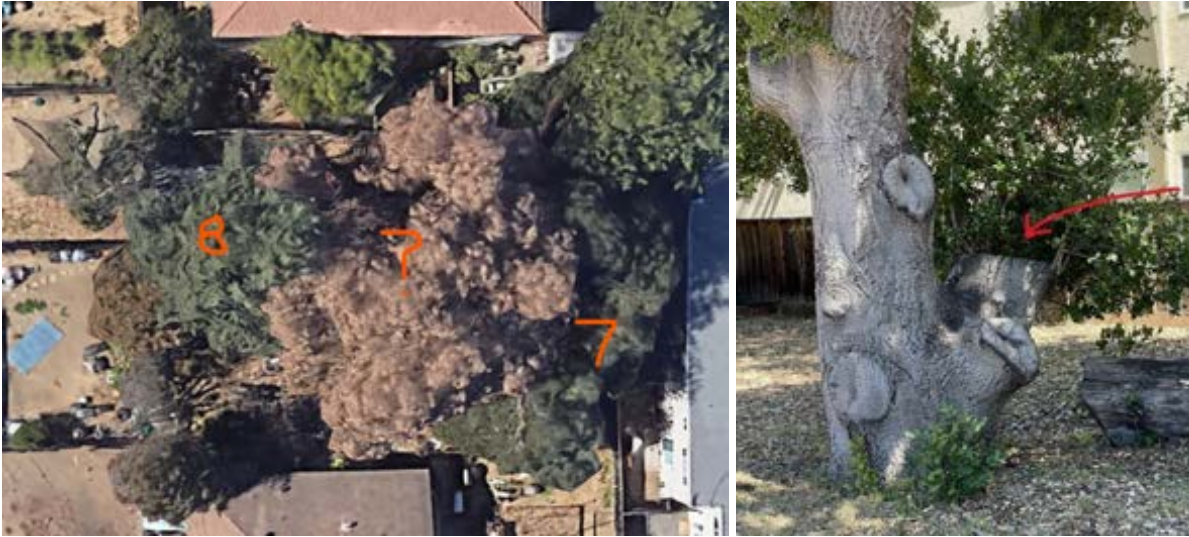
Coast Live Oak tree #7 was given a poor condition rating. Another tree, in the past, was located between oak tree #7 and Deodar Cedar tree #8. This tree was removed for unknown reasons. Looking at old Google Earth images, it looks like the tree was a large dead Monterey Pine judging by the color and shape of the canopy. The removed tree looked to have been the dominant tree in the backyard causing trees #7 and #8 to grow heavy away from the center of the property. Now that the tree has been removed, the oak tree #7 is subjected to windthrow with an increased likelihood of failure due to having an off-balanced canopy. The canopy as a standalone tree is very unbalanced. The tree is also codominant at 15' with included bark observed. Included bark significantly raises risk of a large leader failure. The risk of a codominant leader failure is high due to windthrow in combination with having an unbalanced canopy and included bark observed at 15'. The large codominant leader that was removed in the past at 5' will likely decay as the pruning cut is large and will not compartmentalize leading to an increased risk of a total tree failure at the lower trunk of the tree. The city of Mountain View has asked for risk assessment on the tree. Below you will find a completed tree risk assessment. **Picture showing codominant leaders with included bark (MORE PHOTOS ON NEXT PAGE)**

Showing trees #7 and #8 with past removed tree Showing decay at 5'

A basic level 2 tree risk assessment was conducted for oak tree #7. The tree parts of most concern are the crown/branches and trunk due to an unbalanced crown with over-extended branches and decay observed from a past large leader removal (conditions of concern). Load factors include strong winds and heavy rains which are normal for the area and come from the North West. The load on the crown and branches is significant while the load on the trunk is minor. The load is also increased due to the previous pine tree removal that took place. The likelihood of failure in the crown and branches is imminent (in my professional opinion) and the likelihood of failure of the trunk is possible. The targets looked at are people using the proposed courtyard (#1) and the proposed structure (#2). Both targets are within the tree's drip line. The structure has a constant occupancy rate while people in the courtyard have an occupancy rate of frequent. It is not practical to move the targets or to restrict access. The likelihood of failure is imminent in the crown and branches due to the unbalanced crown with over-extended branches observed. The likelihood of failure of the trunk is possible. The likelihood of impacting people in the courtyard is medium as they are not static targets, while the likelihood of impacting the proposed structure is high as it is a static target.

Tree removal is recommended due to a moderate to high risk of failure in the crown or branches. The tree is very unbalanced with over-extended limbs. Once the load on the limbs exceeds the strength of the wood, large limb failures will take place. Pruning mitigations within ANSI standards would only delay the failure of large limbs. It is my professional opinion that this tree should be removed due to the risk of a large limb failure. The canopy is very unbalanced. This tree meets the following tree removal criteria: *1. The condition of the tree with respect to age of the tree relative to the life span of that particular species, disease, infestation, general health, damage, public nuisance, **danger of falling, proximity to existing or proposed structures**, and interference with utility services.* The developer owner is not comfortable with the tree and its associated risk; therefore, tree removal is recommended as the tree is outside the tolerable risk level of the developer.

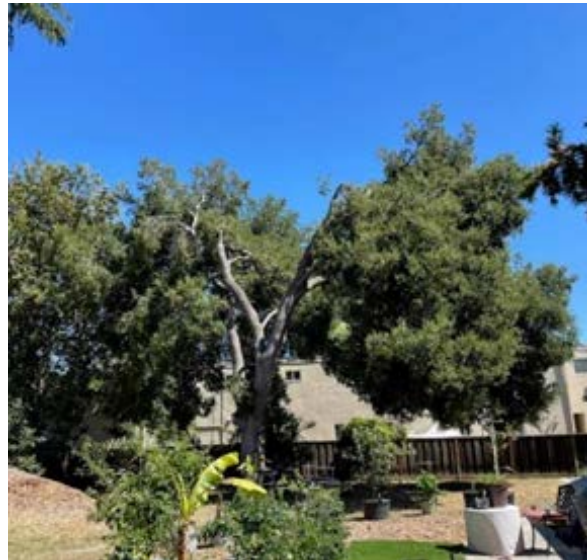
Showing an off balanced canopy subjected to wind throw

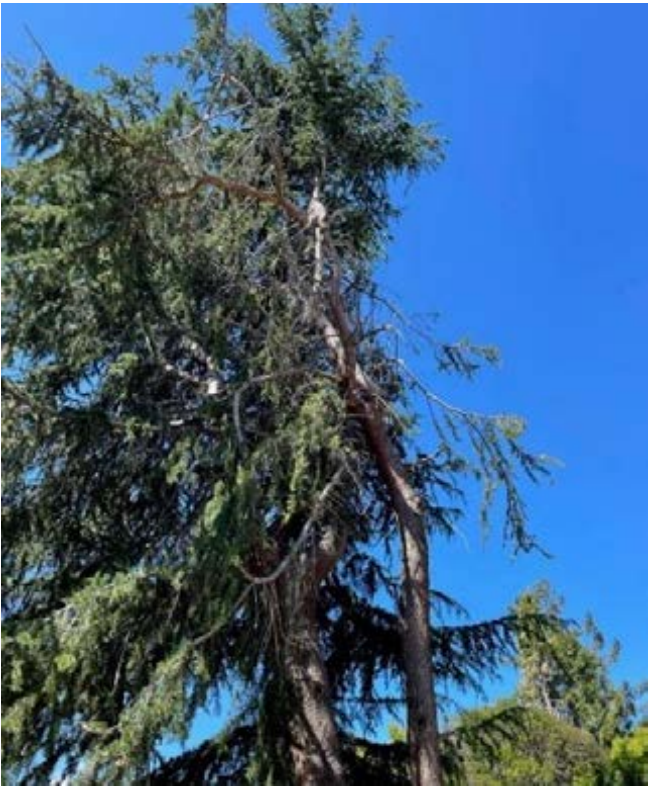
Deodar Cedar tree #8 was given a poor condition rating. An old mature Monterey Pine tree in the past was removed near the tree. The pine tree was removed for unknown reasons. The removed tree looked to have been the dominant tree in the backyard causing cedar tree #8 to grow heavy away from the center of the property. The large Cedar tree is now subjected to windthrow as the tree has lost its protection from prevailing winds. The canopy as a stand-alone tree is very unbalanced. Tree failure risk is high due to windthrow in combination with an unbalanced canopy. Poor codominant unions with included bark were also observed that further increase the risk of a large leader failure. A history of large limb failures was also observed. This tree meets the following tree removal criteria: *1. The condition of the tree with respect to age of the tree relative to the life span of that particular species, disease, infestation, general health, damage, public nuisance, **danger of falling, proximity to existing or proposed structures**, and interference with utility services. 2. **The necessity of the removal of the heritage tree in order to construct improvements and/or allow reasonable and conforming use of the property when compared to other similarly situated properties.*** (Photo showing off balanced canopies subjected to wind throw)

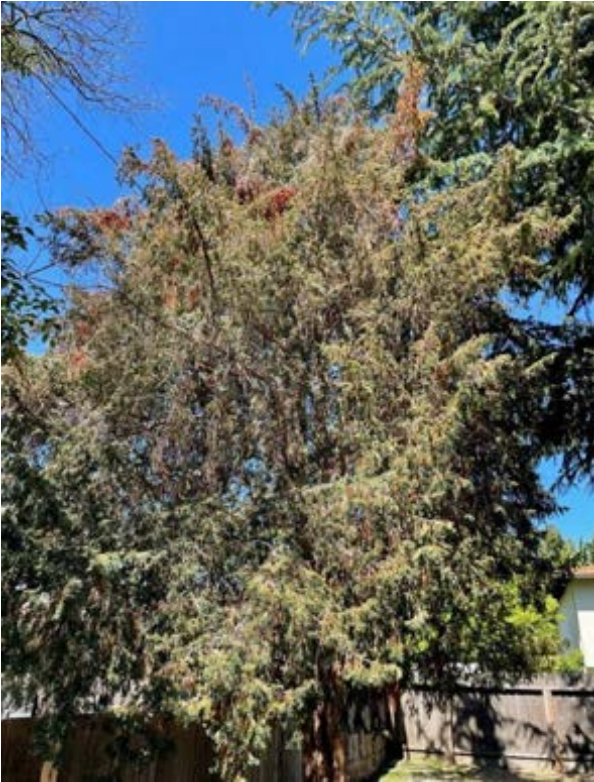
Japanese Yew tree #9 is in poor condition and not expected to improve with any possible mitigation measures. Canker disease caused die back and drought stress have led to the tree into a state of decline. Tree removal is recommended. This tree meets the following tree removal criteria as set forth in the Heritage Tree Ordinance of Mountain View: *1. The **condition of the tree with respect to disease, infestation, general health, damage, public nuisance, danger of falling, proximity to existing or proposed structures, and interference with utility service.***

Showing Yew tree #9 in decline

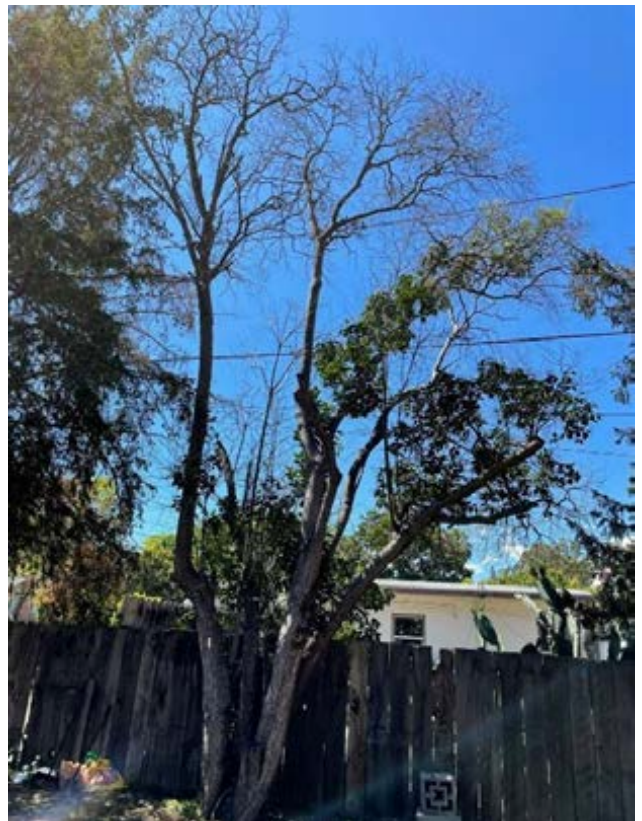
Privet tree #10 is nearly dead and not expected to improve with any possible mitigation measures. Drought stress has led to the tree's decline. Tree removal is recommended. This tree meets the following tree removal criteria as set forth in the Heritage Tree Ordinance of Mountain View: *1. The **condition of the tree with respect to disease, infestation, general health, damage, public nuisance, danger of falling, proximity to existing or proposed structures, and interference with utility service.***

Showing nearly dead privet tree #10

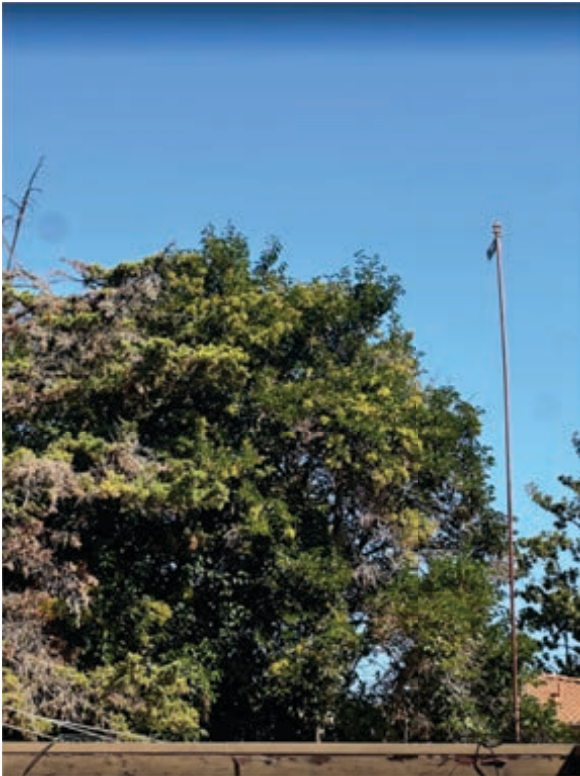
Privet tree #13 is in poor condition. The tree has not been well maintained in the past. The Privet tree is codominant with included bark. The Privet tree does offer some screening for the property but would easily be replaced by new screening material. This tree is not expected to improve. Privet tree #13 meets the following tree removal criteria as set forth in the Heritage Tree Ordinance of Mountain View: *1. The **condition of the tree with respect to disease, infestation, general health, damage, public nuisance, danger of falling, proximity to existing or proposed structures, and interference with utility service.***

Showing privet tree #13

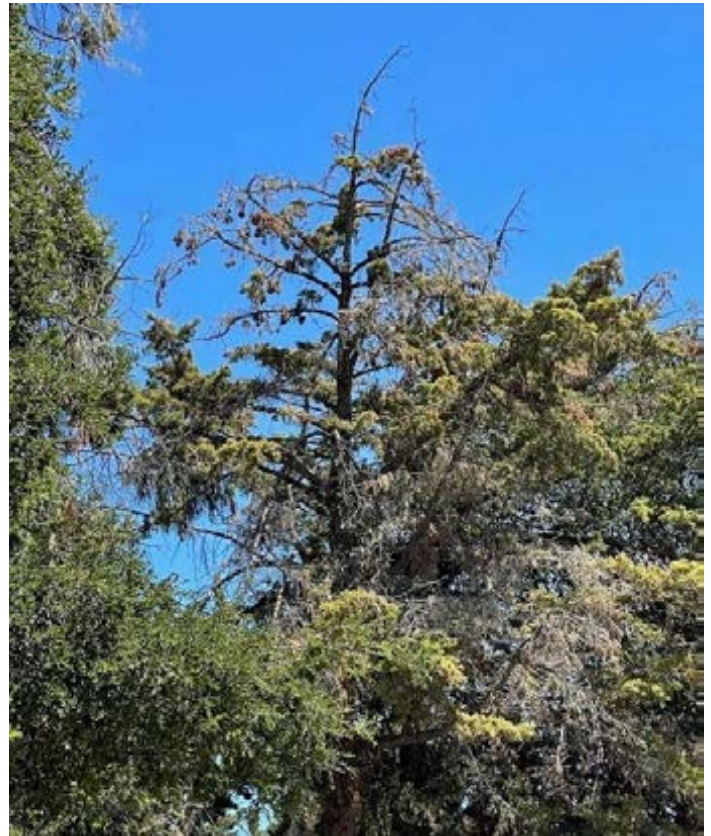
Monterey Cypress tree #15 is in very poor condition. Severe die back due to Cypress Canker Disease was observed. This tree is not expected to improve with any possible mitigation measures. Tree removal is recommended. This tree meets the following tree removal criteria as set forth in the Heritage Tree Ordinance of Mountain View: *1. The **condition of the tree with respect to disease, infestation, general health, damage, public nuisance, danger of falling, proximity to existing or proposed structures, and interference with utility service.***

Showing top of Monterey Cypress tree #15
