# 881 Castro St Mountain View, CA Arborist Report 2025

Updated 09.19.25

Site: 881 Castro St  
Mountain View, CA 94041

Subject Re: Tree Protection Plan for 881 Castro St, Mountain View, CA 94041

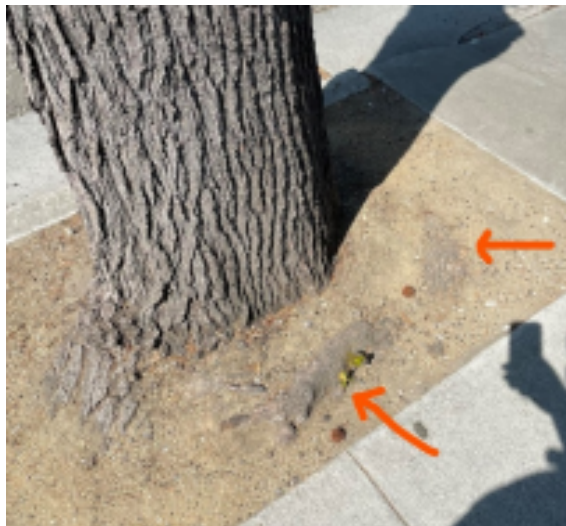
| Tree Tag # | Heritage Tree | Street Tree | Common Name / Scientific Name | Trunk (in.) | Height (ft.) / Canopy Spread (ft.) | Health Rating | Form Rating | Suitability for Preservation | Overall Condition (0-100%) | Feasibility of Transplanting (Heritage trees only) | Comments | Tree Picture | Preserve or Remove | Type of Fencing Required | Required Replacement Ratio |
|---|---|---|---|---|---|---|---|---|---|---|---|---|---|---|---|
| 8 | Yes | Yes | AMERICAN SWEETGUM<br><i>Liquidambar styraciflua</i> | 17.9 | 40/25 | Fair | Poor | Poor | 45% | Low | Fair vigor, poor form, codominant at 8 feet with included bark, girdling root observed, causing sidewalk damage, street tree. | | (P) | Type 3 | |

**Showing girdling root on sweetgum #8**

New sidewalks are proposed for street trees #8 & #9. Demolition of the existing sidewalks are recommended to be done with the use of a jackhammer under the direct supervision of the project arborist. The concrete is recommended to be broken up by a jackhammer into small hand manageable sized pieces. If existing baserock could be retained this would be beneficial as roots would not need to be exposed. If not possible, all base rock material within the tree drip lines would need to be removed by hand. Exposed roots are then recommended to be covered by layers of wetted down burlap with the contractor wetting down the burlap daily while exposed. This will help to avoid root desiccation. New base rock material is then recommended to be packed around tree roots with new sidewalks being built on top of the tree root zones. By packing baserock around roots this would eliminate the need to cut tree roots. Keeping roots moist during this process is essential to the survival of the trees. New baserock material is recommended to consist of Structural Soil (CU Mix). Impacts are expected to be minor to moderate. It is recommended to irrigate the street tree planting strips with 20 gallons of water per tree weekly. The street tree planting strips are also recommended to be deep water fertilized as an additional mitigation measure. **Tree protection:** Trees #8 & 9 are recommended to be protected by type 3 tree protection fencing.

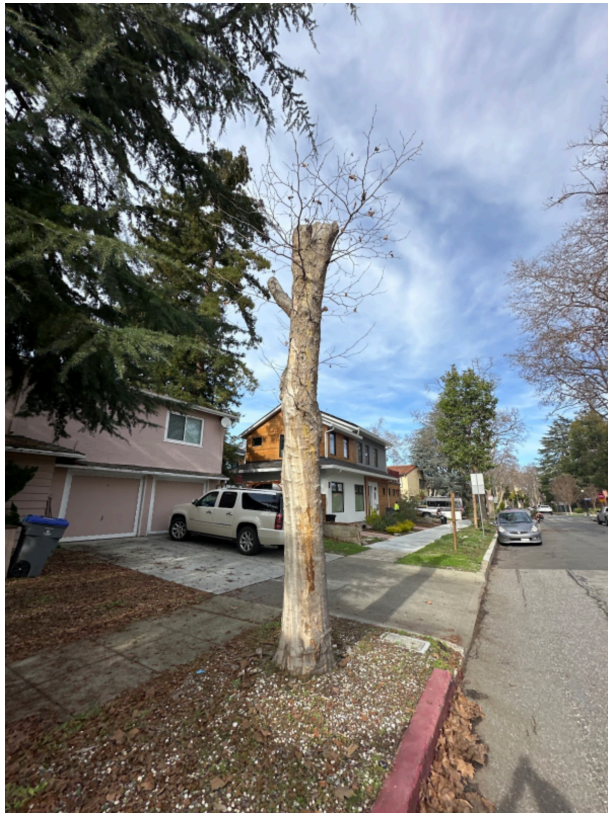
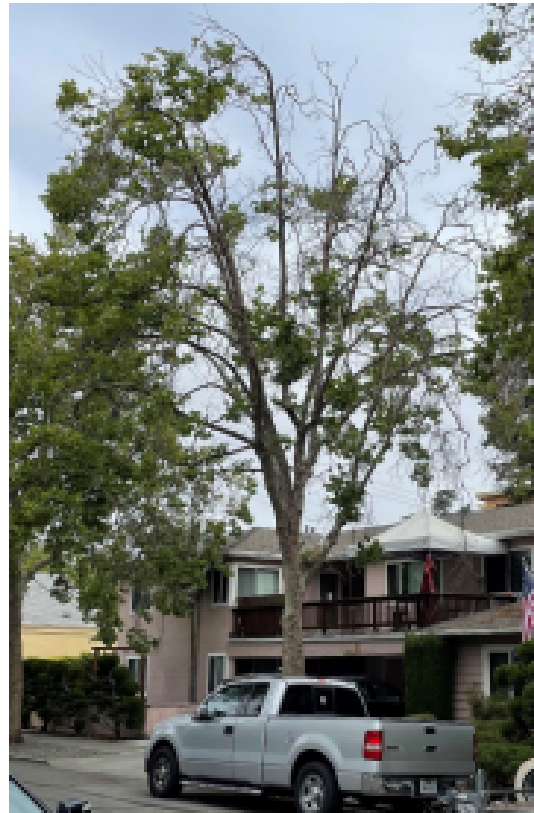
London plane street tree #17 is dead and is proposed to be removed. Removal is recommended regardless of the proposed construction. London plane street tree #25 is in poor condition as large areas of dead wood indicating a decline in health were observed. This tree is proposed to be removed and is recommended to be removed regardless of the proposed construction.

**Showing dead London plane tree #17 (left), Showing London plane tree #25 (right)**

Reason for proposed removal: The tree is dead, removal is recommended irrespective of proposed construction. *Transplanting feasibility:* This tree has a low rating for the feasibility to transplant due to its condition.

Reason for proposed removal: 2' from proposed basement cut, and within proposed concrete area. The tree is also in poor condition and not expected to improve. Removal is recommended irrespective of proposed construction. *Transplanting feasibility:* This tree has a low rating for the feasibility to transplant due to its condition.

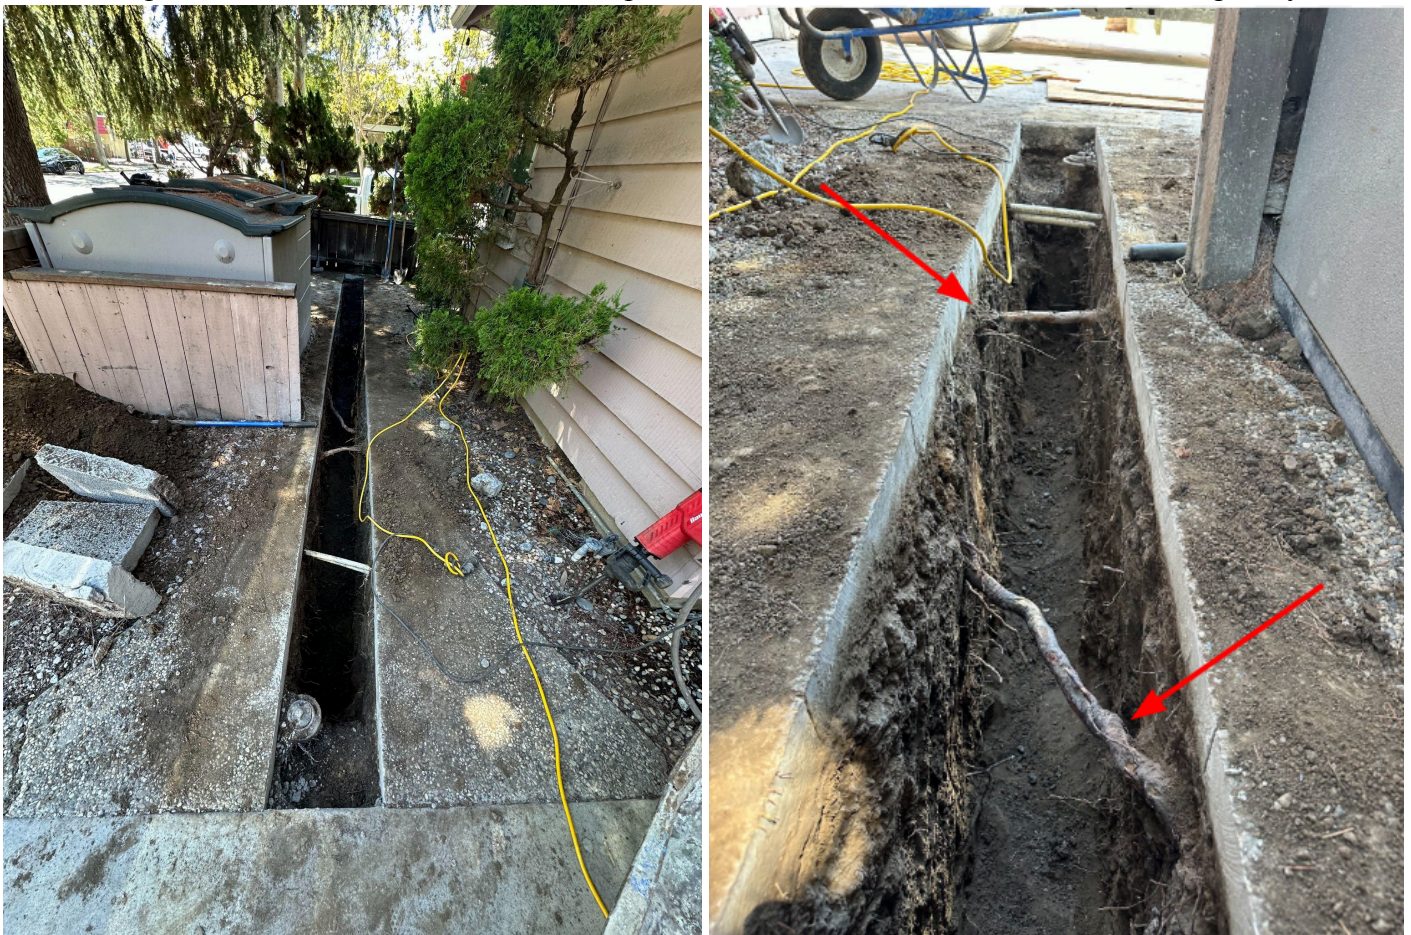
An exploratory trench was completed at the proposed basement wall cut (shown in blue in the diagram) near Cedar Tree #18 in order to determine the feasibility of the proposed plan. The exploratory trench was completed using hand tools, and all roots were retained within the exploratory trench. There is an existing concrete pathway in the exact location of the proposed

basement cut. The concrete and the associated compaction have likely helped to discourage root growth in this area. The exploratory trench was completed to a depth of 3-4 feet and was 18" wide. Only 2 small roots measuring 1.1 and 1.4 inches in diameter were encountered within the exploratory trench. Signs of past trenching were observed as an irrigation line and a sewer cleanout were observed in this area. Given the findings, impacts from the proposed basement cut are expected to be minor. The basement will be required to be vertically shored in order to prevent over-excavation (OSHA cut) that would lead to high impacts. Vertical shoring is likely required due to the location of the street/sidewalk. All encountered roots at the proposed basement cut are recommended to be cleanly cut using a hand saw or loppers back to the basement wall. It is recommended that cut root ends be covered in layers of wetted-down burlap to avoid root desiccation. While exposed, the contractor shall wet down the burlap daily.

**Showing the trench (left), showing only two roots encountered (right)**

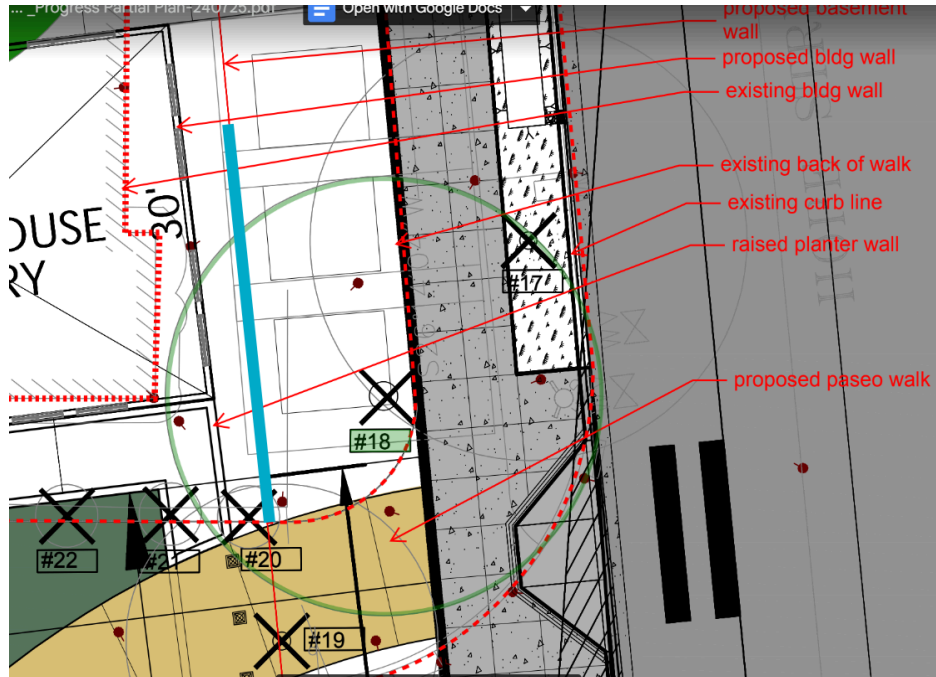
### **Blue line indicating the proposed basement cut and exploratory trench location**

The proposed sidewalk work and Paseo walkway are all within the same footprint of the existing sidewalk near cedar tree #18. The existing hardscapes have all likely discouraged root growth in the area of proposed work. All excavation within 10x the diameter of the tree (22.9') shall take place by hand under the direct supervision of the project arborist. All encountered roots shall be documented by the project arborist. Roots encountered within the proposed aggregate sections are recommended to be retained by packing aggregate around tree roots. Existing grades and proposed grades are recommended to be nearly identical where possible near this tree to prevent excavation near the tree. Overall impacts to the tree are expected to be minor. It is recommended to deep water fertilize the tree with Nutriroot during the dry season as a mitigation measure. This is recommended to be done twice during the growing season. It is also recommended to deeply water the tree once a month using 50 gallons of water within the tree protection zone.

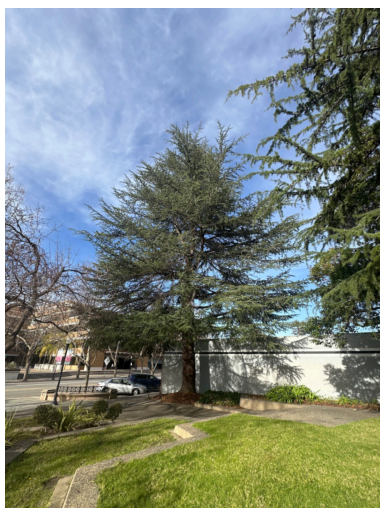
### *Deodar cedar #61*

Deodar cedar tree #61 is located at Gateway Park. The tree is located approximately 5 feet from the property line and has a total canopy spread of 45 feet that extends over the existing structure. The existing structure near the tree is located at the property line. The structure may have acted as a natural root barrier and roots are not likely to be found in abundance on the Castro Commons property side. To confirm this, it is recommended to perform an exploratory trench at the proposed basement cut on the property side once the structures have been demolished. This work is recommended to be done with the use of an air knife and done either by the Project Arborist or underneath the direct supervision of the Project Arborist. This is the only way to confirm that no roots are on the Castro

A new pathway is proposed between the basement cut and property line near deodar cedar tree #61. Due to the existing building located at the property line impacts are expected to be minor to non-existent as the existing foundation likely acted as a root barrier. If roots are found within the exploratory trench at the proposed basement cut (to take place after demolition), the pathway may need to be built up on top of grade to reduce impacts to the tree's roots. This will be decided during the completion of the exploratory trench.

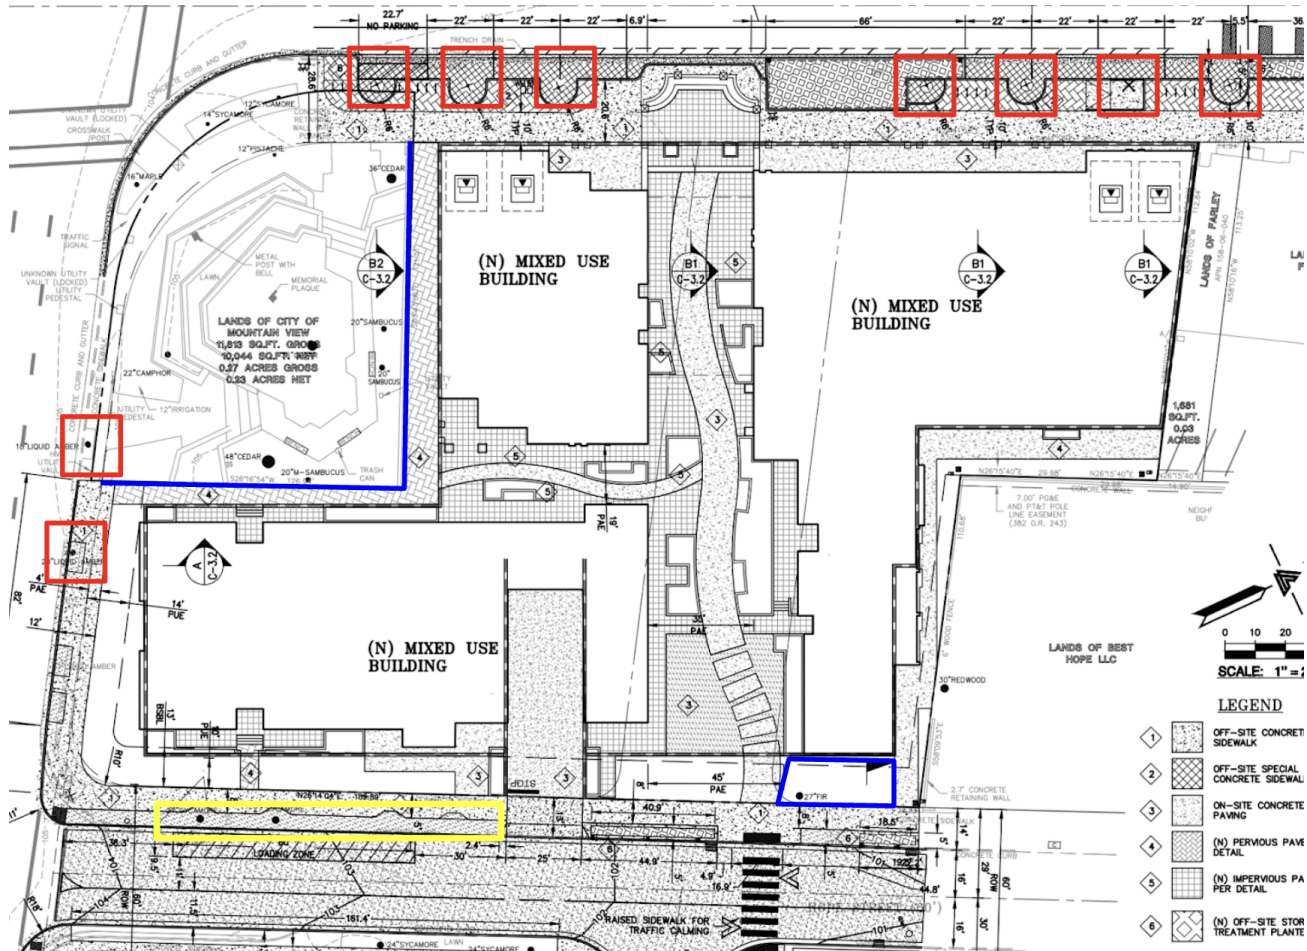
**Red boxes indicate type 3 tree protection fencing, yellow box indicates type 2 tree protection fencing, and blue line indicates type 1 tree protection fencing around Gateway Park**

All trees at Gateway Park are to be protected by fencing placed at the property lines where the subject property is adjacent (type 1). By placing fencing at the property line, the park can still be used by people.
