12/13/2023

Re: Tree Protection for Proposed Landscape Redesign at 240 S Whisman Road

Summary

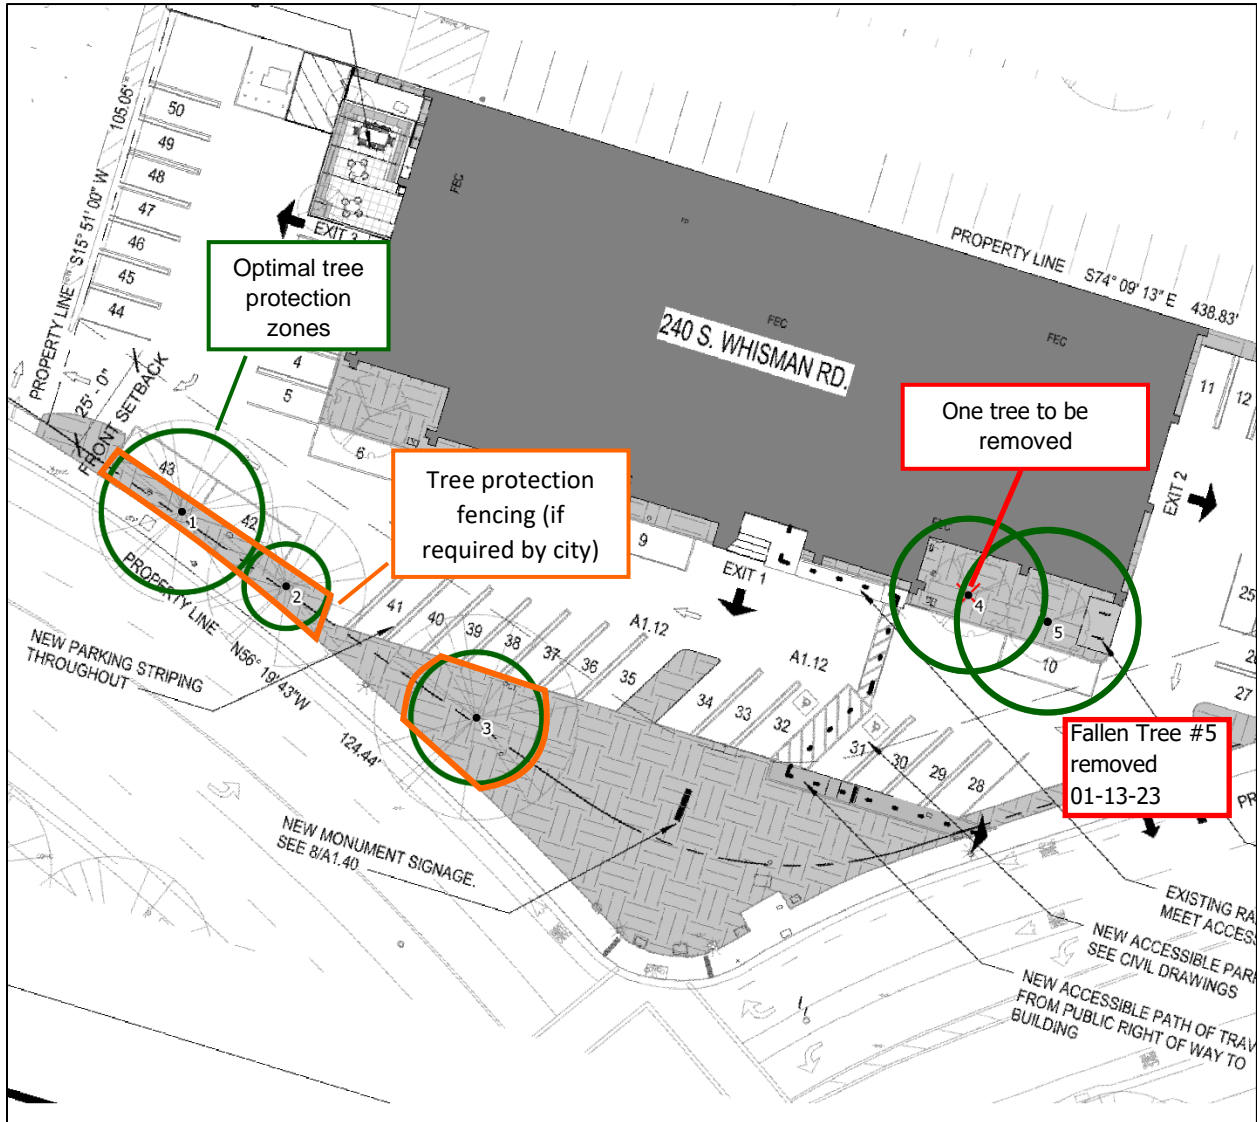
Tree Map²

Irrigation and shrub installation are proposed within all TPZs. No hardscape changes, grading, or major excavation are proposed within TPZs.

- a. Place tree protection fencing at or beyond the edge of each tree's TPZ, approximately as shown in the Tree Map, below.
 - b. If tree protection is required, all fencing must be installed prior to any equipment coming onsite, and must remain in place through the duration of construction.

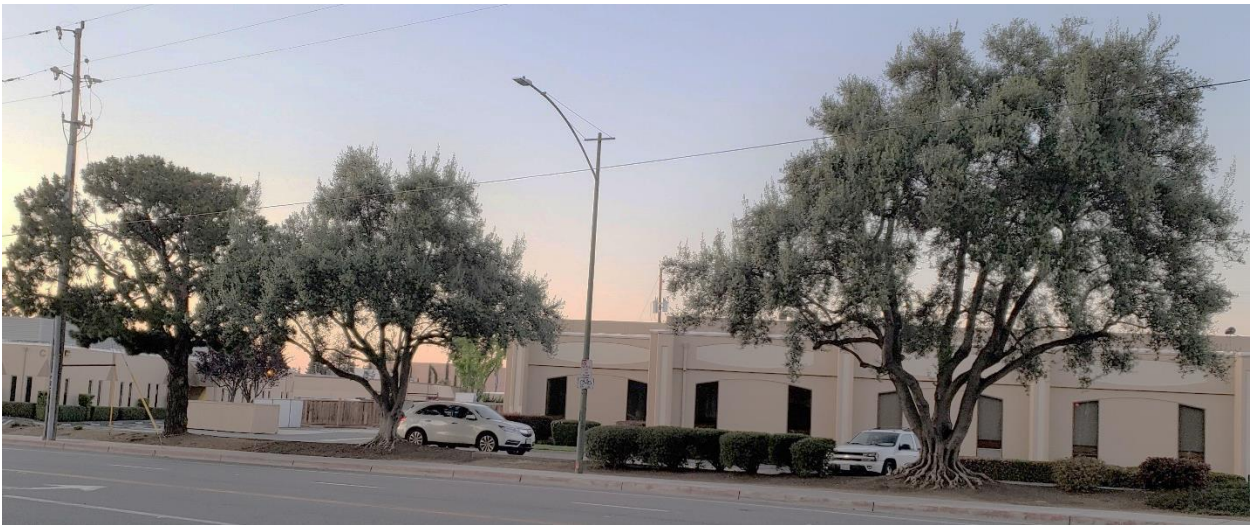
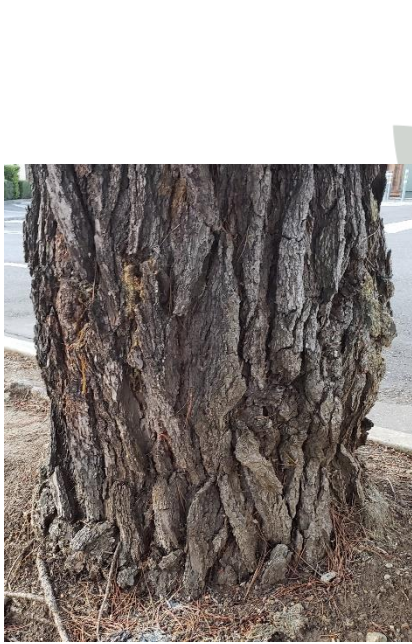
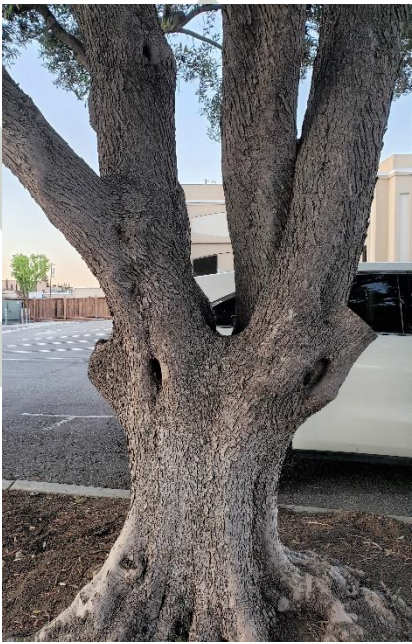
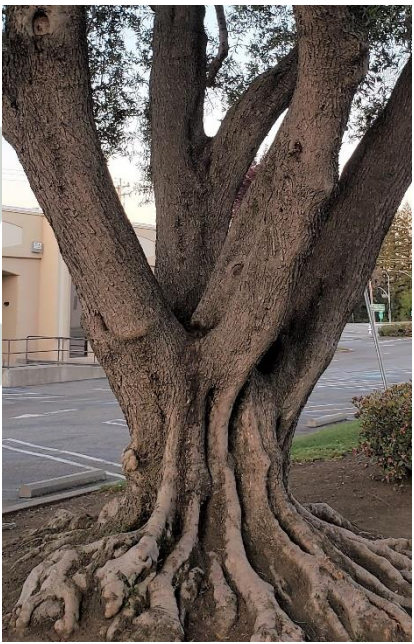
Image 1: Monterey pine #1 and olives #2 and 3 (left to right, trunk details in order below)

Three heritage street trees are present on the property: two olives (*Olea europaea*) and one Monterey pine (*Pinus radiata*) (**Image 1**) One other heritage tree is present while the other fell during a storm and subsequently removed, both purple leaf plums (*Prunus cerasifera*) (**Image 2**). No trees overhang the property from adjacent properties.

The olives and pine are mature and in good overall condition. Both olives' structure is somewhat poor, with multiple leaders. The pine exhibited no red turpentine beetle (*Dendroctonus valens*) damage.

Pine #1 and olives #2 and 3 are in reasonably good condition. Plums #4 and 5 are in poor condition, particularly plum #5, which has since fallen and been removed. Minor impacts to all trees are expected from proposed irrigation and shrub installation.

1. Retain trees #1-3 during and after construction.
2. Remove tree #4, while tree #5 has since fallen and been removed.
3. Install tree protection fencing for trees #1-3 if deemed necessary by the City of Mountain View.

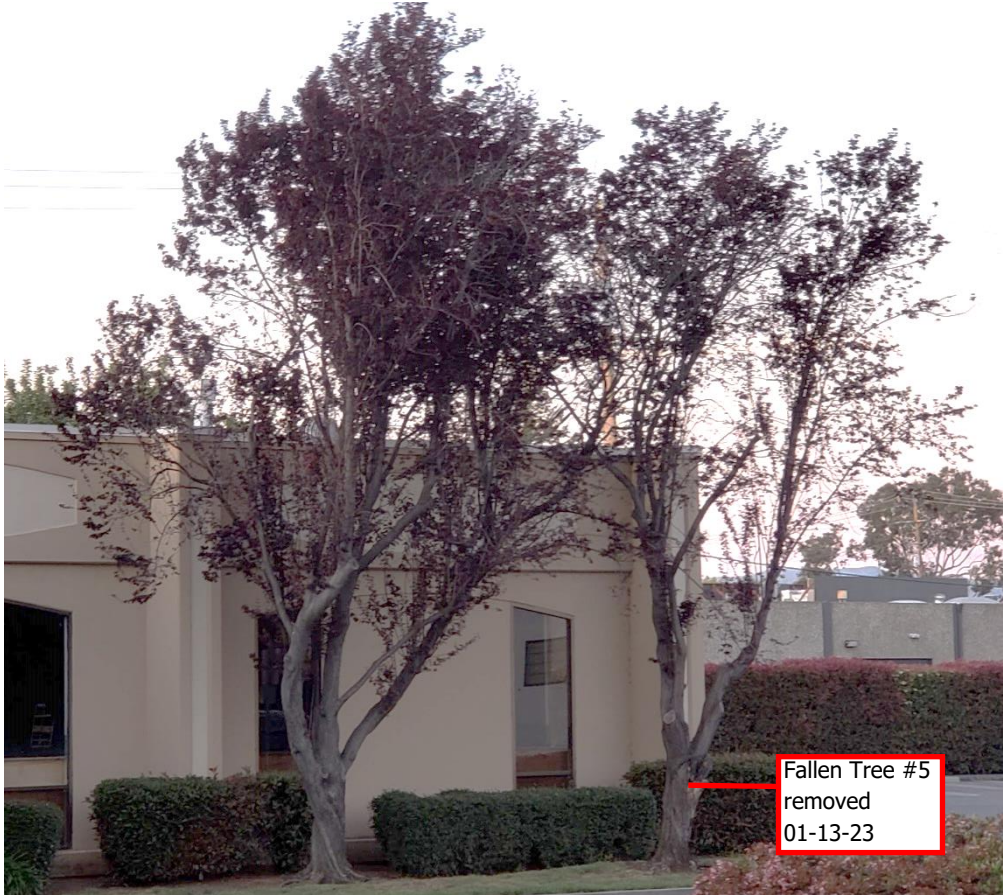
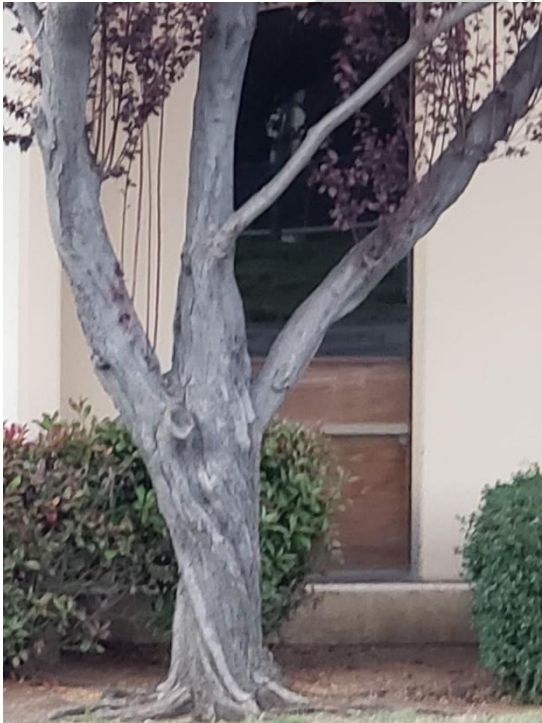
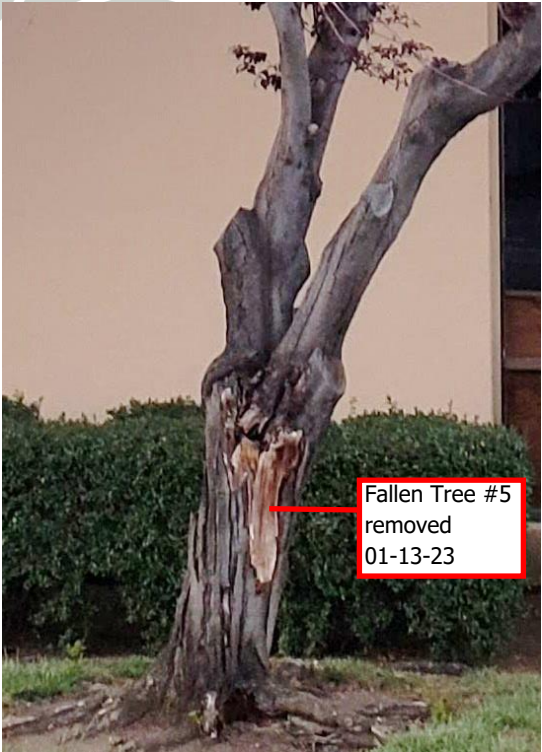
Image 2: purple-leaf plums #4 (left) and 5 (trunk details in order below)

Both purple-leaf plums appear overmature, with thin canopies for the species. Many sprouts are present on the scaffold limbs of plum #4. The lower trunk of plum #5 was heavily damaged with delaminating bark, which has since fallen over in storm and been removed.

Purple-leaf plums – like most ornamental fruit trees, purple-leaf plums are short-lived, with a documented lifespan of less than 50 years.¹ In my experience, this species' lifespan ranges from about 20-40 years under usual landscape conditions. Sprouting from scaffold branches indicates stress in this and many other species, and often occurs near the end of a tree's lifespan.

4	Purple-leaf plum	<i>Prunus cerasifera</i>	14.9	16.5"	2	1	Heritage per City Measurements	Minor from irrigation and shrub installation	Remove due to poor structure and short remaining lifespan	Poor structure. Many sprouts in canopy indicate stress. Thin canopy. Species is short lived, and this specimen appears to be nearing the end of its lifespan.
5	Purple-leaf plum	<i>Prunus cerasifera</i>	14.8	17.6"	0	0	Heritage per City Measurements	Not applicable	Not applicable	Tree fell over during a storm in January 2023. The tree was removed on January 13, 2023 by Frank + Grossman Landscape Contractors
