Arborist Report

411 Clyde Ave
Mountain View, CA
APN: 16057014

June 7, 2023

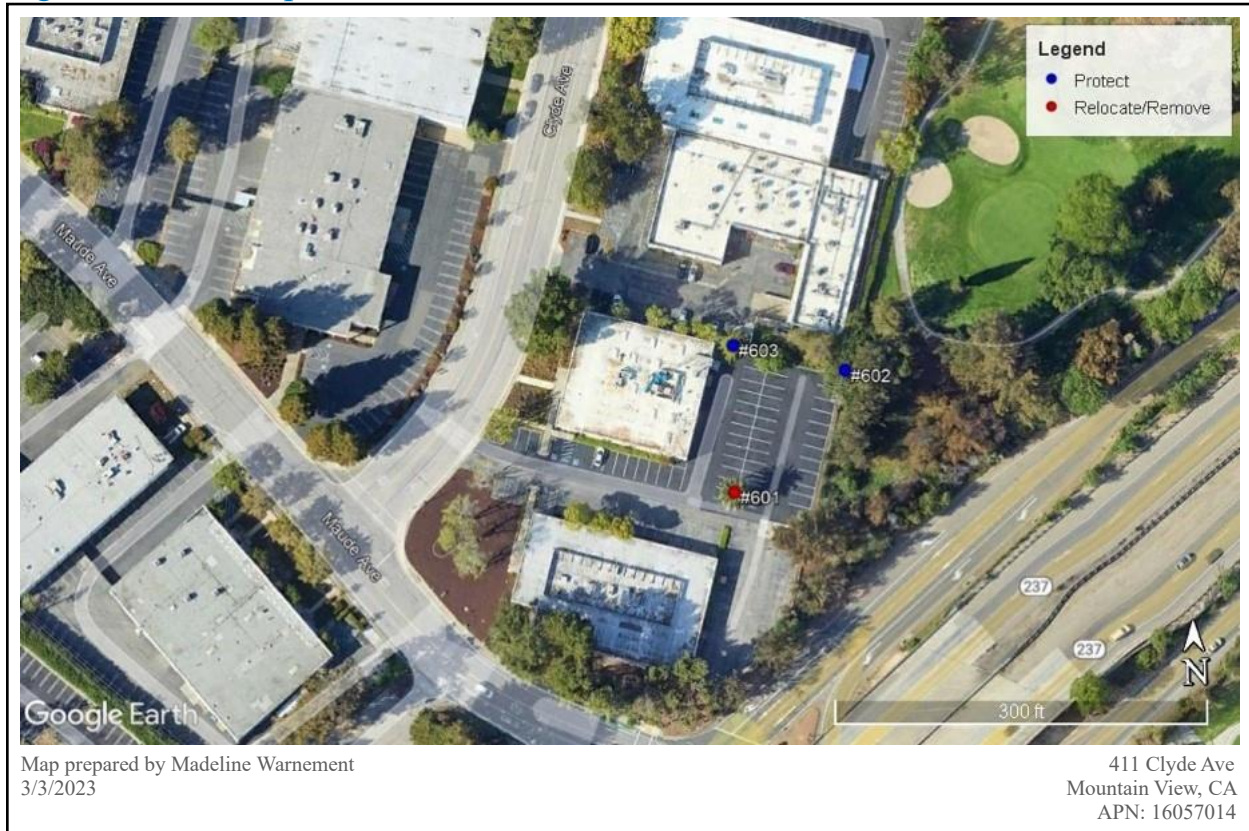
Figure 2: Tree Map

Of the four trees initially thought to be present on or adjacent to the project site, only three trees remained (see Figure 2). One Chinese Elm (*Ulmus parvifolia*) had been previously removed, leaving only the stump and root ball. It was determined that the cuts were old and that this tree had not been removed recently. The remaining three trees in question were the only trees located within close enough proximity to the project site to possibly be affected by construction (see Figure 3, 4, & 5). Based on the needs of the project and health and safety of the trees, it is recommended that the Canary Island Date Palm (*Phoenix canariensis*) be relocated or removed while the Chinese Elm (*Ulmus parvifolia*) and Liquidambar (*Liquidambar styraciflua*) be protected (see Table 3).

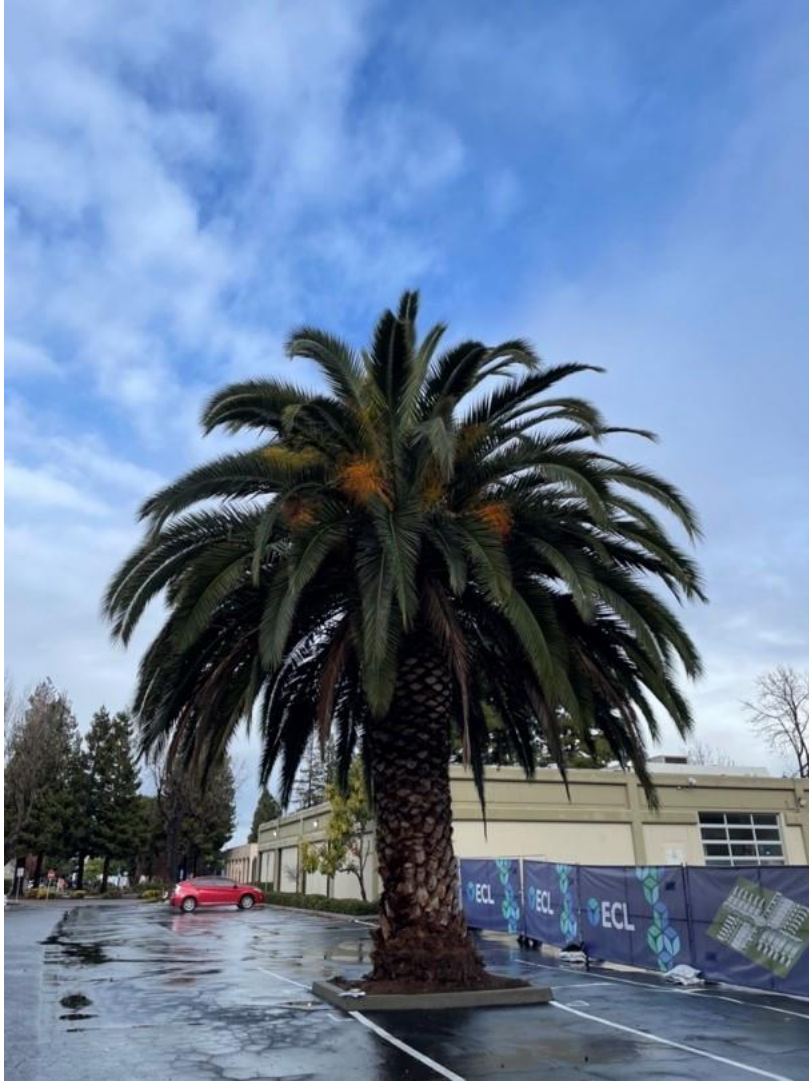
Figure 3: #601 - Canary Island Date Palm (*Phoenix canariensis*)

There is one Heritage tree on site with a circumference of 135 inches (43 inches in diameter). It is in good health and appears to be thriving, making it a good candidate for relocation. The reason for removal is the need to access the work site during construction with equipment, as well as after construction to upkeep the site and refuel the hydrogen tank. Where the tree is located now would block trucks from being able to access the site. Therefore, it is recommended that the tree be removed/relocated.

Tree #	Recommendation
601	In addition to the high success rate of palm tree relocation, this particular tree is also in good health, making it a good candidate for removal and relocation. There would be no reasonable way to protect this tree in the location it is in.
602	Due to the close proximity of proposed digging for construction, root monitoring during construction is recommended.
603	Due to the close proximity of proposed digging for construction, root monitoring during construction is recommended.

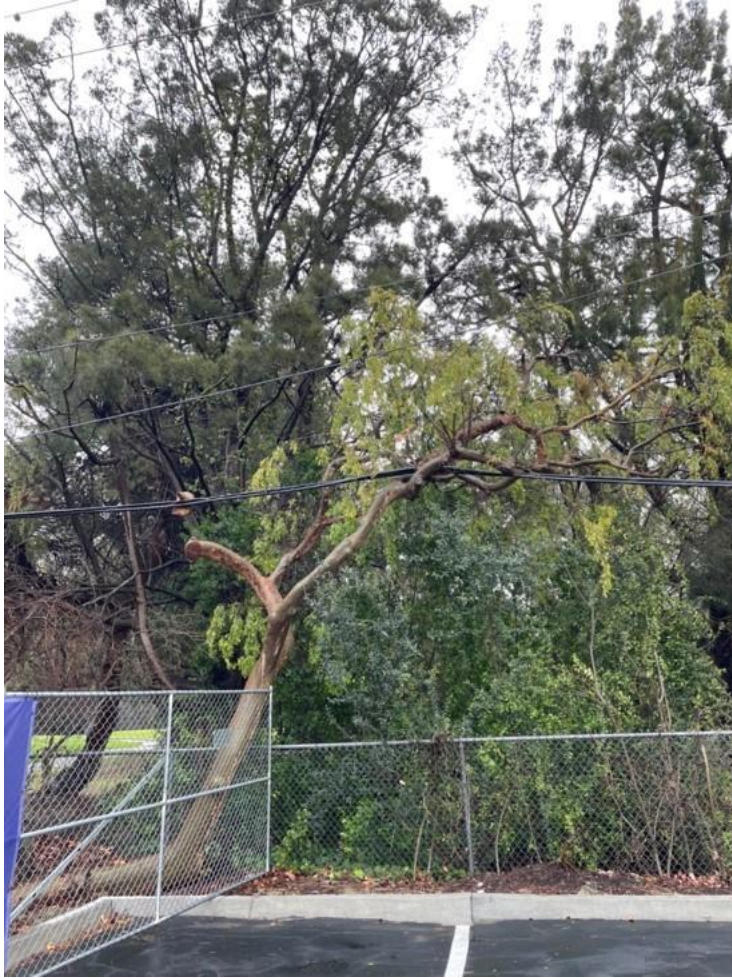
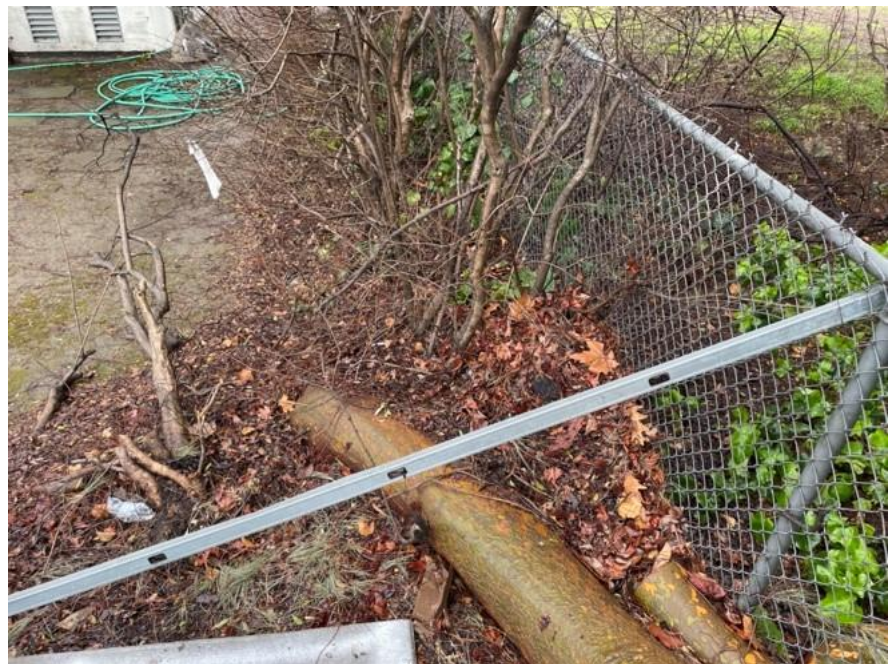
Figure 4: #602 - Chinese Elm (*Ulmus parvifolia*)

There are two trees that are within close enough proximity to be impacted by the proposed work. A fence is being constructed around the work site, which will require digging to install fence posts. The digging poses a threat to the roots and trunk of tree # 602 and 603. Mitigation measures will be imposed to prevent these impacts (see Tree Protection Plan below).

1. **Arborist will be present during construction.** To ensure that no root damage occurs during construction or soil compaction occurs when backfilling, the arborist will be present to monitor the roots and approve work practices around each tree.
2. **Hand digging will be utilized within half of the TPZ.** If digging needs to occur within half of the Tree Protection Zone (TPZ*), hand digging or hydro excavation will be required.

3. **Authorization needed if roots must be trimmed.** The arborist must give authorization if any roots must be trimmed. No roots larger than 1 inch in diameter may be cut and a maximum of 4 roots that measure 1 inch may be cut per tree. Proper root pruning practices must be observed and followed by the arborist.

4. **Fencing will be installed around the trunks of each tree.** As a result of the close proximity of the trunk to the proposed fencing, each tree will be wrapped with 2x4 planks of wood and construction fencing. This will be removed after construction.
5. **Damage will be documented.** Any damage to the trees caused by construction will be documented. This includes, but is not limited to, the trimming of any roots or injuries caused to the trunk or branches.
6. **Tree protection fencing will be installed.** Once the fencing for the project is installed and root monitoring has been completed, tree protection fencing will be installed 6 feet out from the trunk of each tree to ensure tree safety throughout the extent of the project. This will be removed after construction.
