Arborist Report

515 – 525 N. Whisman Road
Mountain View, CA

January 2026

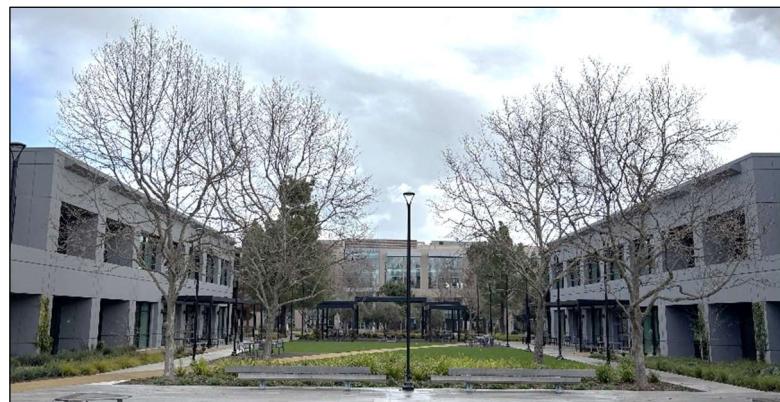
Of the 124 London plane trees, 86 were in fair condition, 29 were in good condition, and nine were poor. Trees were located throughout the property, primarily in small parking lot strips and islands. Development stage ranged from immature to mature with trunk diameters of 4 – 20 inches. Semi-mature and mature trees in good condition grew in significant landscaping areas in the central courtyard and along the west side of the site (Photo 1).

Photo 1: Looking east at mature London planes #106, 107 (L) and 109, 110 (R) in the central courtyard.

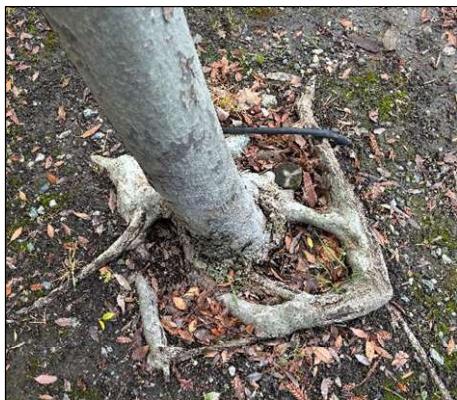
Sixteen (16) London planes grew in the parkway strip along N. Whisman Road. They were in fair and poor condition. Roots had developed into a block where they had been confined within a basin (Photo 2). Tree #191 was a parking lot tree in good condition with good structure and a vigorous, balanced crown. It grew in a narrow island with a metal grate and had impacted a charging station (Photo 3 and Inset).

Photo 2: Street tree roots were shaped by the previous basins.

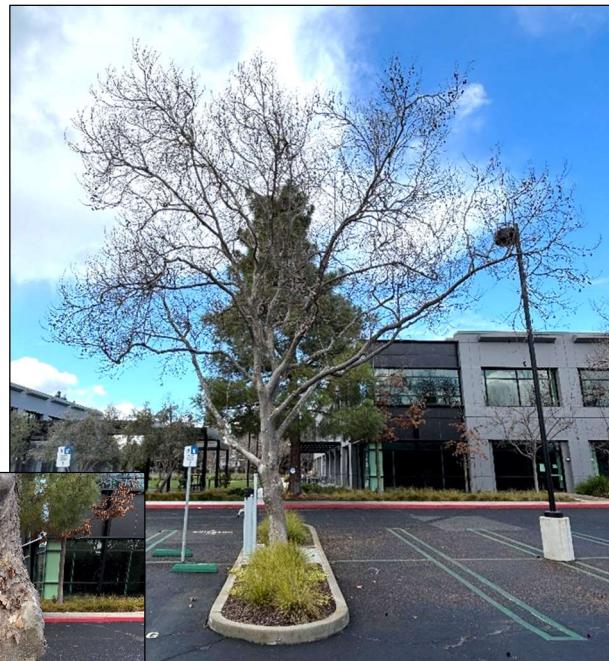
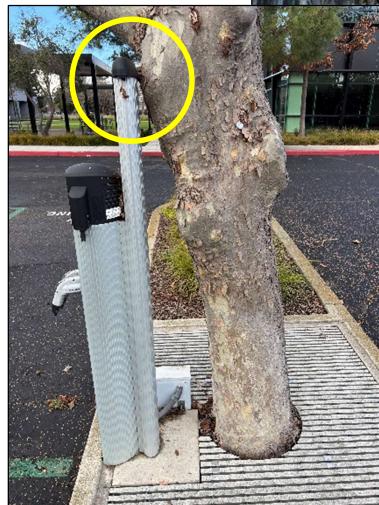
Photo 3 and Inset: London plane #191 grew through a metal grate and abutted a charging station.

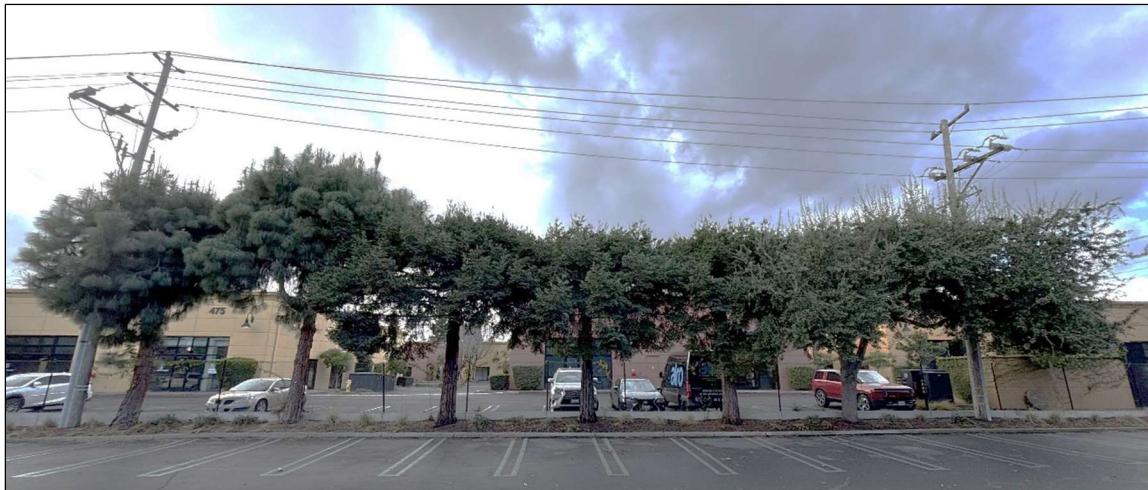
Fifty-eight (58) coast redwoods were assessed. Most grew in groves within park-like landscape areas, while the remainder were located in narrow strips along boundaries (Photo 4). Thirty-three (33) were in fair condition and 25 were good.

Photo 4: Coast redwoods lined boundaries in narrow planters. Canary Island pines (L) and southern live oak (R) grew alongside them.

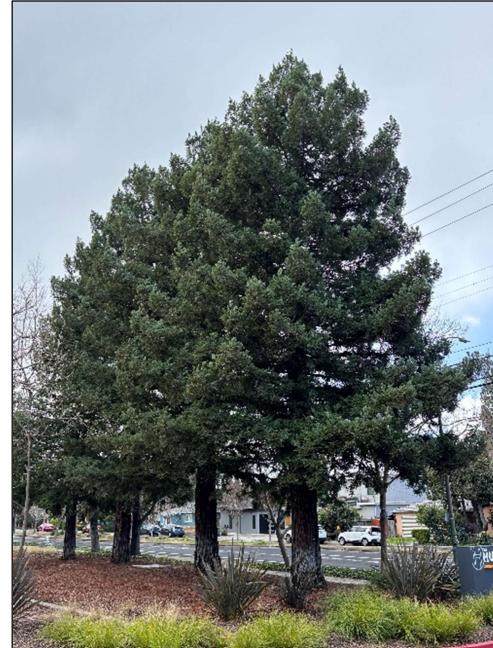
Overall, redwoods were semi-mature to mature in development, with trunk diameters that ranged from 14 – 35 inches. Tree #230 was immature with a 7-inch-diameter trunk. Trees exhibited the typical form and structure of the species along with excellent foliar density and color, except where crowns had been pruned to provide clearance to utility lines. Trees #27, 64, and 91 were specimen trees in excellent condition (Photo 5).

Photo 5: Coast redwood #64 (R) was in excellent condition.

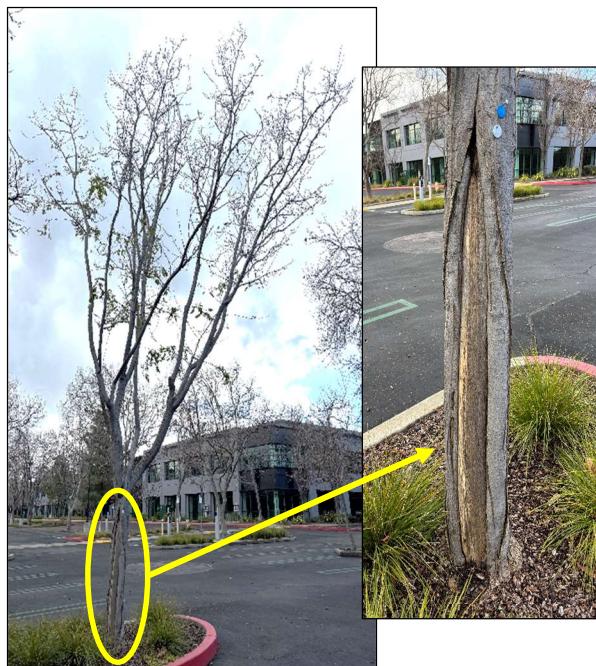
Photo 6 (left) and Inset: Purple Robe locust #201 was all but dead with very low vigor and extensive bark loss on the trunk and branches.

Eleven (11) Purple Robe locust trees grew in parking lot islands. Condition was mostly poor and very poor. Six trees were all but dead (Photo 6 and Inset). Tree #148 was in fair condition with fair structure and a narrow, moderately vigorous crown.

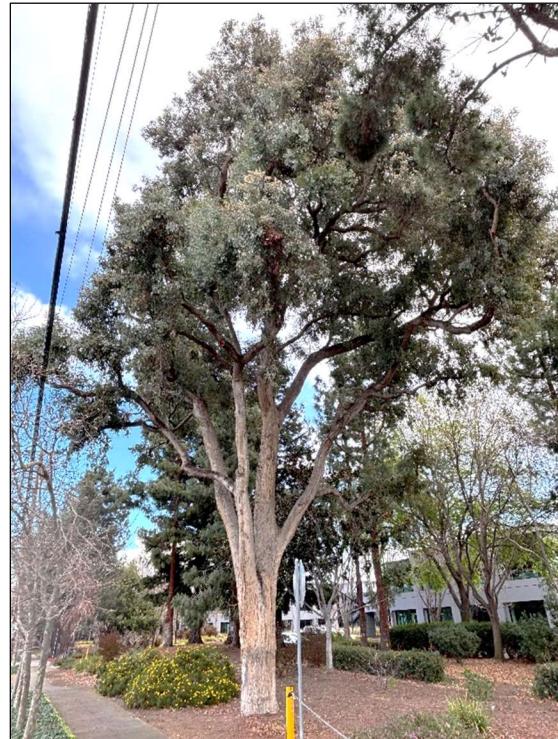
- Two mature silver-dollar trees dominated the west corners of the site. Tree #14 had a 38-inch diameter trunk and was in fair condition with a wide, open crown. Tree #84 grew near a sidewalk and was in good condition with a 36-inch trunk. Crown was compact and vigorous. Branches had been pruned away from utility and power lines, resulting in asymmetry to the east (Photo 7).

Photo 7: Silver dollar tree #84 was pruned away from power lines.
