## Preliminary Arborist Report

**555 West Middlefield Road  
Mountain View, CA**

**PREPARED FOR  
AvalonBay Communities  
455 Market Street, Suite 1650  
San Francisco, CA 94105**

**October 14, 2016  
Updated June 7, 2018  
Updated February 28, 2019  
Updated October 1, 2021  
Updated March 28, 2025  
Updated June 4, 2025**

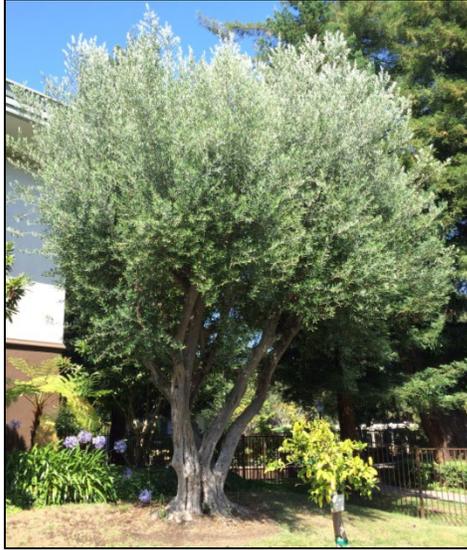
**Photo 1** (far left):  
Olive #318 had been previously topped at 15', but had a full, dense crown and was in good condition.

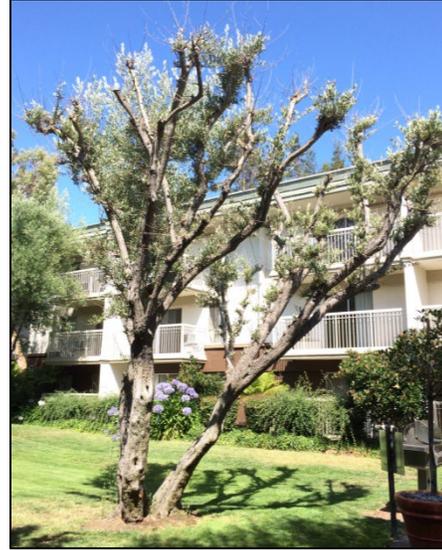
The most frequently occurring species was olive, with 131 trees (30% of the population). Trees were mature. All had multiple trunks and almost all had been previously topped. Most trees were in good condition (86 trees). The olive's had full or slightly thin crowns and minor trunk wounds, which is typical for mature olives (Photo 1). Trees in fair condition (37 trees) had thinning crowns and more significant defects, such as decay in one stem or trunk sunburn. Trees in poor condition (eight trees) had very thin crowns and dieback (Photo 2).

**Photo 2** (left):  
Tree #319 was in poor condition with very little live foliage.

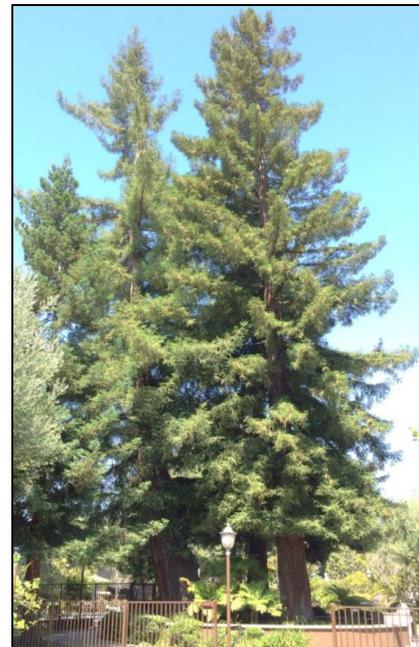
**Photo 3:** A group of three coast redwoods (#178-180) was located in a planter near the center of the site. Tree # 179 (left) was in fair condition with corrected trunk lean and thin crown, while trees #178 and 180 were in good condition with dense crowns.

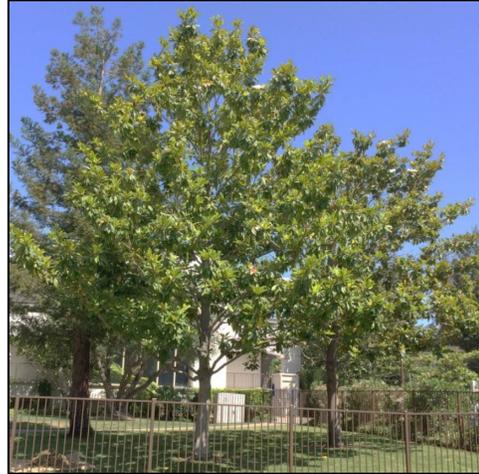
Southern magnolias made up 6% of the population with 27 trees. Magnolias were in good (19 trees) and fair condition (eight trees). Trees in good condition had good form and structure and slightly thin crowns (Photo 4). Trees in fair condition had a thinning crown and/or poor color.

**Photo 4:** Southern magnolia #174 was in good condition with good form and structure.
