## Arborist Report

749 West El Camino Real

**April 22, 2021**  
**Revised April 2022**  
**& September 2022**

**Arborist Report  
749 W El Camino Real  
Mountain View, CA**

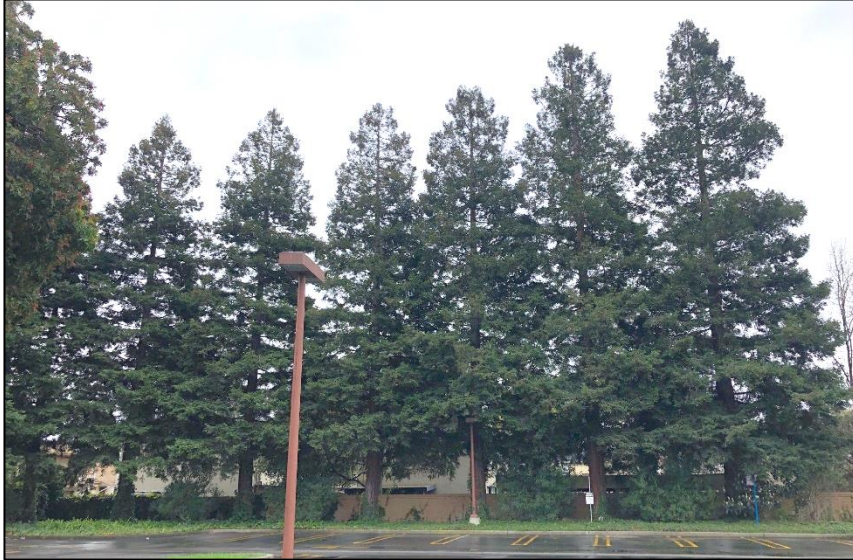
Coast redwood was the second most populous species with 14 trees assessed (4 off site). The 10 on site redwoods were in good condition (Photo 1) while the four off-site coast redwoods were in poor condition. The on-site coast redwoods (#32 – 41) varied in diameter from 21 to 34 inches

**Photo 1 (left):**  
Coast redwoods  
#37-42 along the  
eastern parking  
lot were in good  
condition.

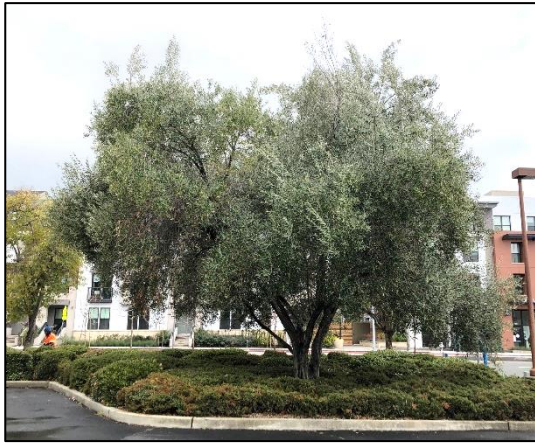
**Photo 2 (top):** Olive #72 was in good condition.

I do not recommend transplanting the olive trees in good condition (#65, 66, and 72). From my review, the current design presents limited opportunity to accommodate relocated trees, unless the landscape plans are revised.
