# Certified Arborist's Pre-Construction Subpar Redwood Tree Status Report

Report Date: February 14, 2023

Site:  
Residential Rebuild  
333 Franklin St.  
Mountain View, CA 94041

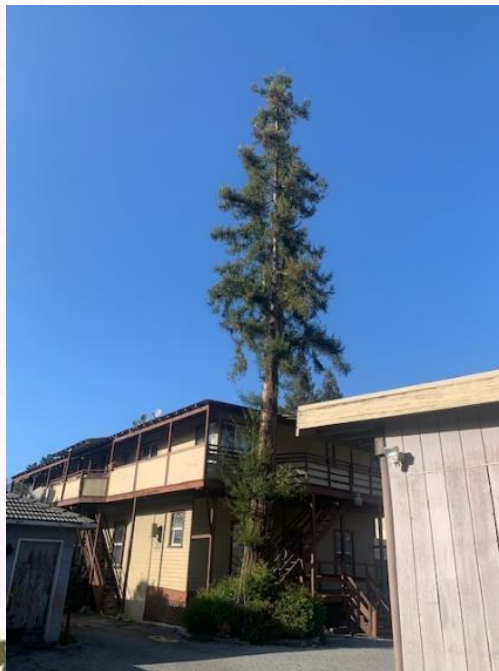
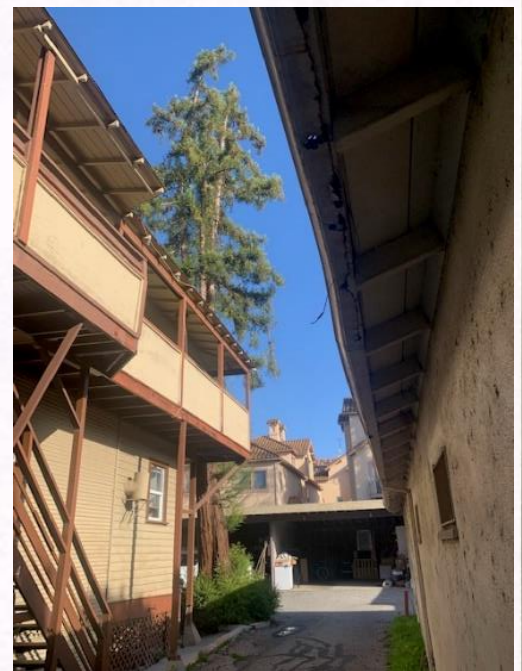
**P-1 & P-2 (at right): Subject Redwood viewing from existing interior courtyard & from driveway looking in off of Franklin Street.**

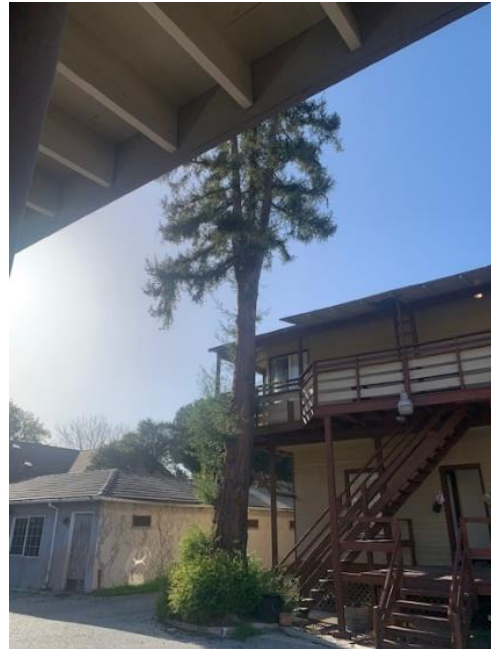
**P-3 at right shows multiple leaders at lowest severe (topping) cut above roof level with all laterals (side branches) also severely truncated/stubbed.**

The already hazardous condition of this tree would only be aggravated by new construction on these Franklin Street parcels ... the risk of failure of the v-crotches with narrow-angled trunk attachments and breakage of limbs due to foliage endweight accumulation will continue to overhang new homes and residents.

Two factors drive the requirement to remove this 37" Coastal Redwood ... current structural defects ... and stability and health after construction

Conclusion: A removal permit for this redwood should be granted by the City with no further delay.

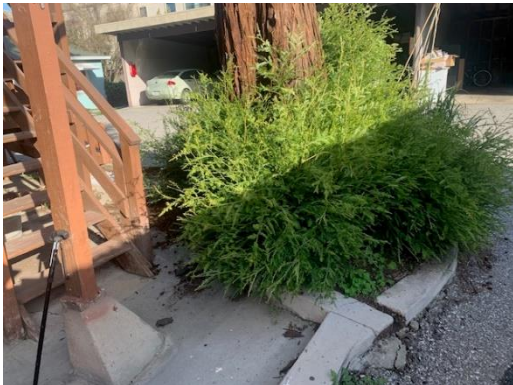
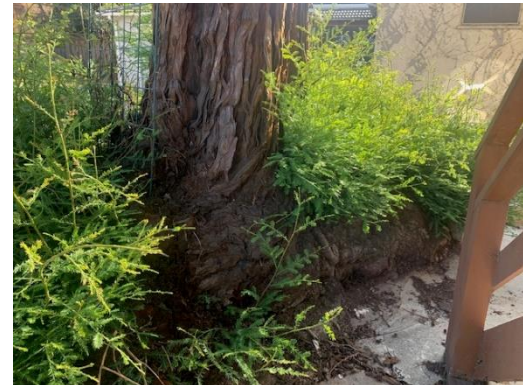
**P-4, P-5, P-6 (below): Subject Redwood crowds existing building/stairs with root flare (burl) breaking concrete curb and driveway ... prior box form retained, adding to accumulated defects.**
