Arborist Report for:

Woodview HOA / Tristate 2211 Latham Street, Mountain View, CA 94040

Prepared by Evan Fuller
ISA Certified Arborist #WE-12508A, TRAQ
evan@aplustree.com

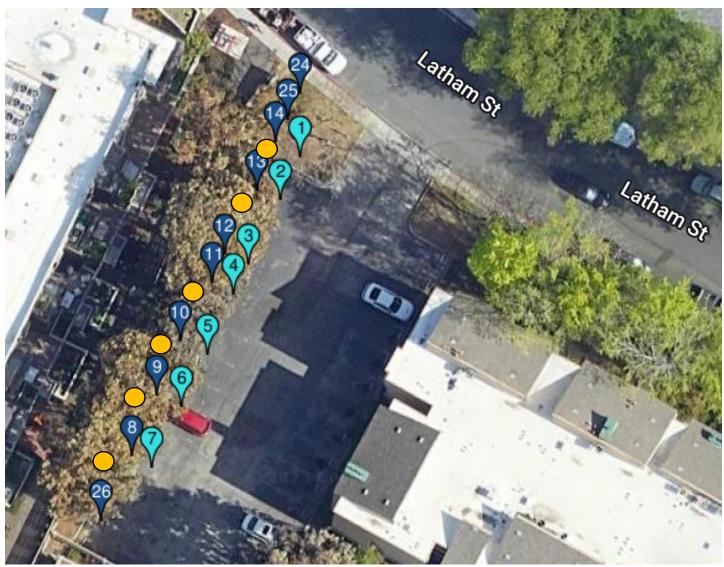
#1-7 are eucalyptus removals.

#8-14, and #24-26 are the Desert Willow replacements

The remaining 6 Eucalyptus are marked as yellow circles

A Plus Tree recommends removal and replacement as outlined above. Replacement trees will be planted in the same locations pending an USA/811 survey for underground utilities. Desert Willows are small CA natives that thrive in hot, dry environments, and will not compete directly with the remaining eucalyptus for growing space. The new trees will require weekly irrigation during the first couple of years to become established. Temporary drip irrigation must be installed.

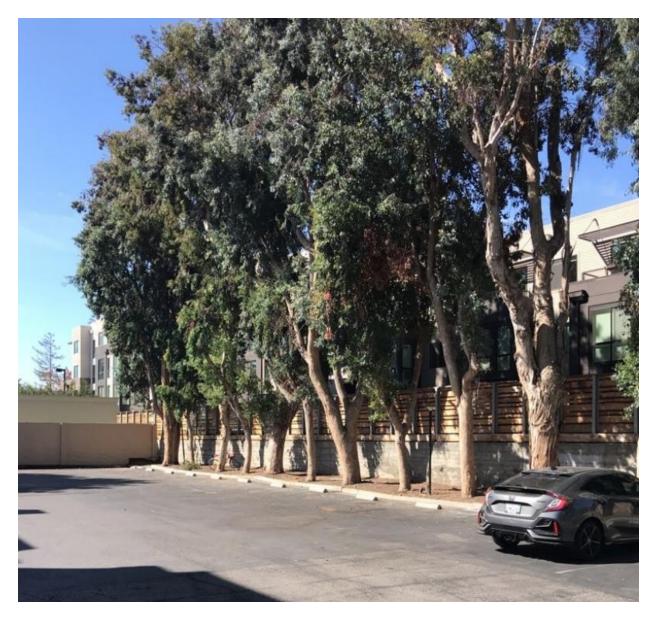
Picture of the row viewed from the driveway entrance

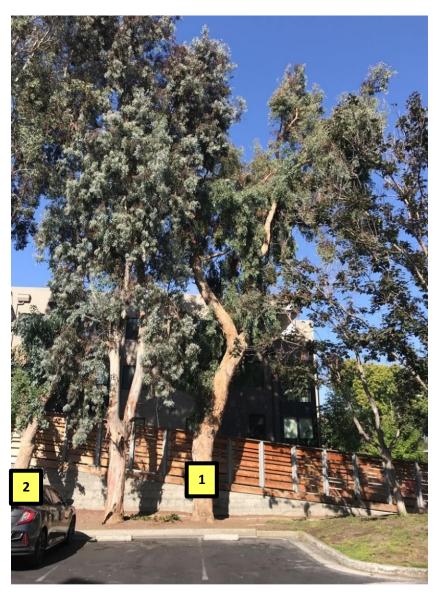
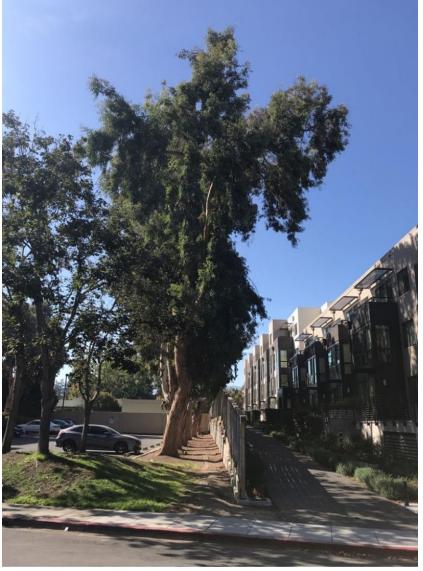
1. Heritage Tree.

Tree is large and healthy, but has a worse structure than its neighboring Eucalyptus and is crowding the nearby maples.

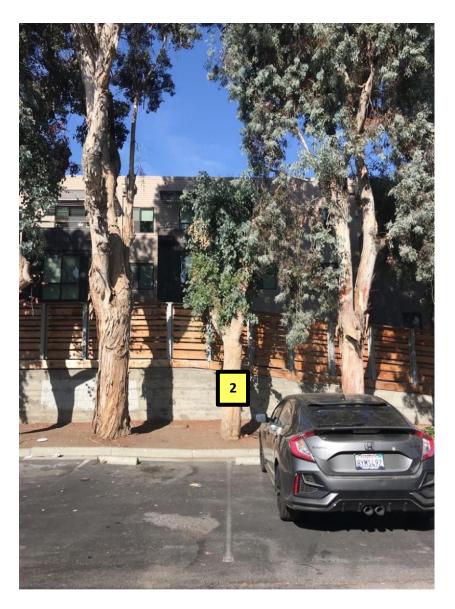
2. Heritage Tree
Very narrow structure due to crowding, then topped

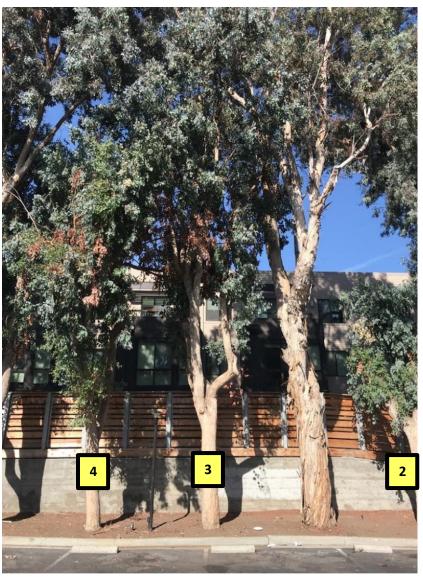
3. Heritage Tree
Very narrow structure due to crowding

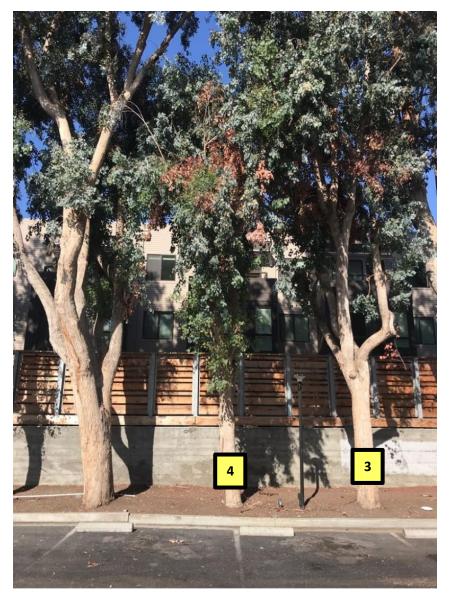
4. Very narrow structure due to crowding

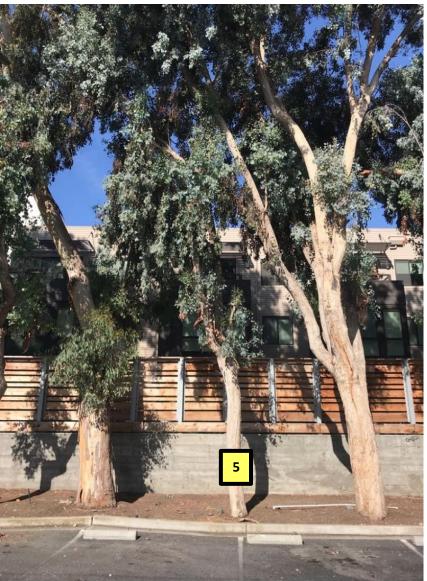
5. Very narrow structure due to crowding

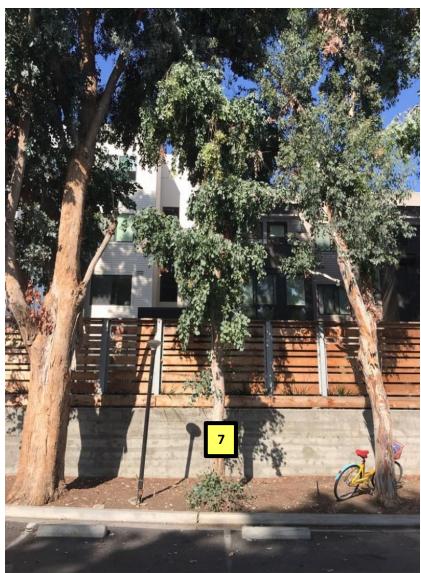
7. Very narrow structure due to crowding
