Arborist Report

October 21, 2024

773 Cuesta Dr

Mountain View Ca 94040

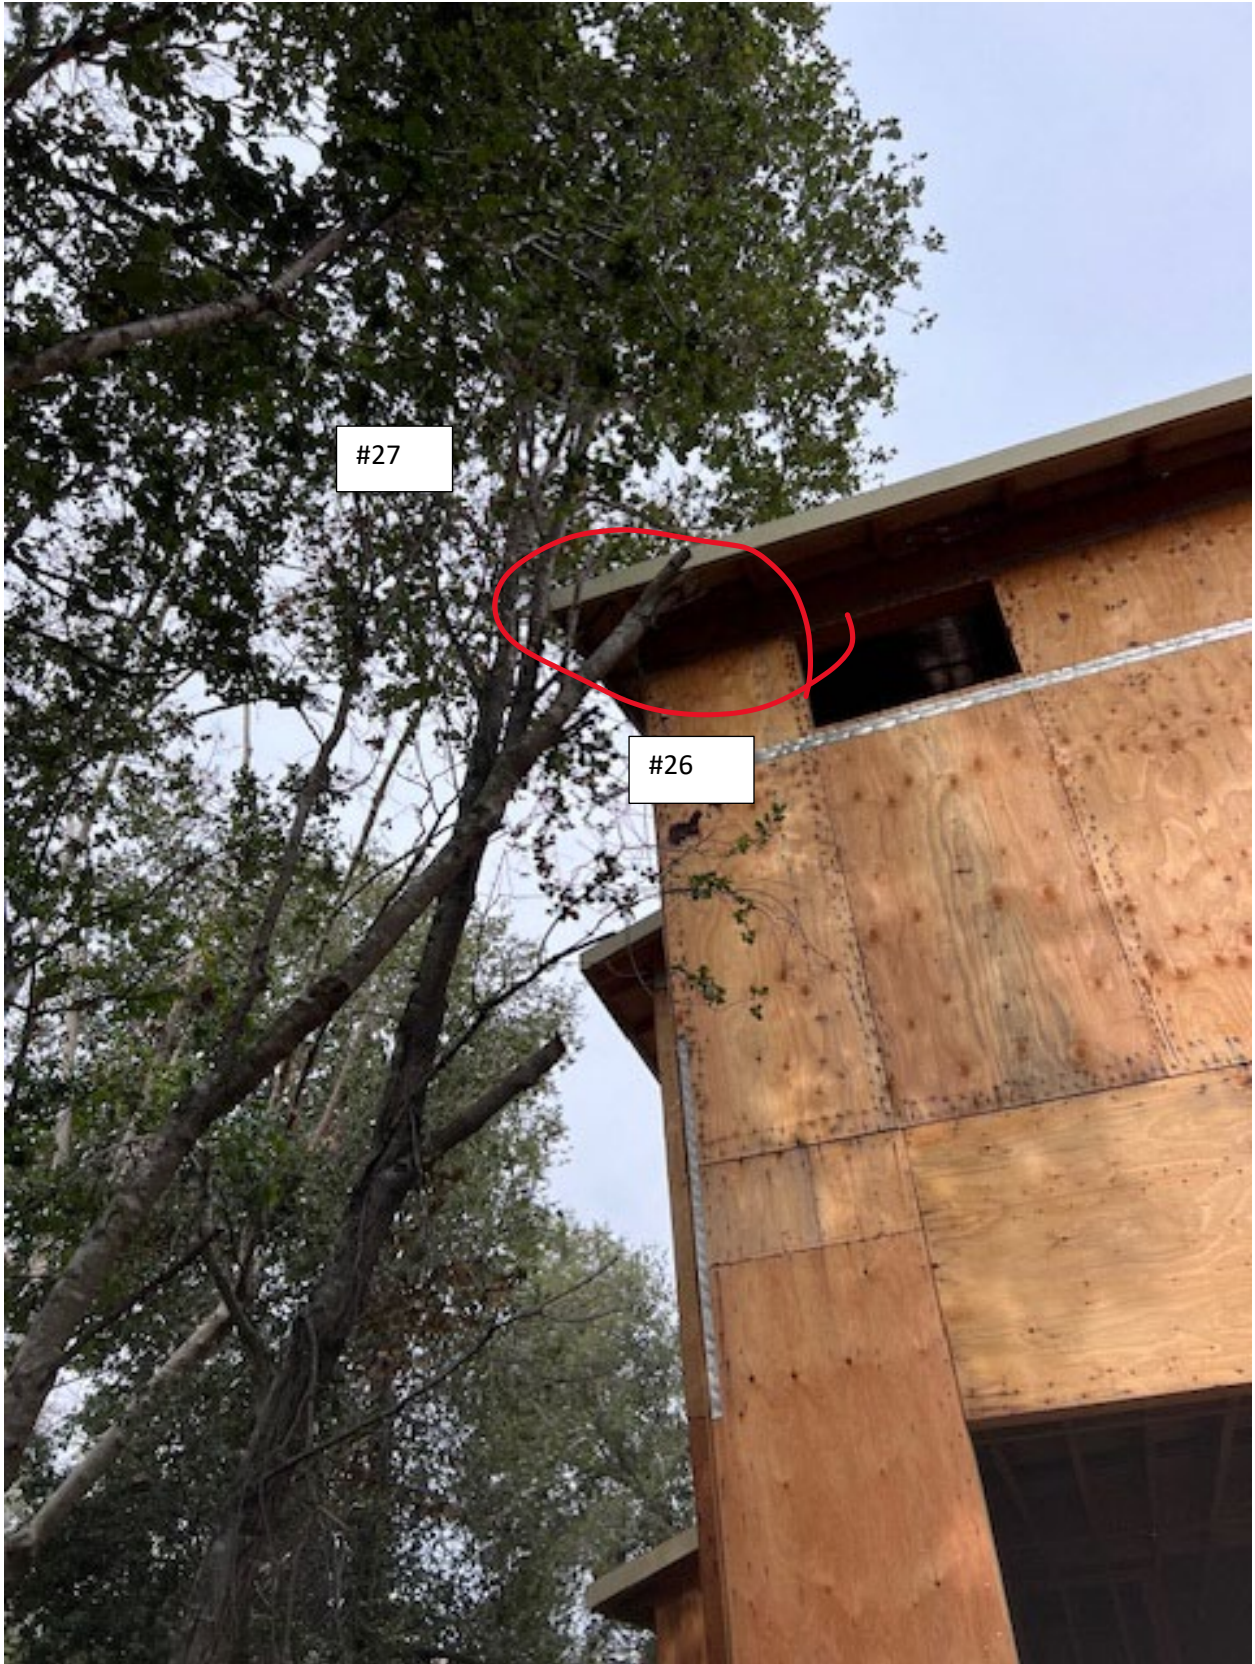
#26

- Tree is growing too close to the building. The tree is growing at an angle into the building and was topped to provide access. The trees structural integrity has been compromised and the tree must be removed to ensure fire clearance from the home.
