WOOD DESTROYING PESTS AND ORGANISMS INSPECTION REPORT

Building No. 961	Street Eichler Dr.	City Mountain View	ZIP 94040	Date of Inspection 08/06/2024	Number of Pages 6

REPORT #3984

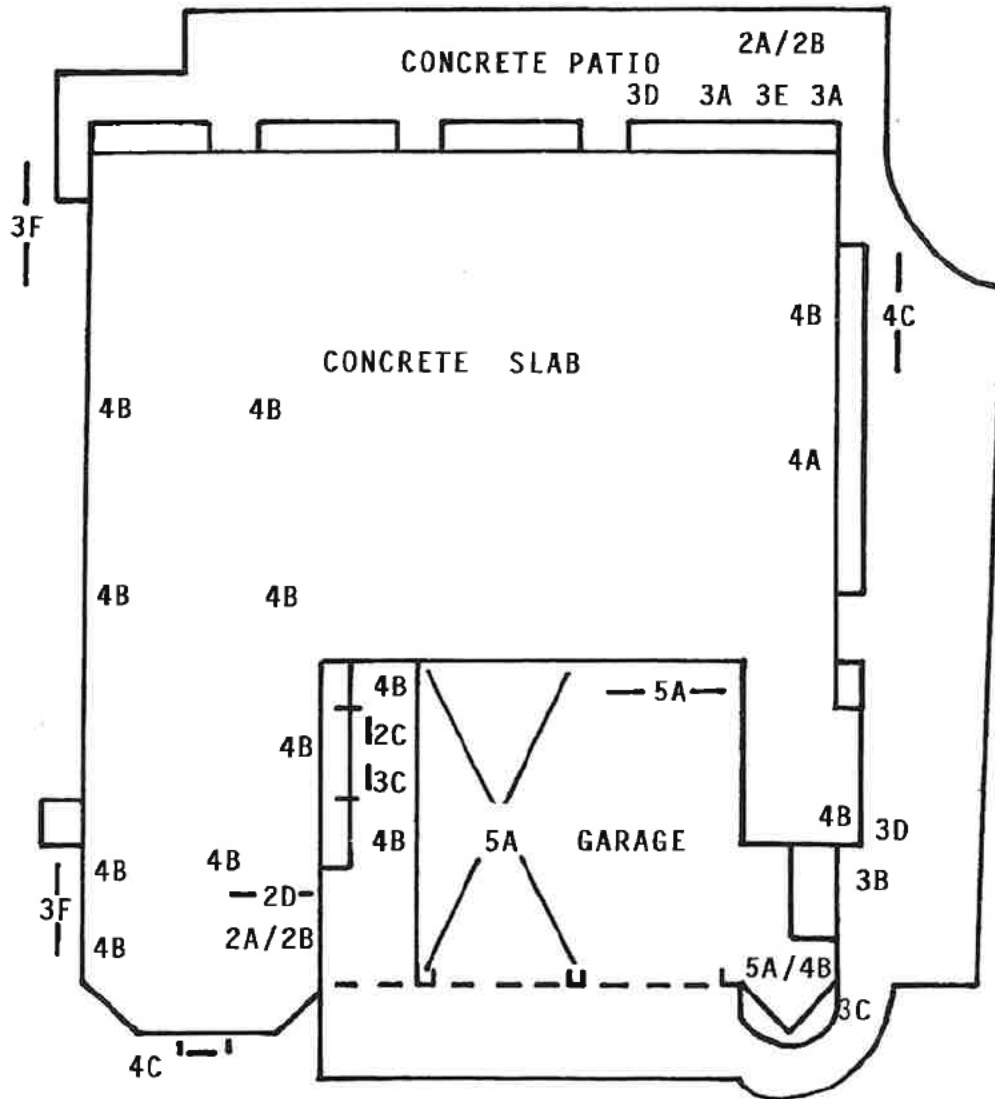
Diagram Not To Scale

Evidence of drywood termite activity was found to the interior and exterior of the structure. Indicated at 2A on the diagram. This infestation appears to go into inaccessible areas.

Evidence of drywood termite activity (fecal pellets) were noted to the interior and exterior of the structure. Indicated at 2B on the diagram.

Drywood termite damage was found to the exposed roof sheathing to the skylight at the covered front entry. Indicated at 2C on diagram.

Minor drywood termite damage was found to the exposed roof sheathing in the front left bedroom. Indicated at 2D on diagram.

Fungus and drywood termite damage were found to the plywood siding at the rear of the structure. Indicated at 3A on diagram.

Fungus and moisture damage were found to the utility closet door on the right side of the structure. Indicated at 3B on diagram.

Fungus damage was found to the wood siding (combed) at the front of the structure. Indicated at 3C on diagram.

Fungus damage was found to the roof trim boards on the right and rear sides of the structure. Indicated at 3D on diagram.

Fungus damage was found to the wood window framing at the rear of the structure. Indicated at 3E on diagram.

Fungus damage was found to the plywood siding on the left side of the structure. Indicated at 3F on diagram.

The sink cabinet bottom in the kitchen is moisture damaged. Indicated at 4A on the diagram.

Water stains were noted to the exposed roof sheathing in various areas. Indicated at 4B on the diagram. This could indicate possible past or present roof leakage.

A marginal to faulty grade condition exists at the front and right sides of the structure. Also, earth to wood contacts were noted to

the base of the exterior wood siding in some areas. Indicated at 4C on the diagram.

A thorough inspection of the garage walls was impractical at this time due to storage and cabinets. Indicated at 5A on the diagram.

RECOMMENDATION: Fumigate the structure with an approved lethal gas to eradicate the infestation of drywood termites. Termite operator is not responsible for any damage to the roof, plant life around the building or the TV antenna during the course of fumigation. All reasonable care will be taken to avoid damage of any type. Fumigant to be used is Vikane (Sulfuryl Fluoride). Warning agent Chloropicrin. (SECTION 1)

RECOMMENDATION: Remove and/or mask all accessible termite pellets to aid in future inspections. (SECTION 1)

RECOMMENDATION: Owner is advised to contact a licensed contractor to make all necessary repairs/replacements to correct these conditions. (SECTION 1)

RECOMMENDATION: Owner is advised to contact a proper tradesman to make any necessary repairs. (SECTION 1)

RECOMMENDATION: Owner is advised to contact a licensed roofing contractor to inspect the roof covering and to make any repairs deemed necessary. (SECTION 2)

RECOMMENDATION: Owner is advised to lower the soil in this general area to break all earth to wood contacts and also to expose 2" to 4" of the concrete foundation. Grade soil to slope away from the structure. (SECTION 2)

RECOMMENDATION: If owner or interested parties would like a further inspection of this area, one would be performed after stored and cabinets have been moved. A supplemental report will be issued listing any findings and cost, if any. NOTE: A \$95.00 fee will be charged for this report. (UNKNOWN)
