August 22, 2024

RE: Magnussen's Toyota Auto Dealership Mountain View- Arborist Report and Tree Protection Specifications

The report includes images of the trees. Attached are the Tree Evaluation Data Matrix (Appendix A), Tree Protection Requirements Matrix (Appendix B), Tree Protection Specifications (Appendix C), and an Existing Tree Exhibit.

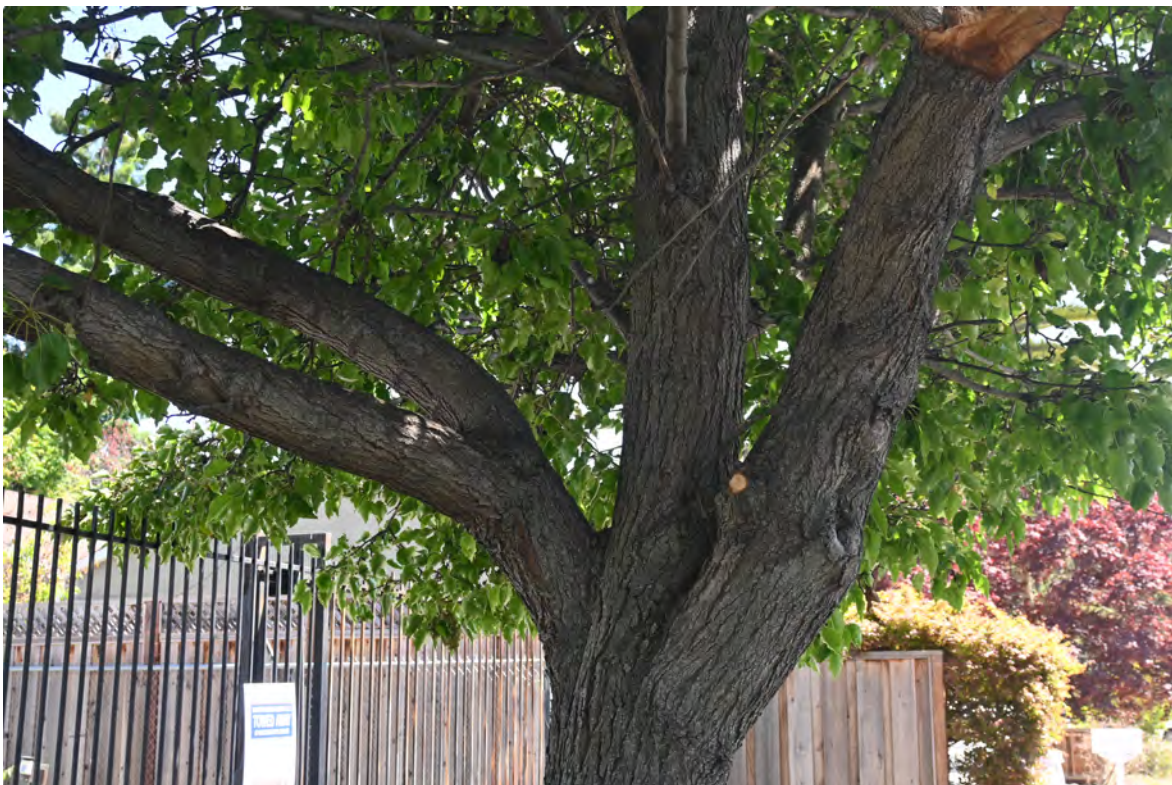
Closely spaced limbs are characteristic of Bradford pears and are prone to failure.

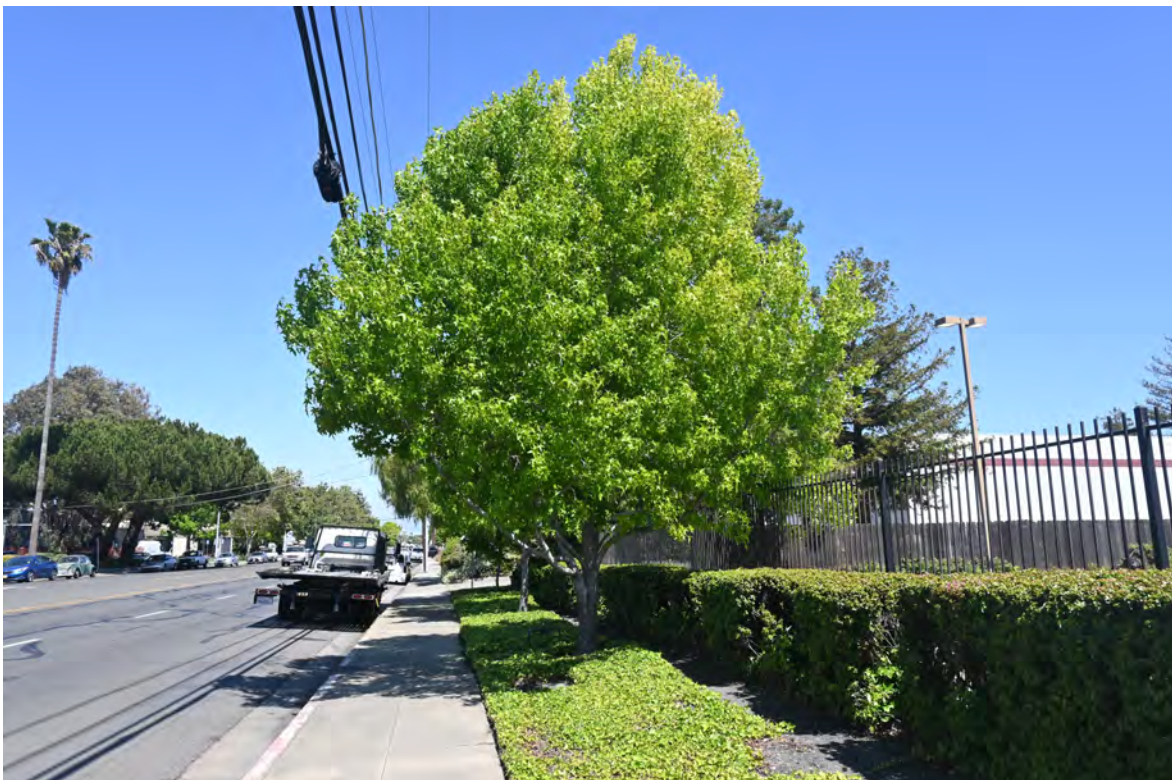
One of the four liquidambar street trees on Old Middlefield Way. The trees are in variable condition.

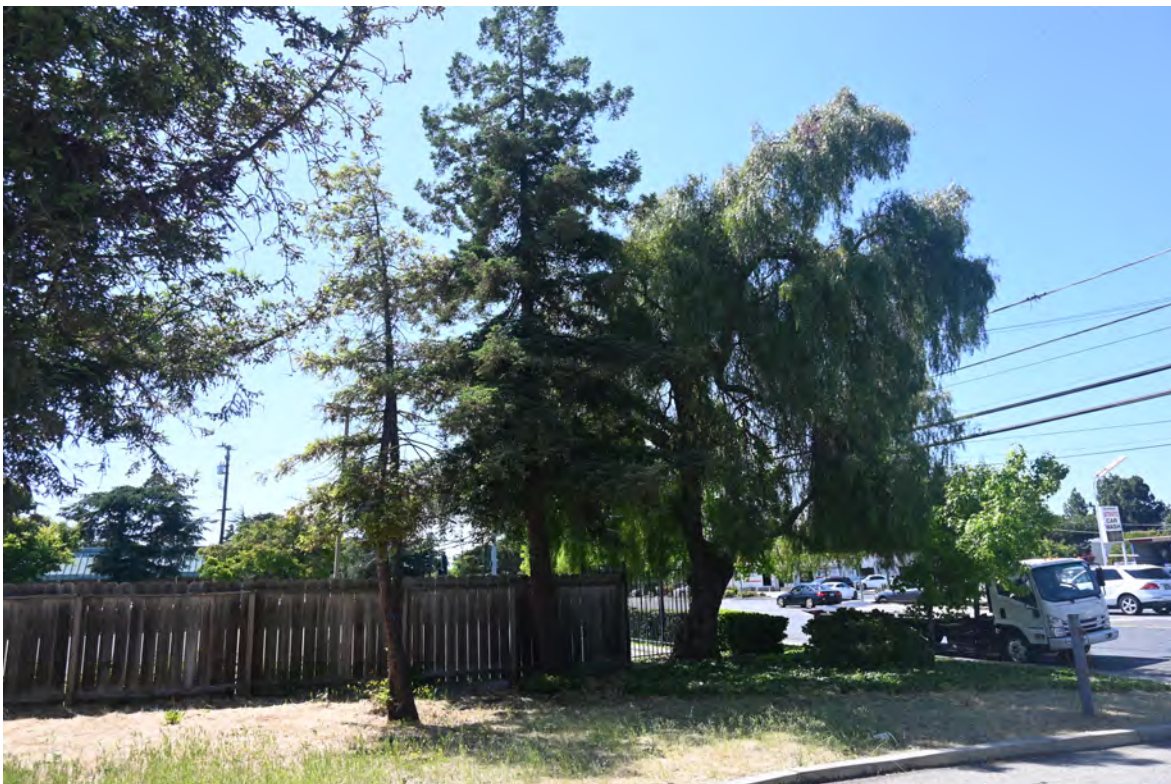
Peruvian pepper, tree #9., and coast redwoods #10 and #11.

8	liquidambar	2	3.0	9	1.5	2.5	10±	10±	3.0	1.5	Leaning tree with defective root system. Located adjacent to the pepper tree.	Poor	No (Street Tree)	Located in project grading limits. Removal required.	RC	1
9	Peruvian pepper tree (<i>Schinus molle</i>)	1	27.0	85	27.0		35'-40'±	25'-30'±	3.0	3.0	Mature tree with an extended second trunk. Lower trunk wounds and galls. Wound on southwest limb in mid-crown. Vigor and foliage density are moderate.	Moderate	Yes	Located in project grading limits. Removal required.	RC	2
10	coast redwood (<i>Sequoia sempervirens</i>)	1	16.0	50	16.0		45'-50'±	22±	3.0	3.0	Semi-mature tree with single trunk structure and no significant structural defects. Vigor and foliage density are moderate.	Moderate	Yes	Located in project grading limits. Removal required.	RC	2
11	coast redwood	2	10.7	26	6.5	8.5	20±	8±	1.5	2.0	Low two-trunk twisted structure. Vigor is low with significant branch dieback occurring.	Poor	Yes	Located in project grading limits. Removal required.	RC	2

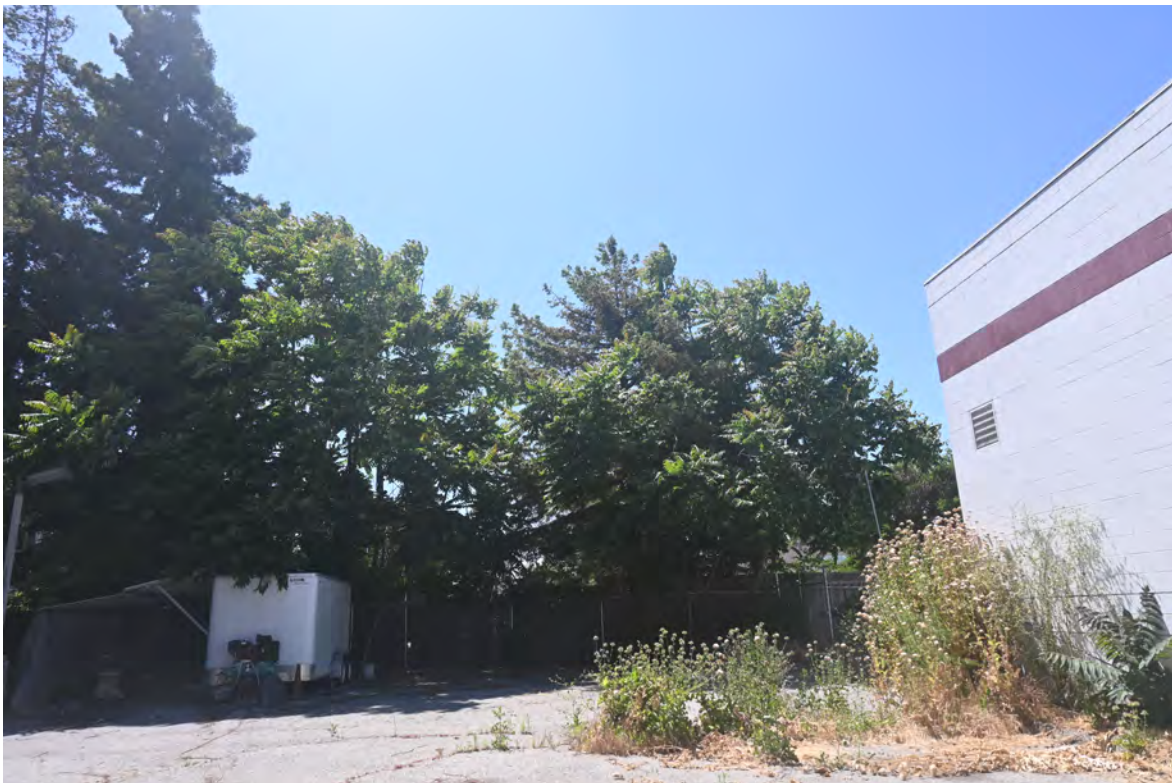
Redwoods and tree-of-heaven are growing on the adjacent property in the south portion of the project site. Trees #28- # 32.

28	coast redwood	1	24.0	75	24.0		50'±	25'-30'±	3.0	1.5	Mature tree with single trunk structure. No significant structural issues. Vigor and foliage density are moderate. Probable significant damage to root system from adjacent property construction.	Poor to Fair	Yes	Located in grading limits including bio retention area.	MI	0
29	coast redwood	1	32.0	100	32.0		60'±	30'±	3.0	3.0	Mature tree with single trunk structure. No significant structural issues. Vigor and foliage density are moderate. Located on adjacent property at fence line. Possible root loss from adjacent construction on south side.	Moderate	Yes	22' to parking area. Masonry wall required next to trunk.	MI	0
30	tree-of-heaven (<i>Ailanthus altissima</i>)	20±	2"-10"				40'-45'±	30'-35'±	3.0	2.0	Dense cluster of 20 or more stems surrounding original tree. Appears healthy. Located on adjacent property at fence line. Overhangs fence 30'.	Poor (Invasive)	Yes	Located in grading limits with significant grading cuts required and the construction of a masonry wall.	RC	1
