## **Arborist Report**

**749 West El Camino Real**

**April 22, 2021**  
**Revised April 2022**  
**& September 2022**

**Arborist Report  
749 W El Camino Real  
Mountain View, CA**

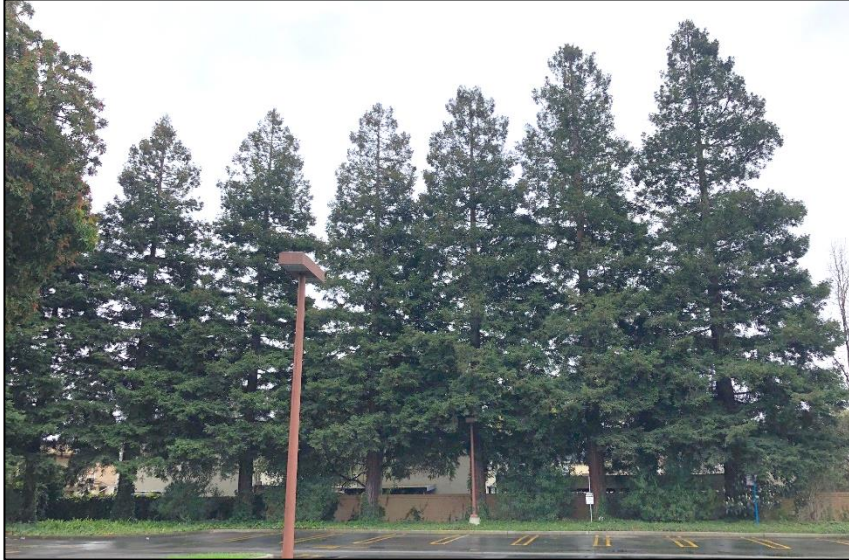
Coast redwood was the second most populous species with 14 trees assessed (4 off site). The 10 on site redwoods were in good condition (Photo 1) while the four off-site coast redwoods were in poor condition. The on-site coast redwoods (#32 – 41) varied in diameter from 21 to 34 inches

**Photo 1 (left):**  
Coast redwoods  
#37-42 along the  
eastern parking  
lot were in good  
condition.

Coast redwoods #36-41 can be preserved with meticulous adherence to the tree preservation guidelines. The walkway is planned between 5 to 8 feet away from the trunks of the trees the existing pavement is around the same distance from the trunks (Sheet L-1 screenshot 1 below). To enable preservation, I recommend reducing the extent of the excavation required for the adjacent concrete walkway. Permeable pavers will be used to enhance water flow in the root zone.

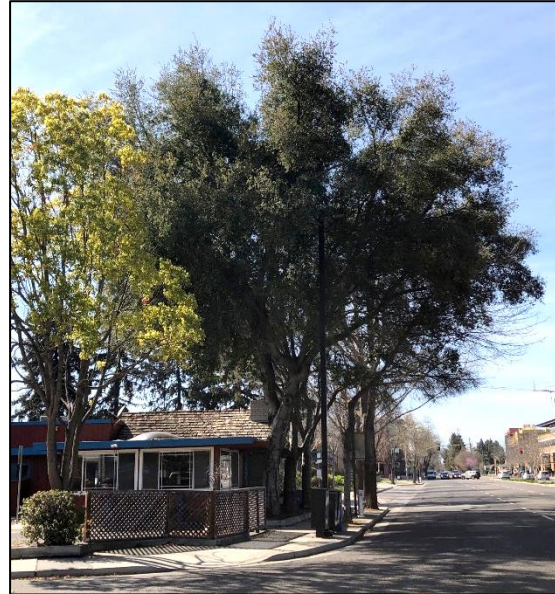
Four coast live oaks were assessed. One was in poor condition, two were in fair condition, and one was in good condition. Their trunks measured between 17 and 25 inches in diameter. All oaks in Mountain View with a diameter of 4 inches or greater are considered *Heritage*, therefore all coast live oaks were *Heritage*.

**Photo 3 (right):** Coast live oak #111 on El Camino Real was in good condition.

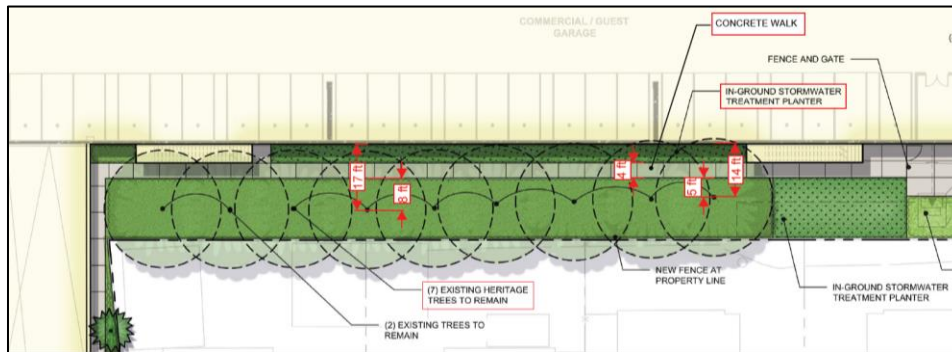
The in-ground stormwater treatment planter is located where the existing parking lot is located. Root loss in this area is expected to be minimal. Excavation within the tree protection zone should be done by hand and should seek to preserve roots 2-inches in diameter and larger. Once roots are severed, they should be covered. The trees should be irrigated regularly with potable water before, during, and after construction to help the trees tolerate and recover from construction impacts better. Tree protection fencing should also be installed between the trees and the edge of the proposed work area. Fencing should remain in place for the duration of the project.
