Certified Arborist's Tree Inventory & Pre-Construction Report –

Tree Inventory Data: August 19, 2023
Report - original: September 20, 2023
Report - revamped: January 24, 2024 ... & April 29, 2024 ... & July 24, 2024... & Oct. 21, 2024
... & Oct 24, 2024... & Oct. 25, 2024

Dividend Homes
317 Moorpark Way
Mountain View, CA 94043

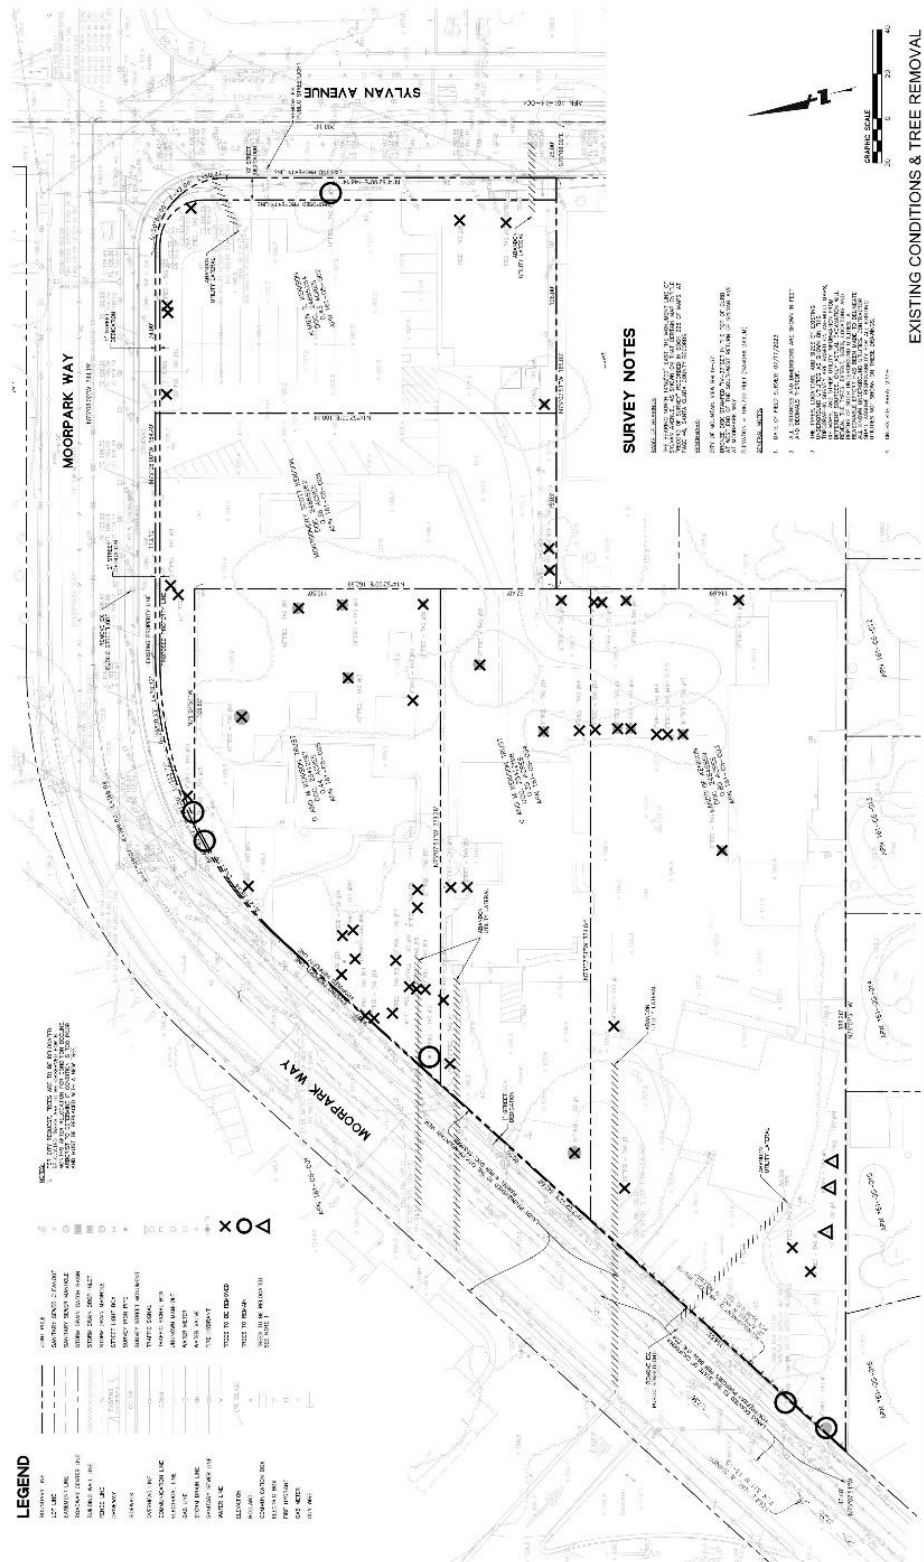
EXISTING CONDITIONS & TREE REMOVAL
 JOB NO. 297-5900
 DATE 04/26/2024
 C1.0

3.1 Tree Locations Map using the BKF-Dahlin Sheet C-1.0 "EXISTING CONDITIONS & TREE REMOVAL: ...RECEIVED 7/24/2024 8:30pm
