ARBORIST REPORT AND TREE PROTECTION PLAN

151 Calderon Ave., Mountain View CA 94041 November 2024 - Updated July 2025

Arborist Report & Tree Protection Plan for 151 Calderon Ave., Mountain View, California 94041

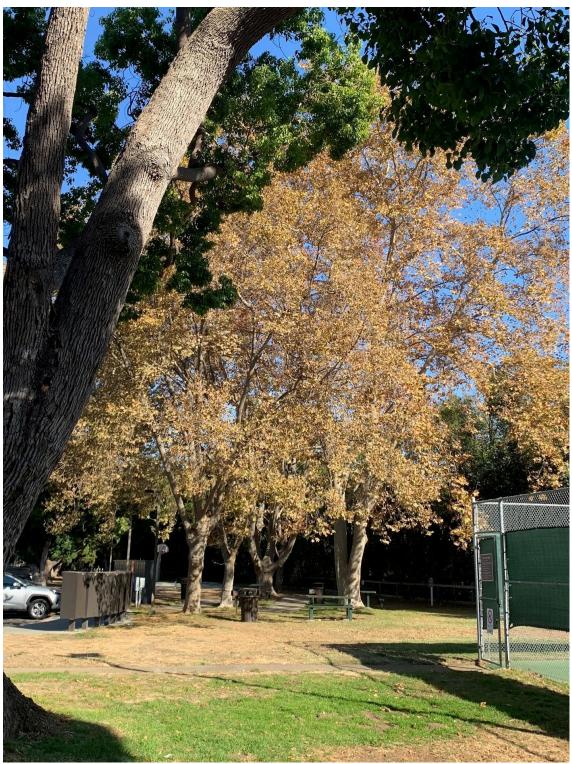
- Trees #3-5 are in the footprint or within 2 feet of the proposed ADUs. Impacts to the trees will be high. Removal of the trees is required. Permits are required for the removal of all three trees.

Photo 1. View of trees #3-5, all in fair condition.

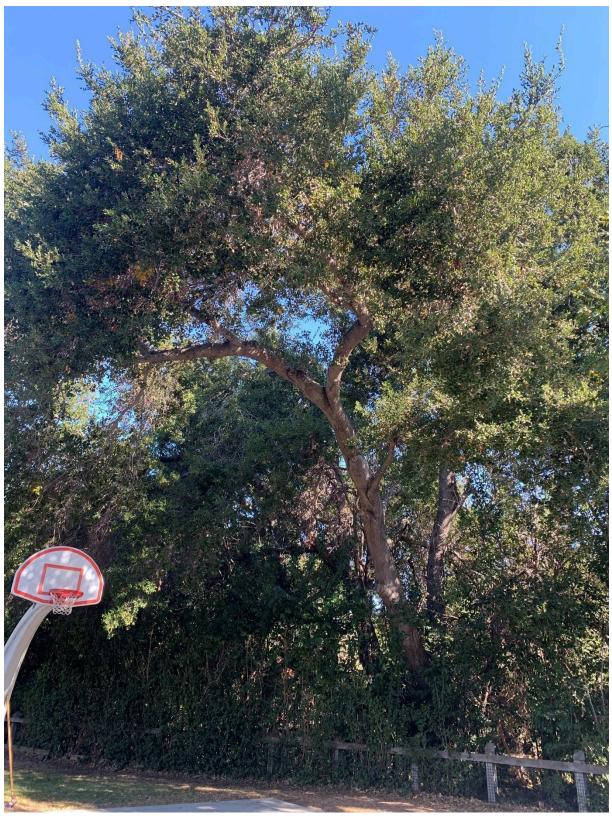
Photo 2. Tree #12 is in fair condition and is a Heritage Tree.

- Tree #12 was previously recorded based on the previous plans. As long as the basketball court is planned to be retained, then work is not to occur in this area, but tree protection fencing should still be installed at least 10 ft. from the fence to keep heavy machinery out of the root zone. If machinery must be under the canopy, plywood should be set on the ground, and machinery should remain on it to reduce soil compaction in the root zone. Impacts are expected to be low.

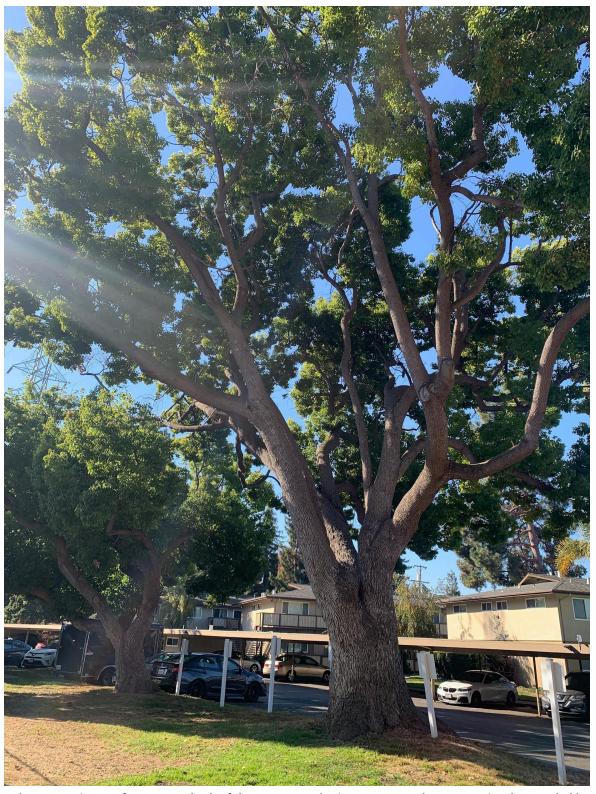
Photo 3. A picture of trees #1-2, both of these trees are heritage trees. Both were previously recorded because of previous plans.

- Trees #1-2 were previously recorded based on the previous plans. Work is not to occur in this area, but tree
 protection fencing should still be installed to keep heavy machinery out of the root zones. The trees are
 expected to have no to low impacts. The tree protection fencing should have the trees grouped together
 along their driplines.

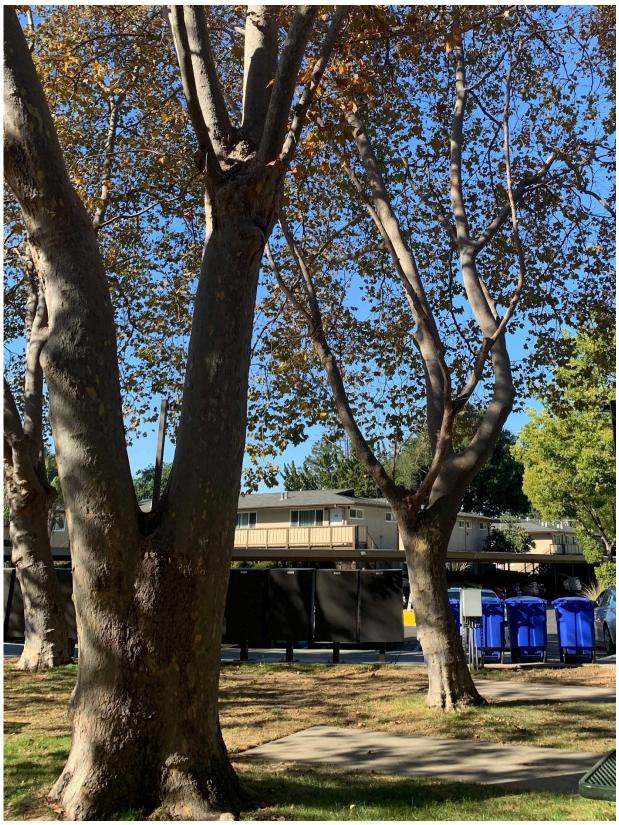
Photo 4. Close up on trunks of trees #3-5.

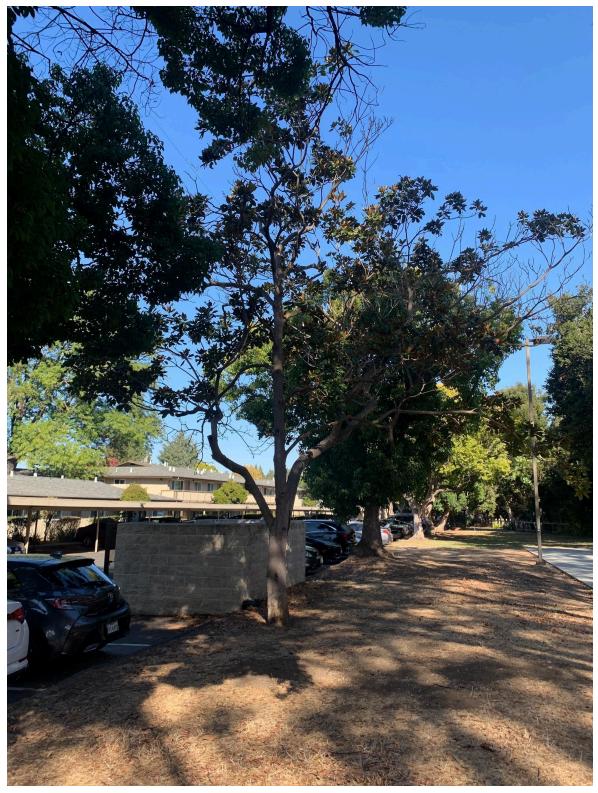
Photo 5. A full picture of tree #9 in poor condition.

- Trees #9-10 are about 8 ft. from the utility paths. Impacts are expected to be low to moderate. Tree protection fencing should be installed to the furthest extent of the canopy of the tree and can only be moved when work is to occur within the TPZ. Due to the sensitive nature of working within the CRZ of trees to be retained, any excavation or grading within the TPZ must be performed with hand tools and supervised by a Certified Arborist to monitor and document any tree impacts. Any significant roots (roots 2 inches in diameter or larger) encountered should be cut cleanly and photo documented. If severed roots increase failure risk beyond the property owner's tolerance, the Arborist may recommend tree removal, and a permit would be required for the removal of these trees.

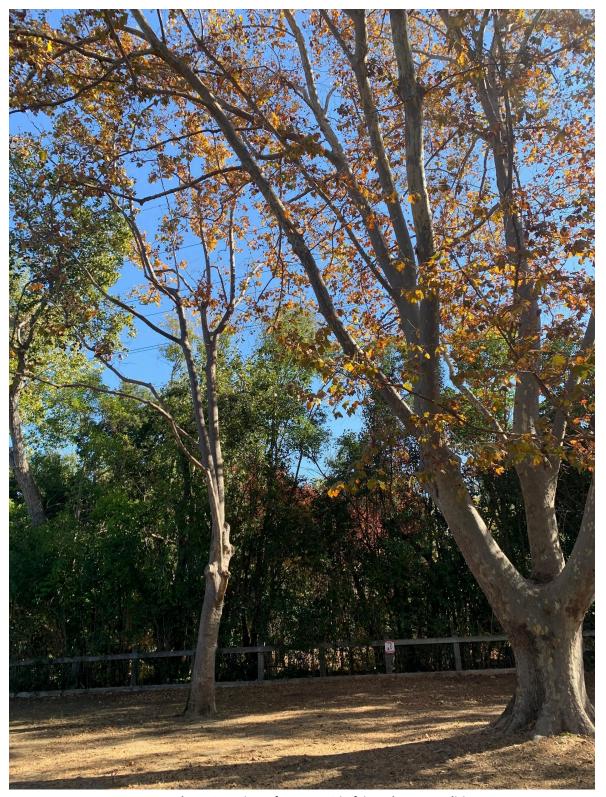
- Tree #7 is in the footprint of the proposed ADUs. Removal of the tree is required. A permit is required for the removal of the tree.
- Tree #8 is 8 and 12 feet from the proposed ADUs. Impacts to the tree are expected to be moderate. Tree protection fencing should be installed along the SRZ. This tree should be considered for removal regardless of construction. The tree is in overall poor condition. The tree has been lion-tailed, and the canopy has been excessively raised. If the client chooses to remove the tree, then a permit is required.

Photo 6. A view of trees #7-8 in fair and poor condition.

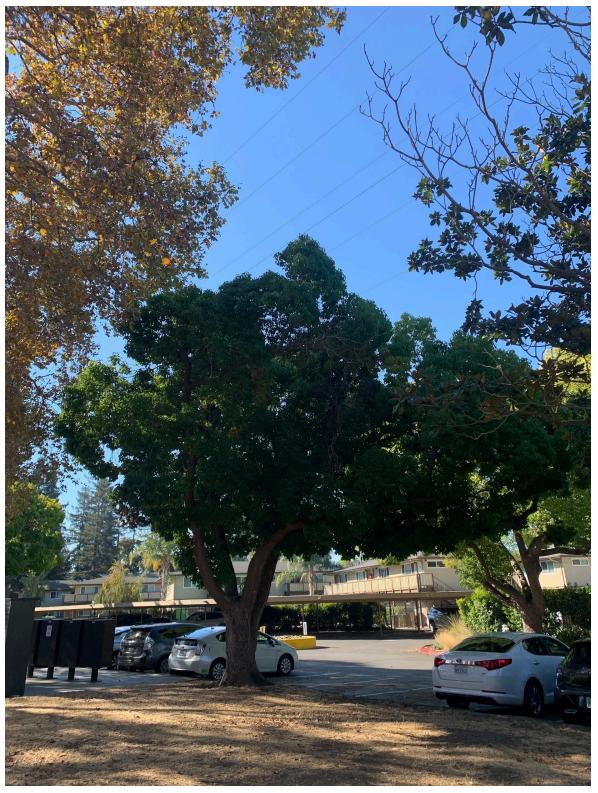
- Tree #6 is about 4 ft. from the proposed trenching. Impacts are expected to be high. Removal of the tree is recommended and a permit is required for the removal of the tree.

Photo 7. A full view of tree #6 in fair condition.

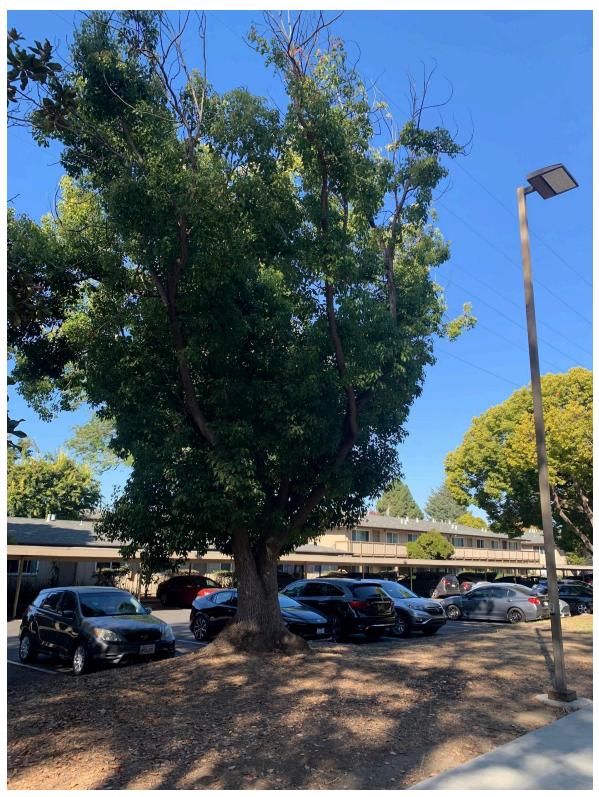
Photo 8. A full view of tree #10 in fair condition. The tree is scheduled for removal, and a permit is required.

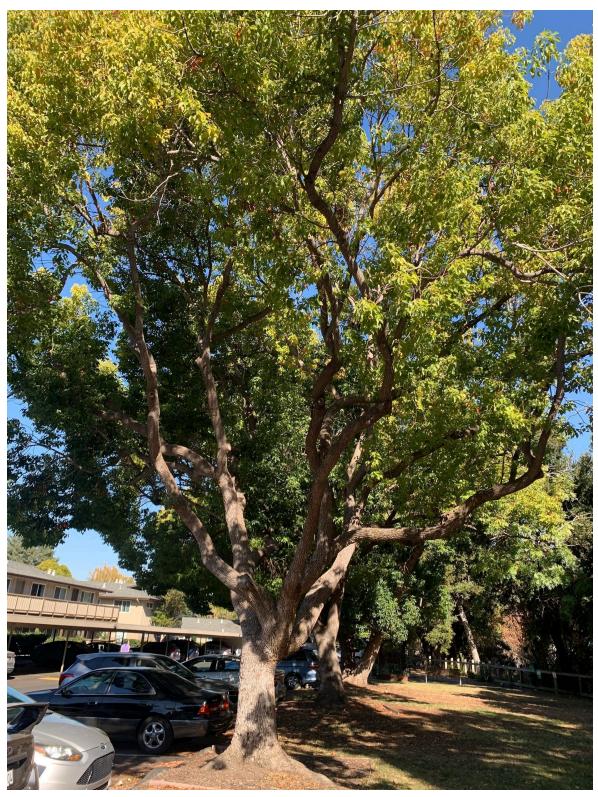
- Tree #11 is within 2 ft. of the proposed ADU and along the path of the utility lines. Impacts are expected to be high. Removal of the tree is recommended. A permit is required for the removal of the tree.

Photo 9. A full view of tree #11 in fair condition.

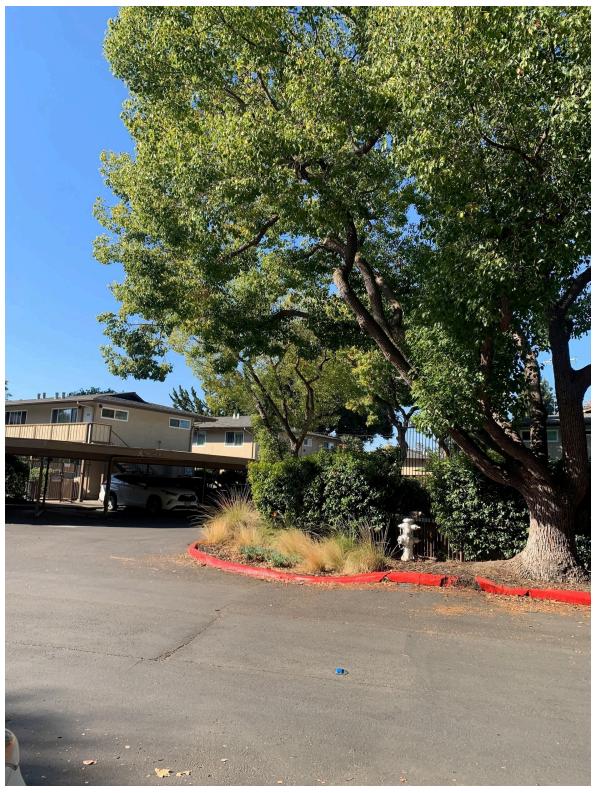
Photo 10. A view of tree #13 and tie-in for the water line.

- Tree #13 is in fair condition and is about 6 ft. from the water tie-in and about 14 ft. from the proposed trenching. Impacts are expected to be low to moderate. Tree protection fencing should be installed to the furthest extent of the existing island where the tree is located.

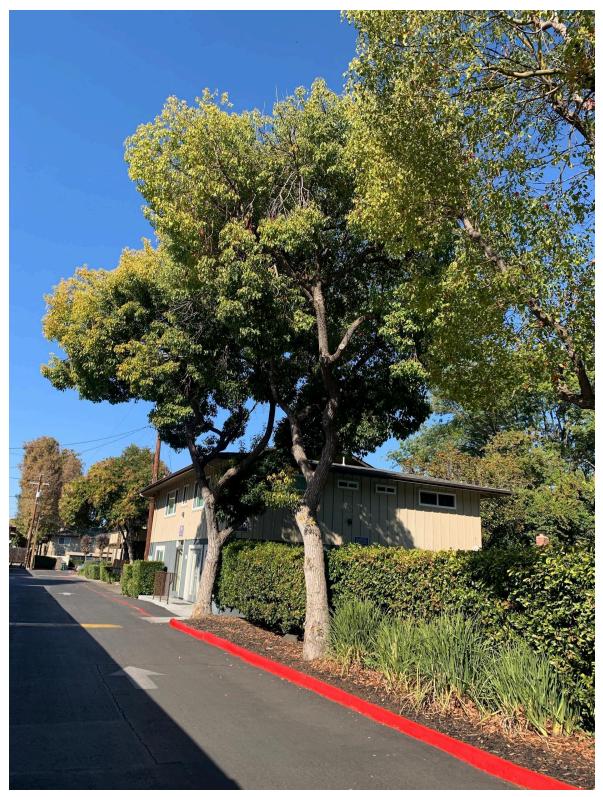
Photo 11. A view of trees #15-16 in fair condition, about 2 ft. from the proposed trenching.

- Trees #14-16 are trees are in fair condition. The trees are located within planters along one of the existing pools. The trees are about 2 ft. from the proposed trenching. Exploratory trenching with hand tools should be done to determine the root quantity and size in the area for the trenching. Alternatively, the trench should be bored at 3 ft. or more below grade beneath the canopies; this would avoid impacting the structural roots. Impacts are expected to be moderate to high. Tree protection fencing should be installed to the furthest extent of the existing planter where the trees are located.

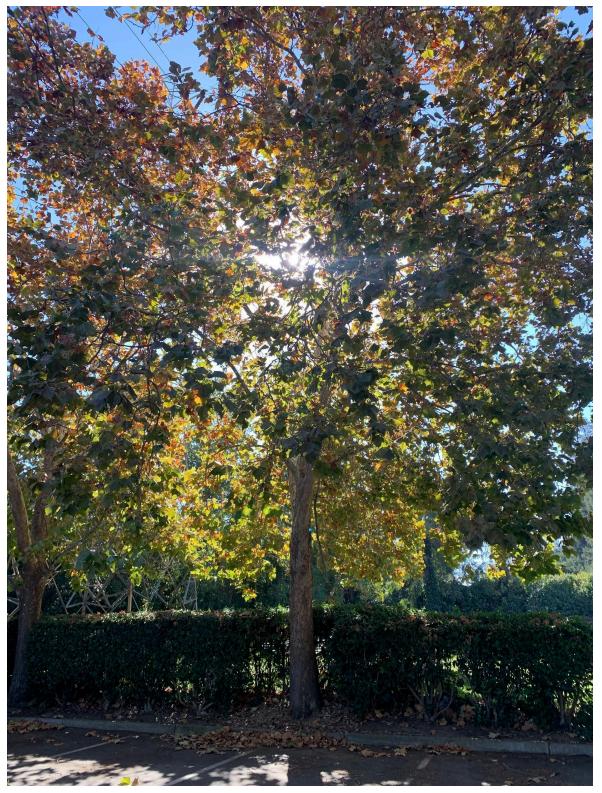
Photo 12. A view of tree #17 in fair condition, the tree was previously recorded due to previous plans.

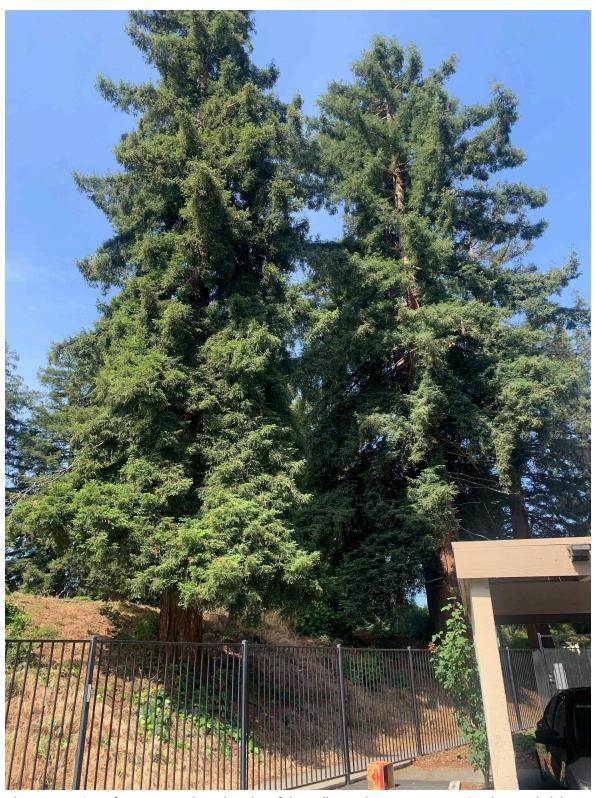
Photo 13. A view of trees 24-25 along the edge of the walkway, the trees were previously recorded due to previous plans.

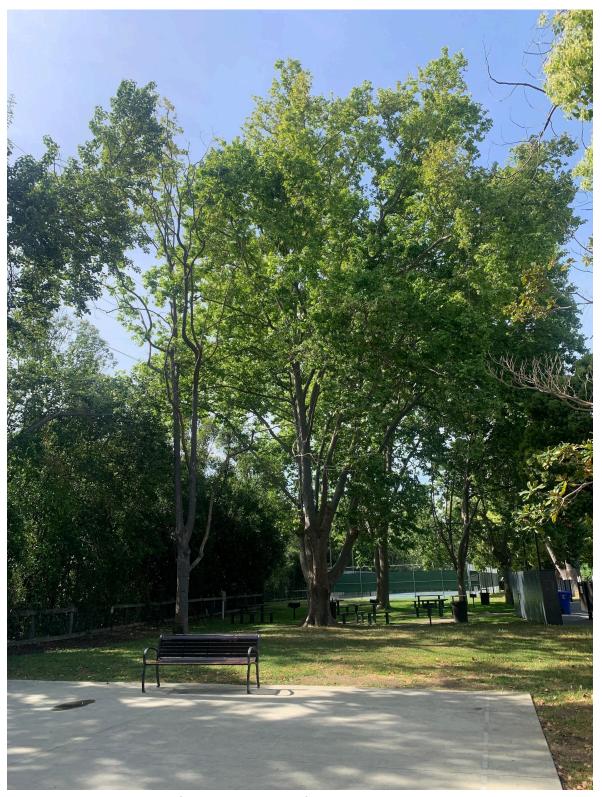
Photo 14. A view of trees 3-5, 7-8. Most of the ADUs are proposed to be located in this area.

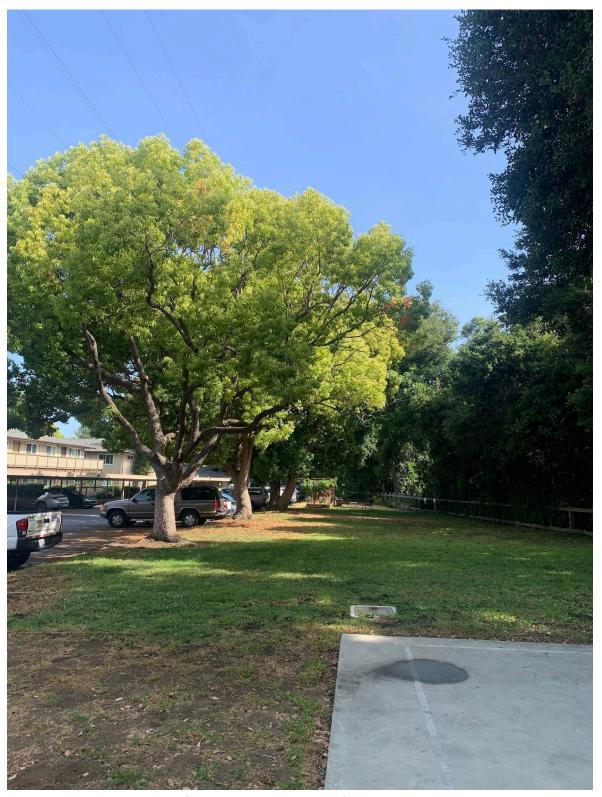
Photo 15. A view of trees #11, 18-19. The rest of the ADUs are proposed to go in this area.

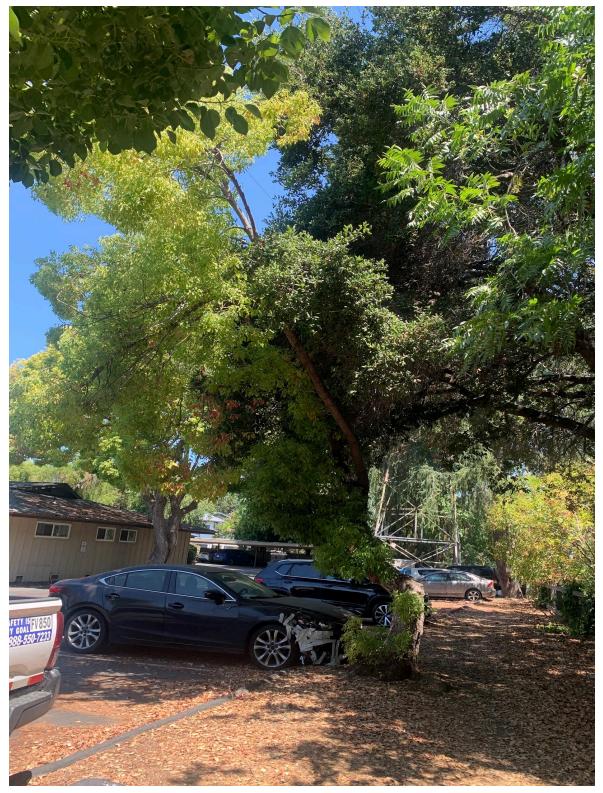
Photo 16. A view of tree #27 with the utility line about 6 ft away from the tree.

• Trees #26-27 are about 6 ft. from the utility paths. Impacts are expected to be moderate. Tree protection fencing should be installed to the furthest extent of the canopy of the tree and can only be moved when work is to occur within the TPZ. Exploratory trenching with hand tools should be done to determine the root quantity and size in the area for the trenching. Alternatively, the trench should be bored at 3 ft. or more below grade beneath the canopies; this would avoid impacting the structural roots. Due to the sensitive nature of working within the CRZ of trees to be retained, any excavation or grading within the TPZ must be performed with hand tools and supervised by a Certified Arborist to monitor and document any tree impacts. Any significant roots (roots 2 inches in diameter or larger) encountered should be cut cleanly and photo documented. If severed roots increase failure risk beyond the property owner's tolerance, the Arborist may recommend tree removal, and a permit would be required for the removal of these trees.
