February 19, 2024  
Project No. 2024-22

Subject: **Structural Evaluation Report for Heritage Tree Removal Permit  
The Avalon Apartments  
1911 California Street, Mountain View, CA**

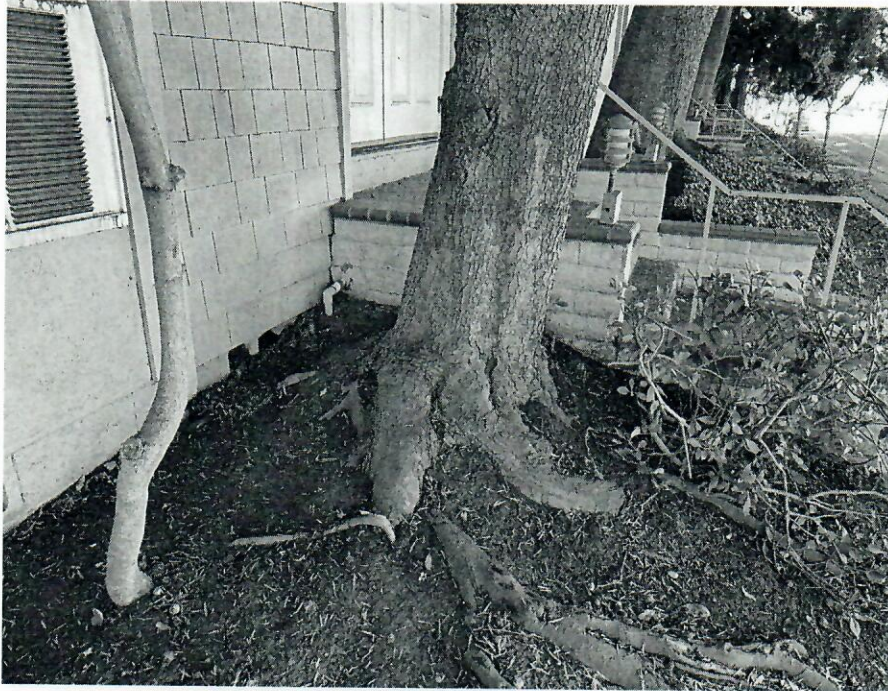
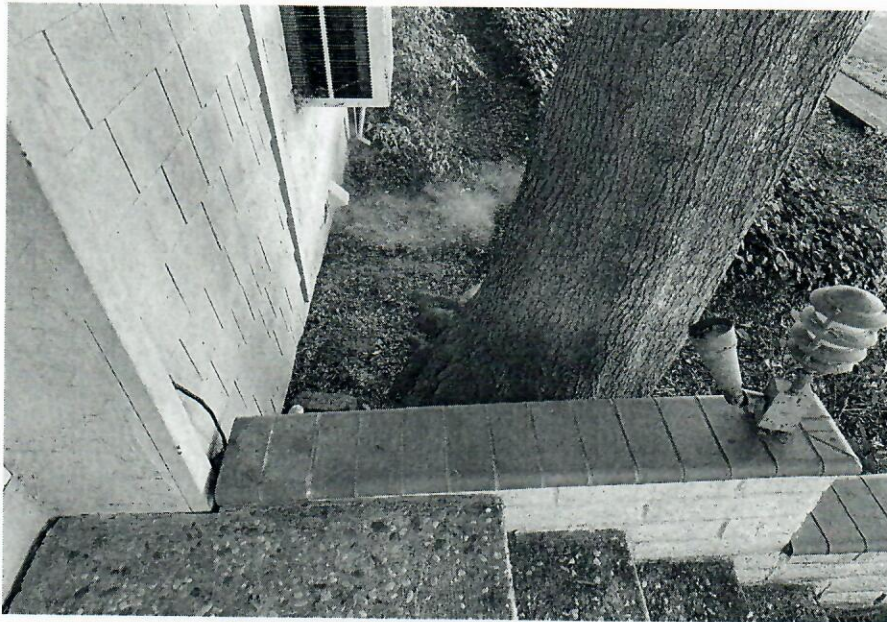
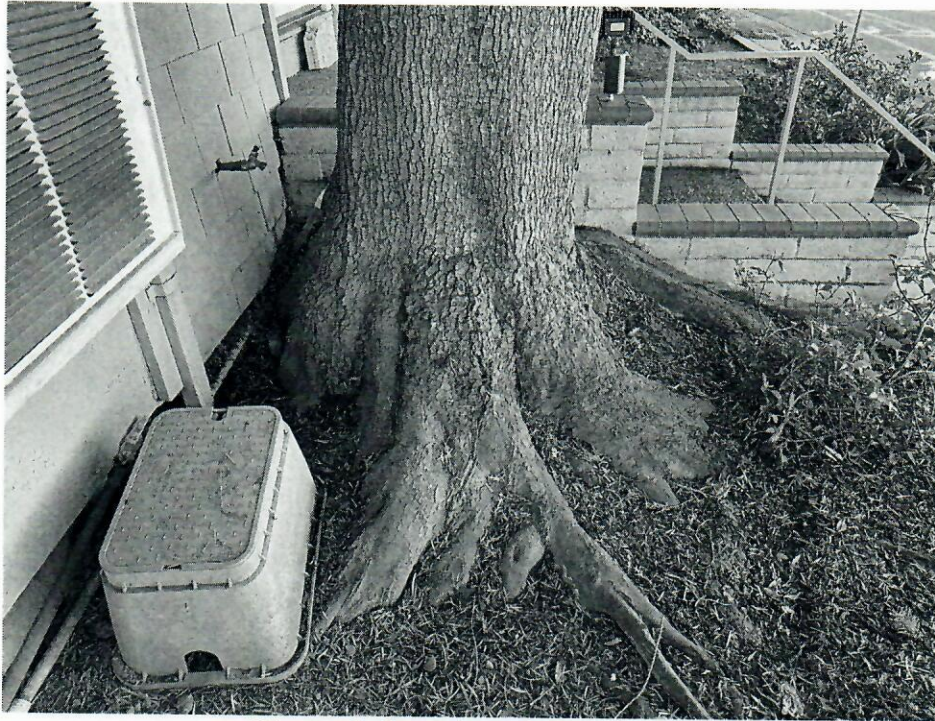
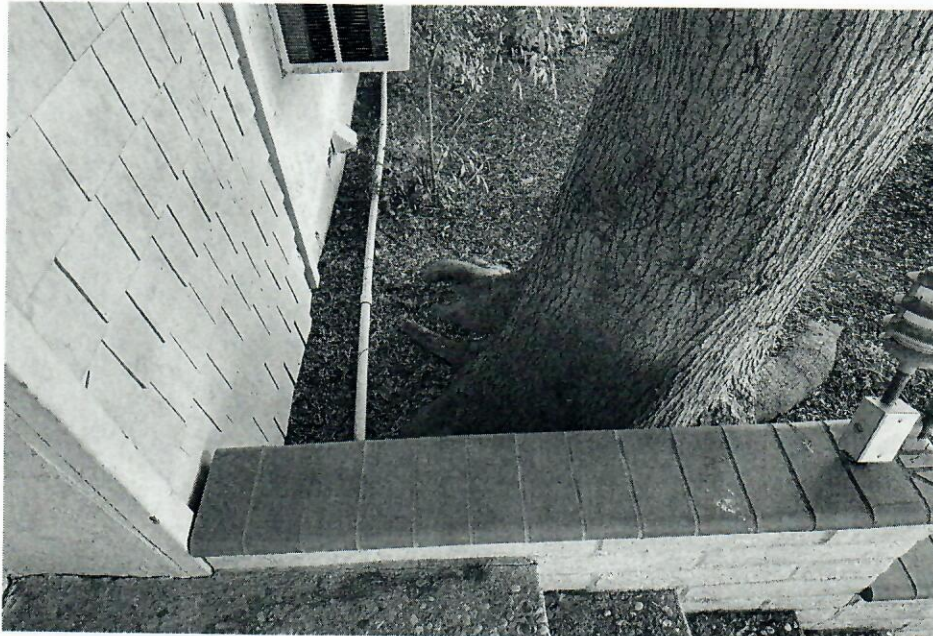
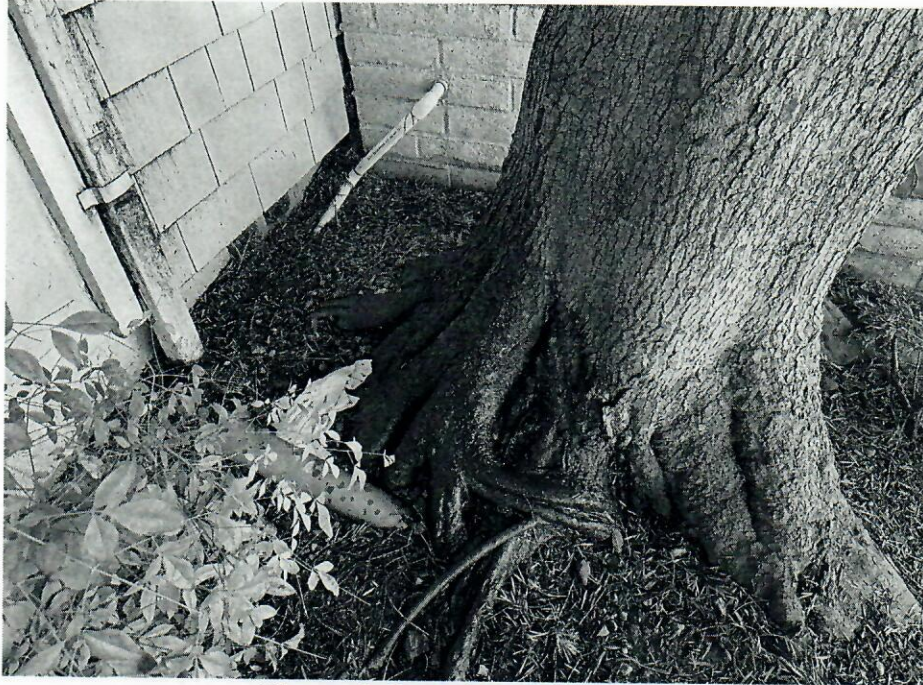
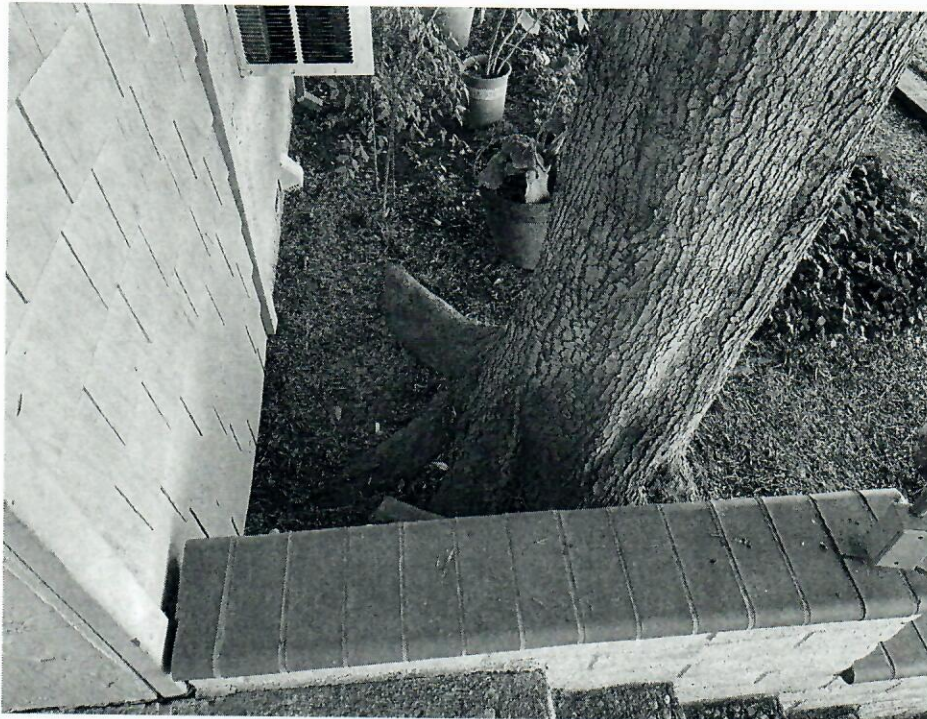
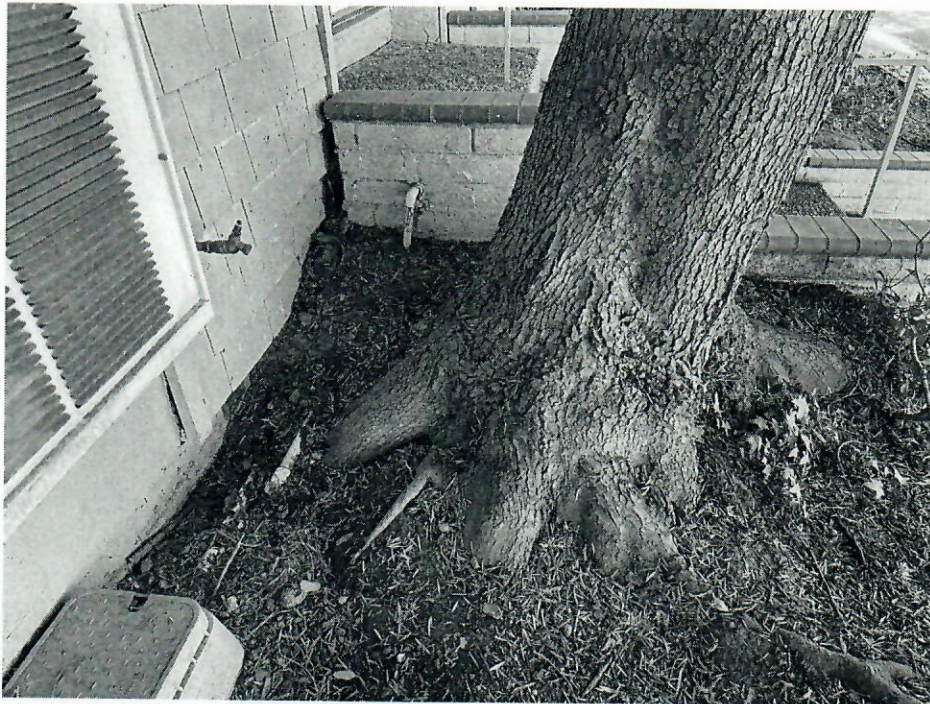
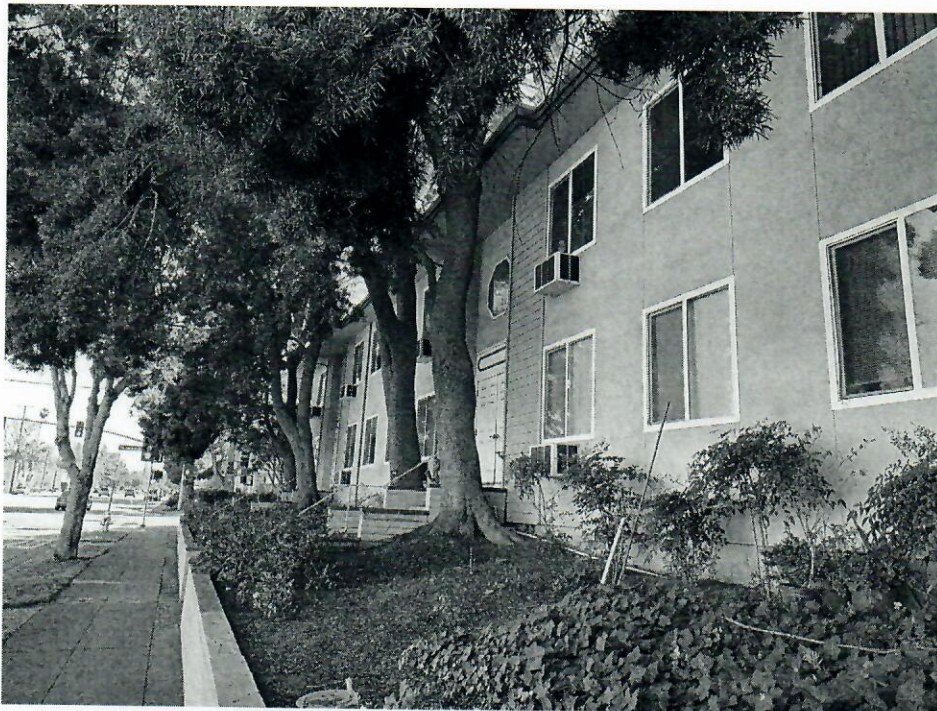
10. The edge of tree's base is approximately less than 12" away from the existing exterior retaining wall foundation and in one or two cases are fully connected with the outside face of the existing foundation. See pictures 1 through 8 attached with this report.

Picture 1: Location of tree No. 1

Picture 2: Location of Tree No. 2

Picture 3: Location of Tree No. 3

Picture 4: Location of Tree No. 4

Picture 5: Location of Tree No. 5

Picture 6: Location of Tree No. 6

Picture 7: Location of Tree No. 7

Picture 8: Location of Tree No. 8

Therefore, it is very clear and obvious that the trees are too close to the exterior foundation of this building and I highly recommend that all eight (8) overgrown trees and their roots as described in this report and as shown on the attached site key plan "KP-1", detail 1/S-1, and photos taken be completely removed and cleared away from the existing foundation in accordance with procedure and requirements of a competent and professional arborist report.

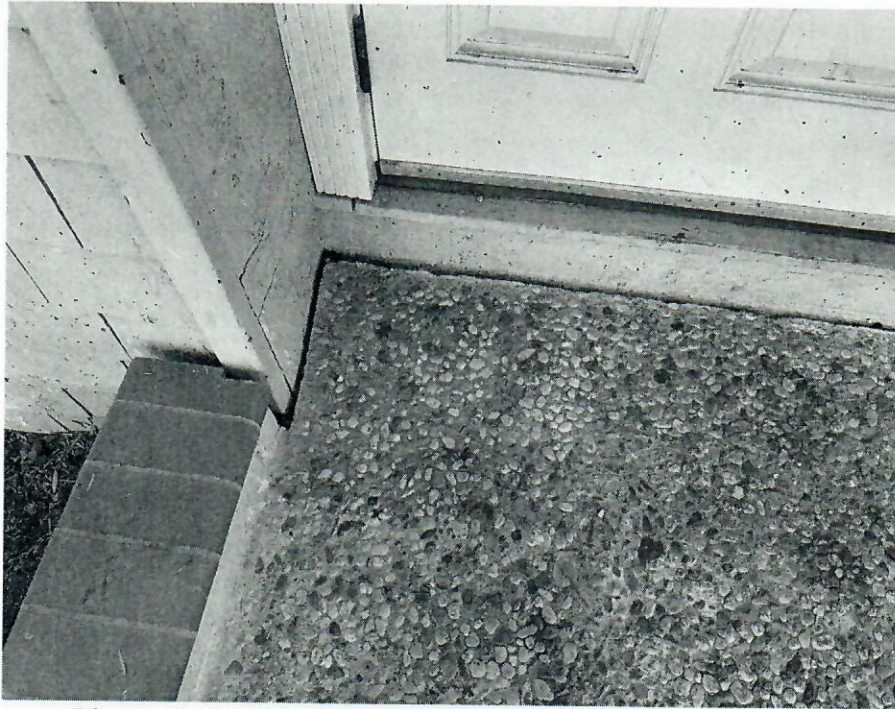
8. There are/is a moderate separation/gap between the building exterior foundation and landing at entry areas. See pictures 9 and 10 attached with this report.

Picture 9: Location of approximately 1" plus gap at landing

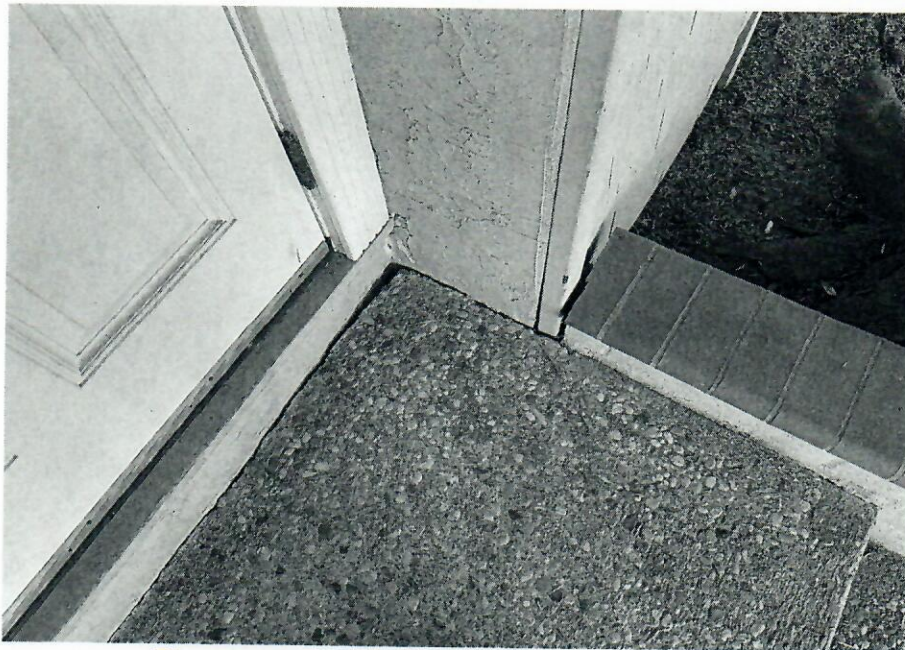
Picture 10: Location of landing tilt at corner

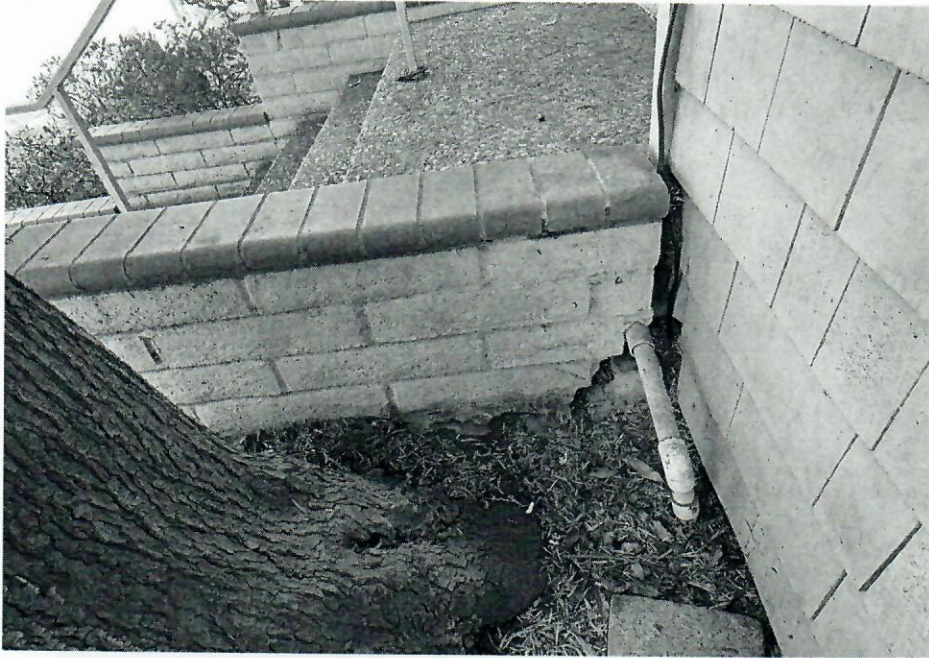
6. The roots of trees appear to have well extended below the exterior grade and into the bottom of foundation. See the attached detail 1/S-1.
7. Few short walls at steps near or next to entry landing areas are broken or separated. See pictures 11 and 12 attached with this report.

- The breakage of short walls at steps leading to landing and unevenness of landing area itself at front entry exterior foundation will be dangerous for people using that area and will cause an unsafe and hazardous condition. This condition is shown on pictures 11 and 12 attached with this report.

Picture 11: Location of short step wall separation from building

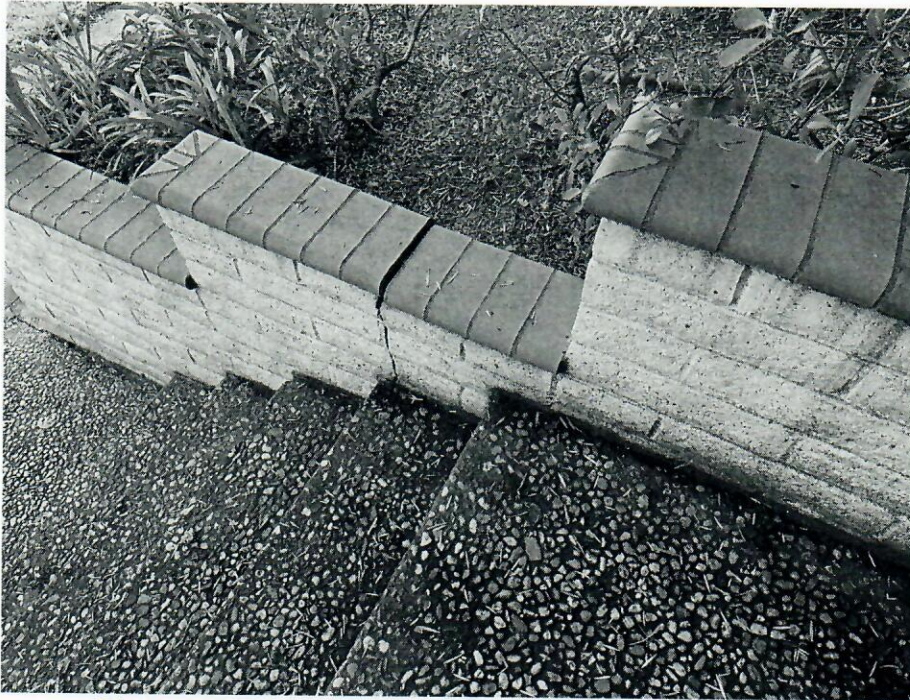
Picture 12: Location of vertical crack at step short wall

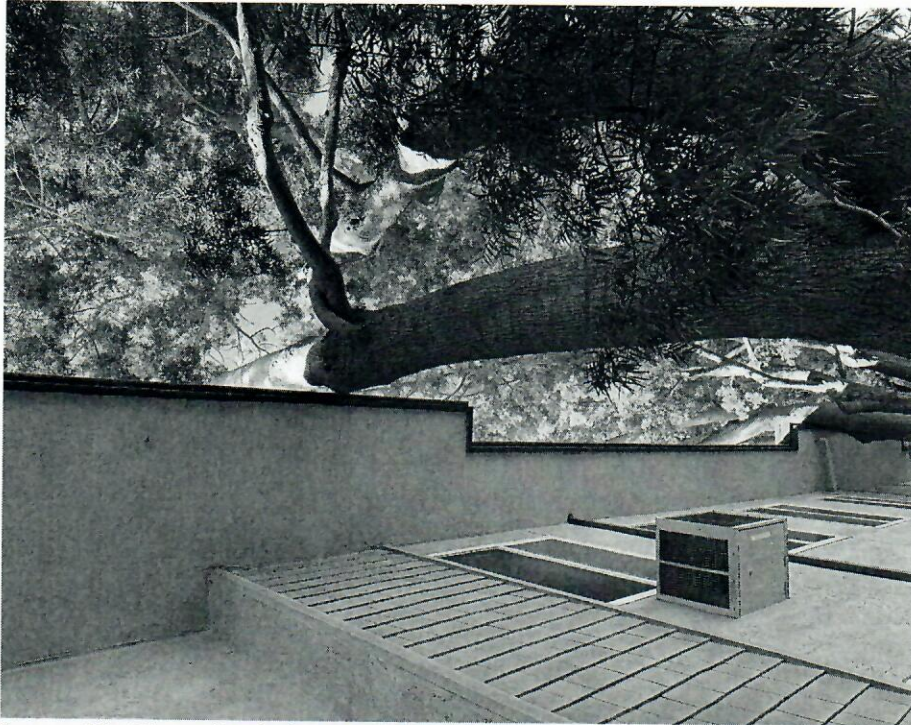
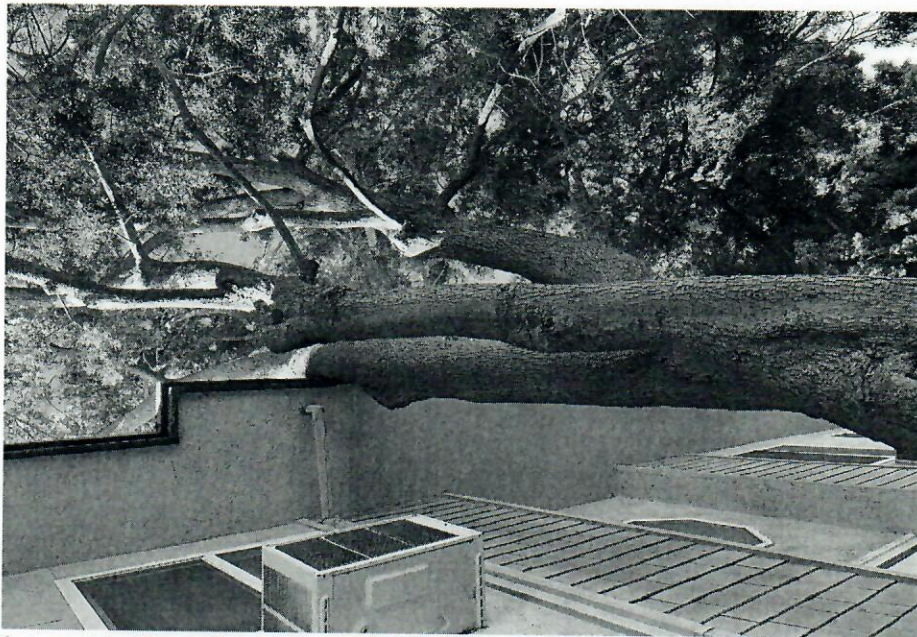
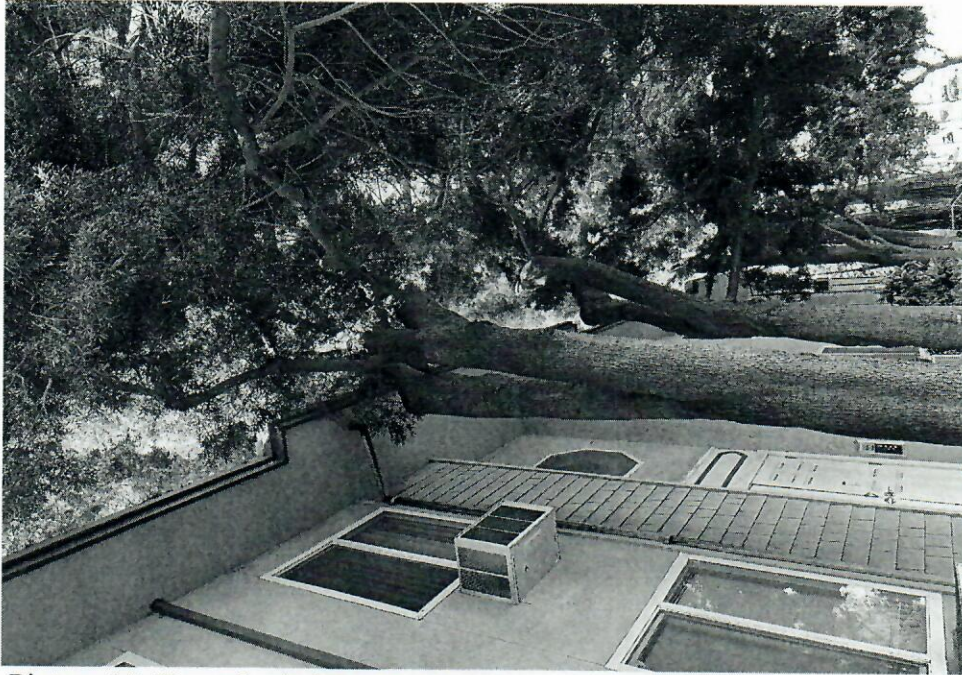
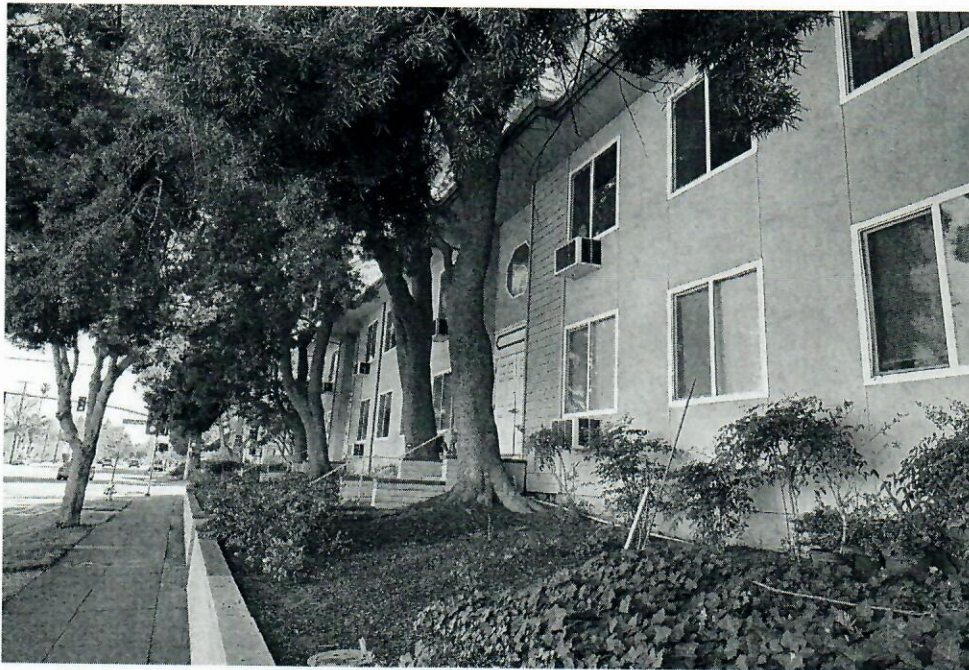
9. Some of the upper branch of trees has either encroached into the eave of the existing roof framing rafters or are too close to the fascia board. See pictures 13, 14, 15, and 16 attached with this report.

- The upper branch of some of the trees that are in contact with the existing roof framing rafters appears to have already caused some damages to existing roof framing system. Having the branch of the tree in contact or being too close to the roof framing system could be an easy pathway for mice, rats or other pets to have access to the building and eventually could cause more structural damages and create a hazardous living environment for tenants. See pictures 13, 14, 15, and 16 attached with this report.

Picture 13: Top of existing tree No. 2 in contact with roof framing system

Picture 14: Top of existing tree No. 3 in contact with roof framing system

Picture 15: Top of existing tree No. 5 in contact with roof framing system

Picture 16: Elevation of tree No. 4 at top with roof framing system

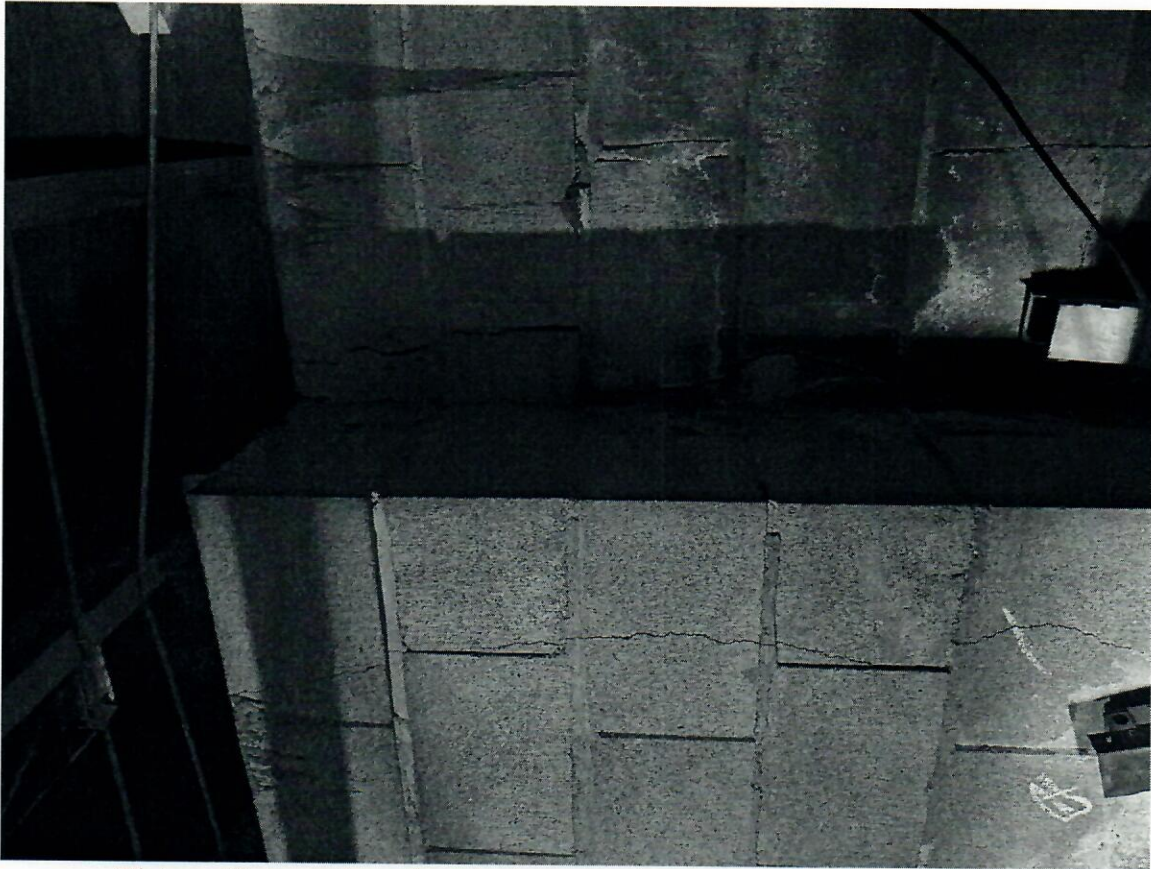
11. Sign of minor vertical cracks along the inside face of the existing block retaining wall foundation in the vicinity of some of the overgrown trees appears to have either been developed or are in the process of developing.

- The base and roots of trees are too close to the existing block retaining wall at exterior foundation and are subsequently causing additional surcharge beyond the normal hydrostatic pressure which the wall initially was designed for. Unfortunately in the absence of having any existing as-built construction documents including structural calculations and details that can justify the size and spacing of existing wall reinforcing be able to resist this additional surcharge load we have no choice but to conclude that this additional surcharge will cause overstressing of wall vertical and horizontal reinforcing which can potentially result into development of new cracks and further widening of the current existing small cracks at the inner face of the as-built block retaining walls which could eventually cause more structural damages to existing foundation. See picture 17 attached with this report.

Picture 17: Location of vertical crack at inner face of existing block retaining wall foundation

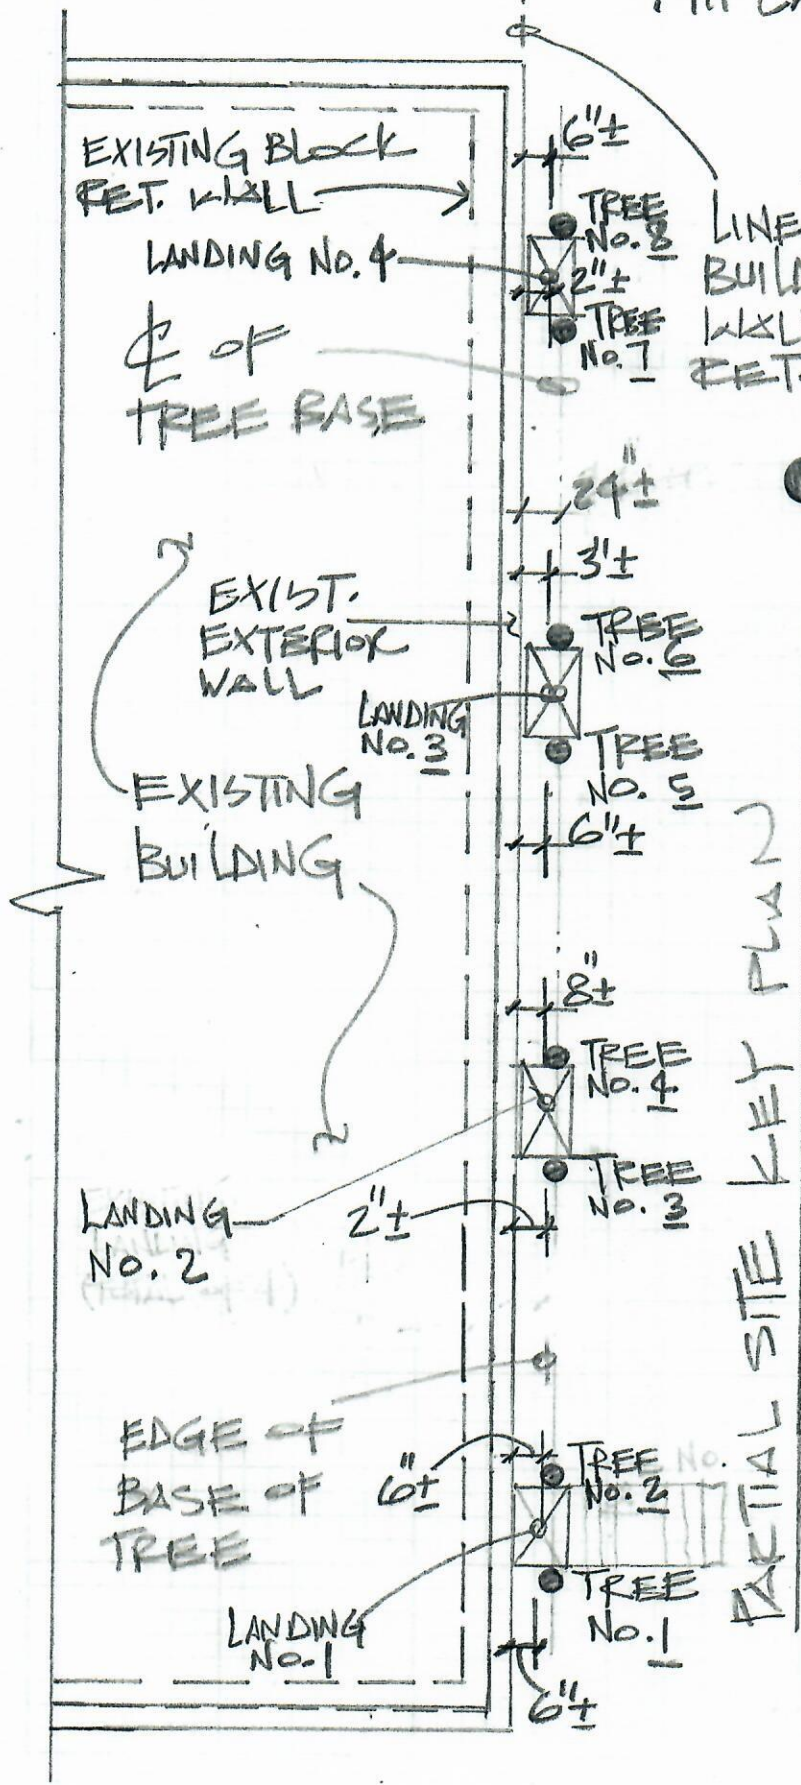
ACTUAL SITE KEY PLAN  
 N.T.S.

● EXISTING APPROX. 24" DIAMETER AT BASE TREE, TOTAL OF EIGHT (8) TO REMOVE

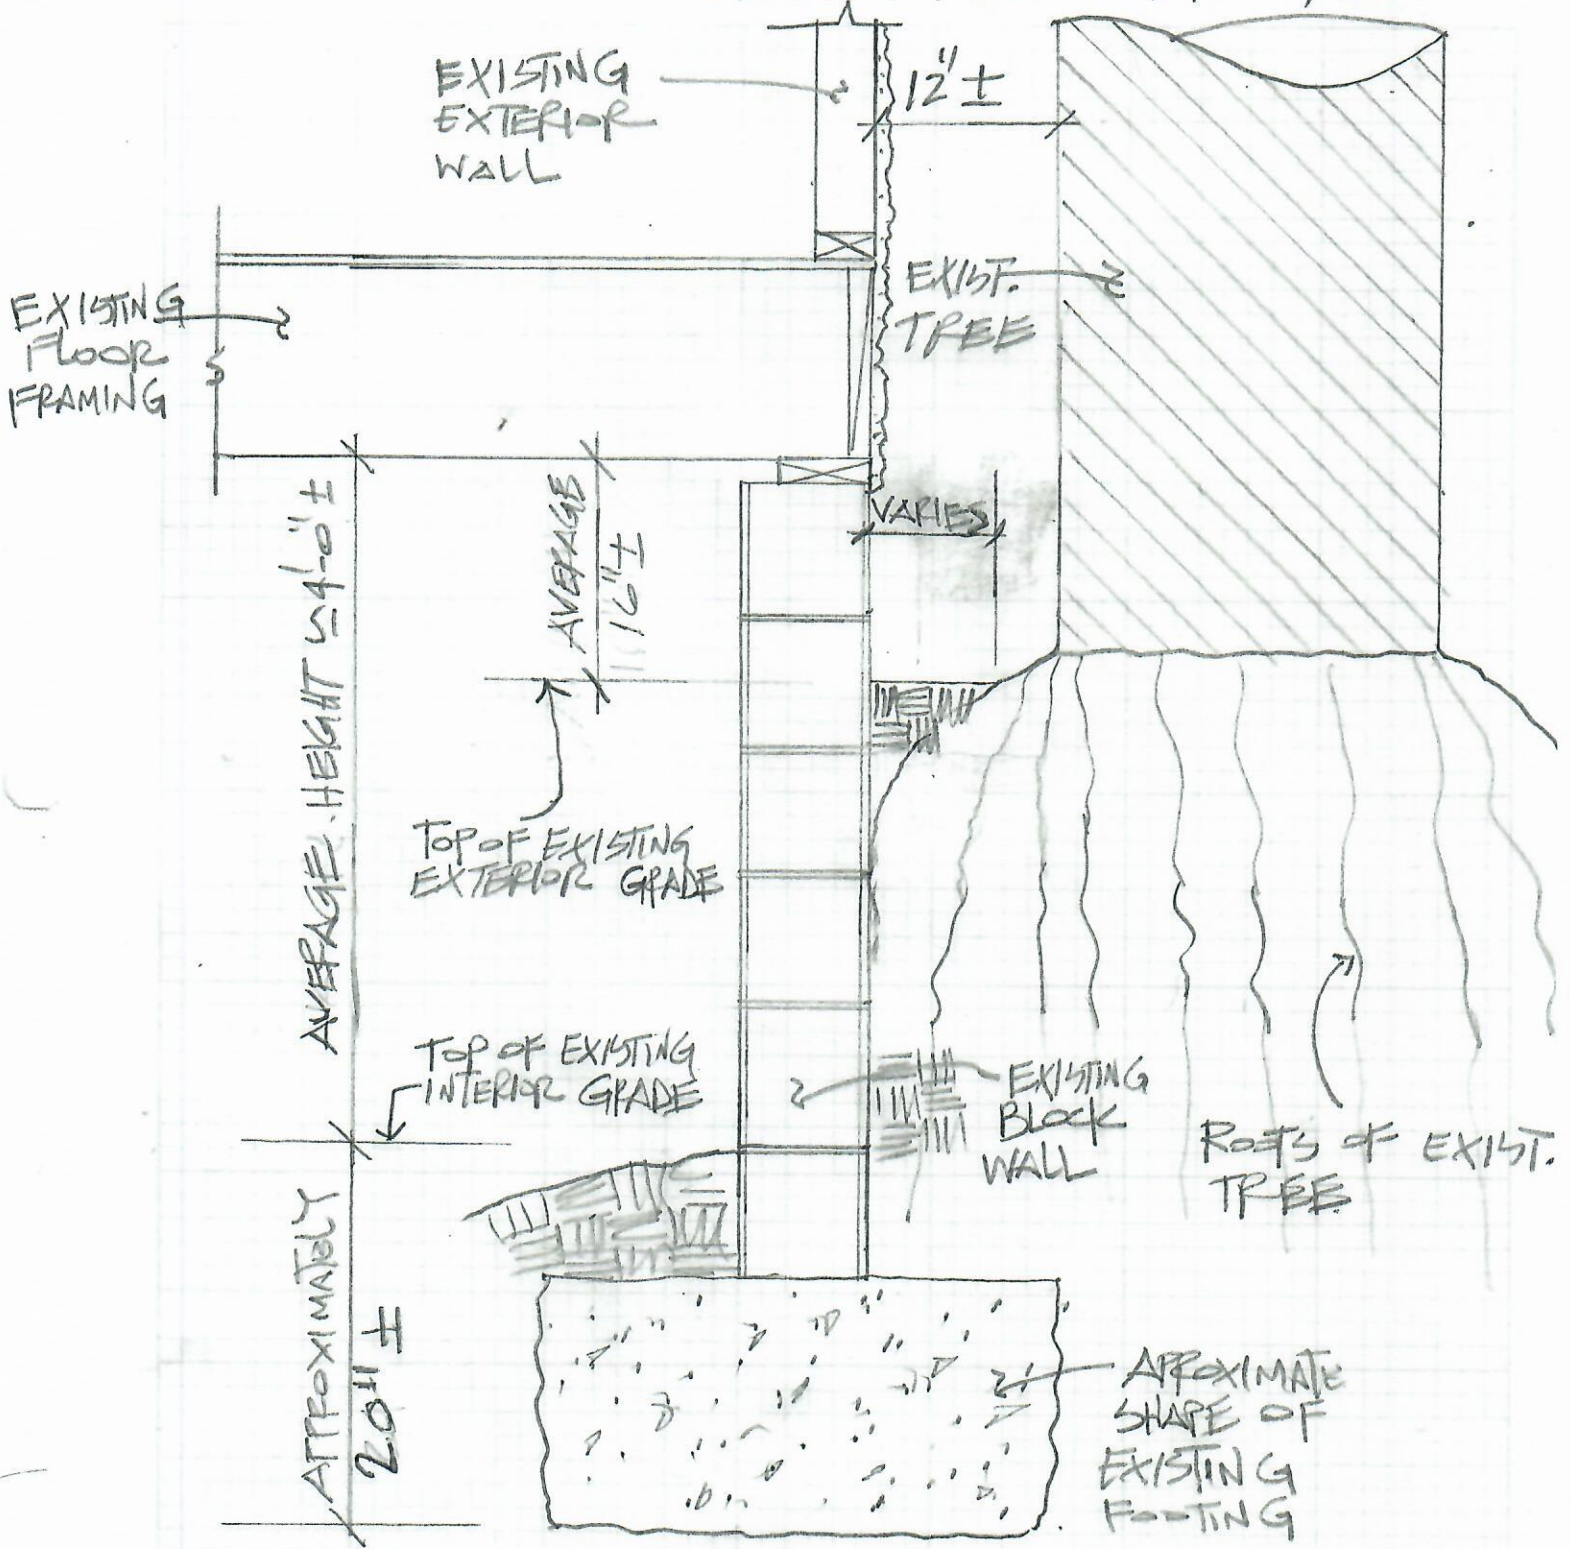
① SECTION AT (E) TREE NEXT TO EXT. FOUNDATION  
 1" = 1'-0" ±

1. The approximate average height of grade retained behind the existing concrete block retaining wall is 5' plus or minus to bottom of wall footing. Please see the attached detail 1/S-1.
2. All trees are numbered from 1 to 8 and identified on the attached "partial site key plan".
3. There is a total of four (4) landing at front entry door. They are numbered and identified on "partial site key plan"
4. The distance between the edge of each tree's root to the outside face of existing exterior foundation block retaining wall are as follow:
  - Approximately 6" at tree No. 1.
  - Approximately 6" at tree No. 2.
  - Approximately 2" at tree No. 3.
  - Approximately 8" at tree No. 4.
  - Approximately 6" at tree No. 5.
  - Approximately 3" at tree No. 6.
  - Approximately 2" at tree No. 7.
  - Approximately 6" at tree No. 8.
