То:	Elaleh Kerachian 500 Castro St, Mountain View California, 94041, United States
REFERENCE:	El Camino Women's Hospital – a) Removal of Mature Trees West of the Building and b) Replacement trees and spacing
SITE ADDRESS:	2495 Hospital Dr. Mountain View, CA 94040
DATE:	October 12, 2023, Updated December 18, 2023
PREPARED BY:	Matthew Sesody, ISA Certified Arborist WE-12524A

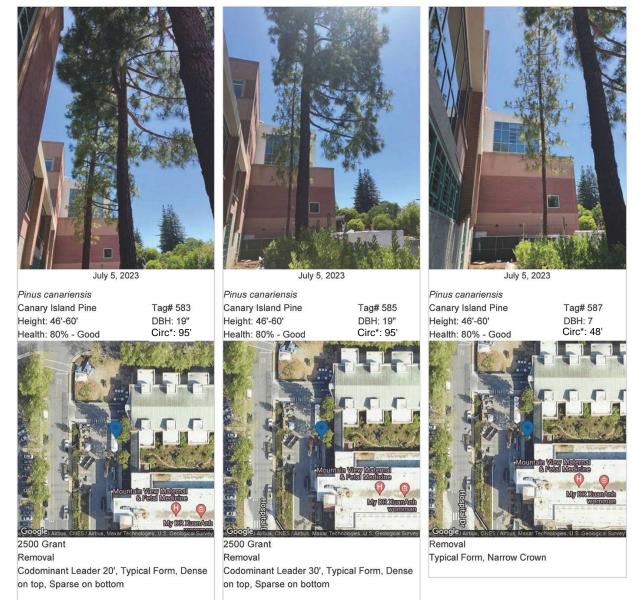
#### ASSESSMENT

Upon meeting with everyone onsite and seeing where the planned wall was going to be built, it is my professional opinion that trees #583A, #585A, and #587A will need to be removed. Excavation to build the wall will be well within the canopy of the trees and within 2-3' of the trunk. With the trees losing up to 40% of their anchoring roots to the building of this wall and the location of these trees at a hospital, the risk of failure is too great to keep these trees. These trees are fully mature and well established that are not candidates for transplanting due to size, root mass, location, and cost.
