**A Preliminary Tree Protection Plan  
1958 Latham Street  
Mountain View, California**

1958 Latham Street  
Mountain View, CA

**A Comparative Impact Study  
Between Two Design Site Plans  
1958 Latham Street  
Mountain View, California**

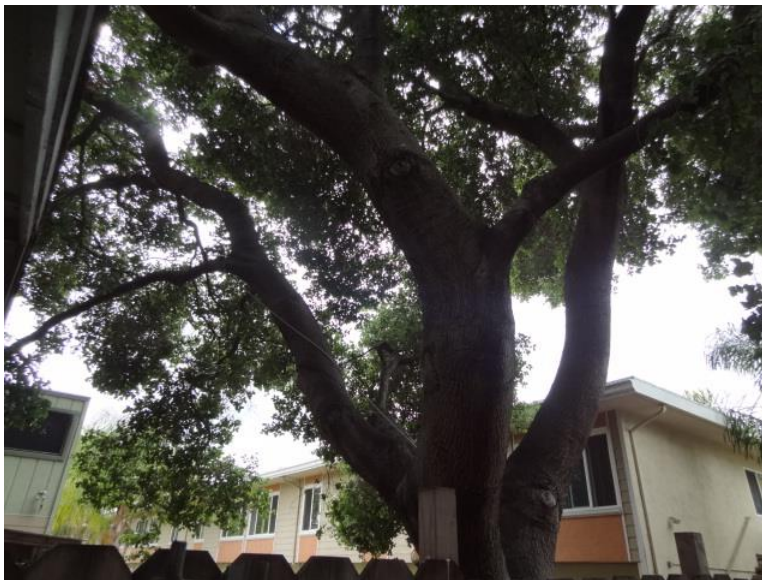
In this photo, Leader A is in the center.  
Leader B is on the right.  
Leader C is on the Left.  
Leader D is hidden by A.

The roof of the existing shed is seen in the top left corner of this photo.

Leader A from this tree extends over the shed, which is 12 feet from the trunk.

The relationship between this shed and the scaffolding of the Tree # 2 provided a good estimated of the quantity of canopy loss expected to occur to this tree by each of the proposed Site Plans.

Obviously Tree # 2 would experience some canopy losses by each of these designs. The significant difference is that the Leader A would be severed at 10-12 feet from the trunk of Tree # 2 should Option 2 be construction. This would result in a stub cut or “topping” cut on Leader A leaving a stub approximately 15-17 inches in diameter. Almost all of the live canopy on Leader A would be removed by making this cut. Because Leader A has a relatively high percentage of the total canopy, I estimate that the removal of Leader A would be a reduction of approximately 1/3 of the total canopy.

In addition, a stub of 15-17 inches in diameter in all likelihood would develop into a cavity. Branch wounds approximately 8-10 inches in diameter in most cases develop into a cavity over time. Thus, it is reasonably assured that a stub of 15-17 inches by the removal of Leader A, as described, will develop into a cavity.

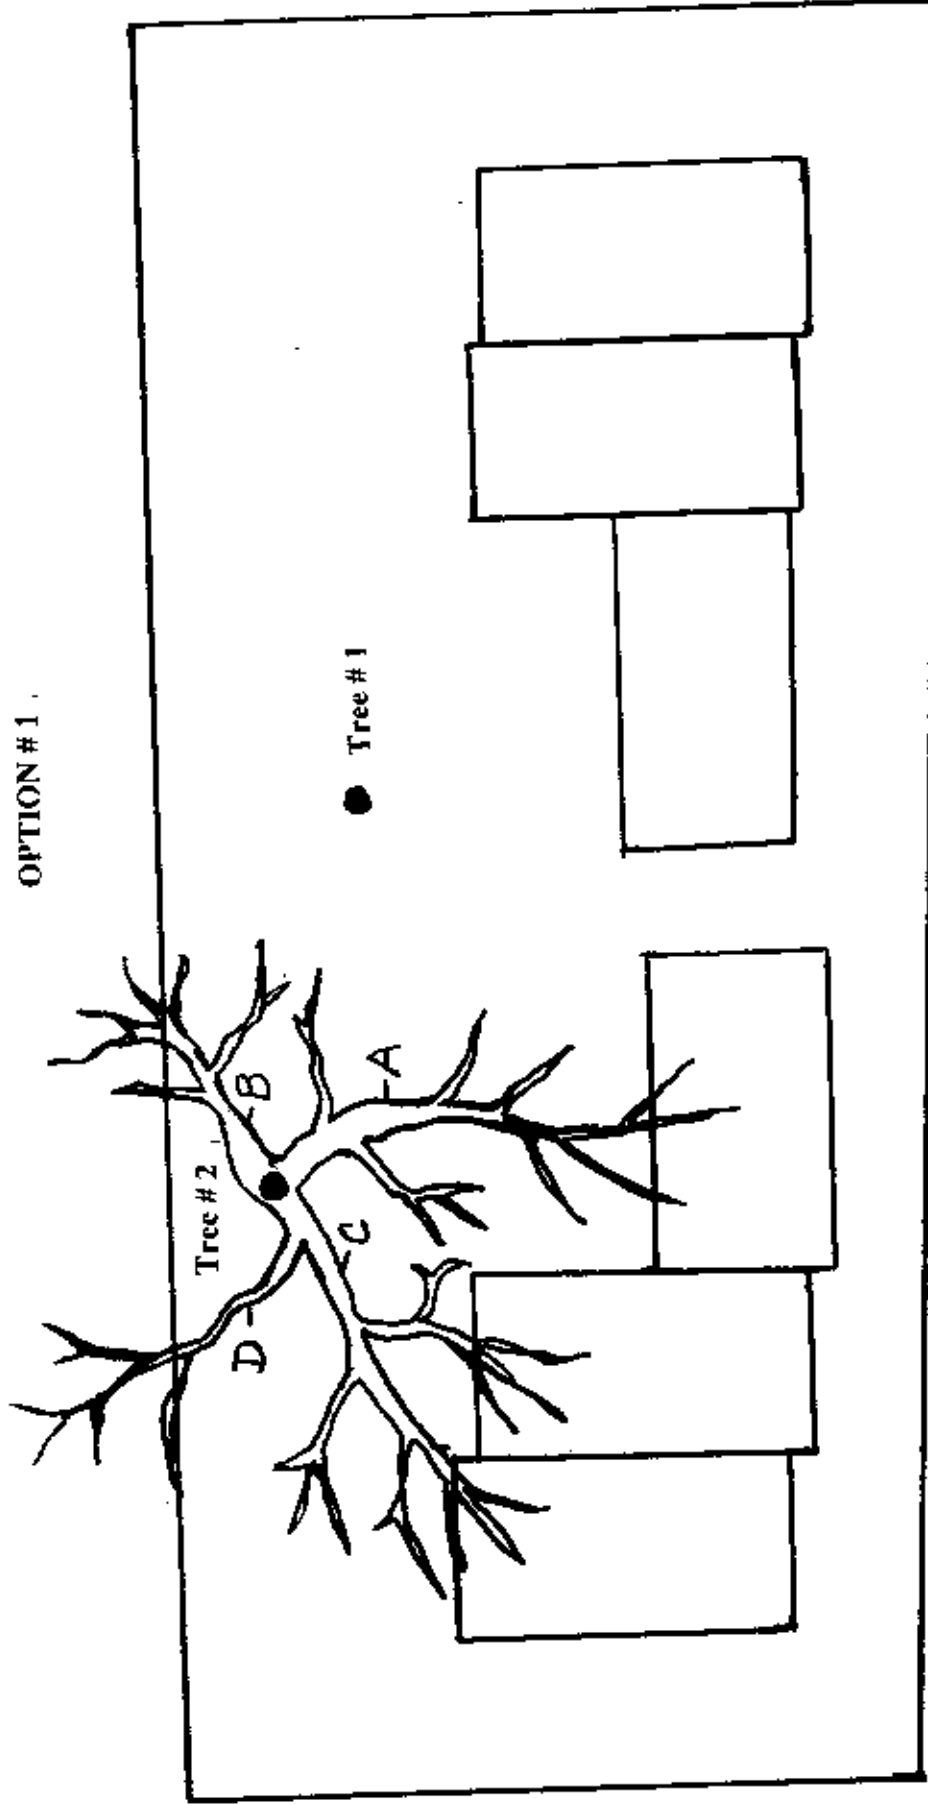
Site Plan Option # 1

By comparison, the canopy loss to Tree # 2 by the construction of Option 1 would be greatly reduced. Per this Option, I estimate that the largest wounds would be 2-3 inches in diameter. Overall I estimate that the total canopy loss to Tree # 2 by the construction of Option 1 would be approximately 15%, which is well within industry standard.

The canopy loss to Tree # 2 by the proposed Option # 1 would be approximately 15% by my assessment, which would be relatively minor.

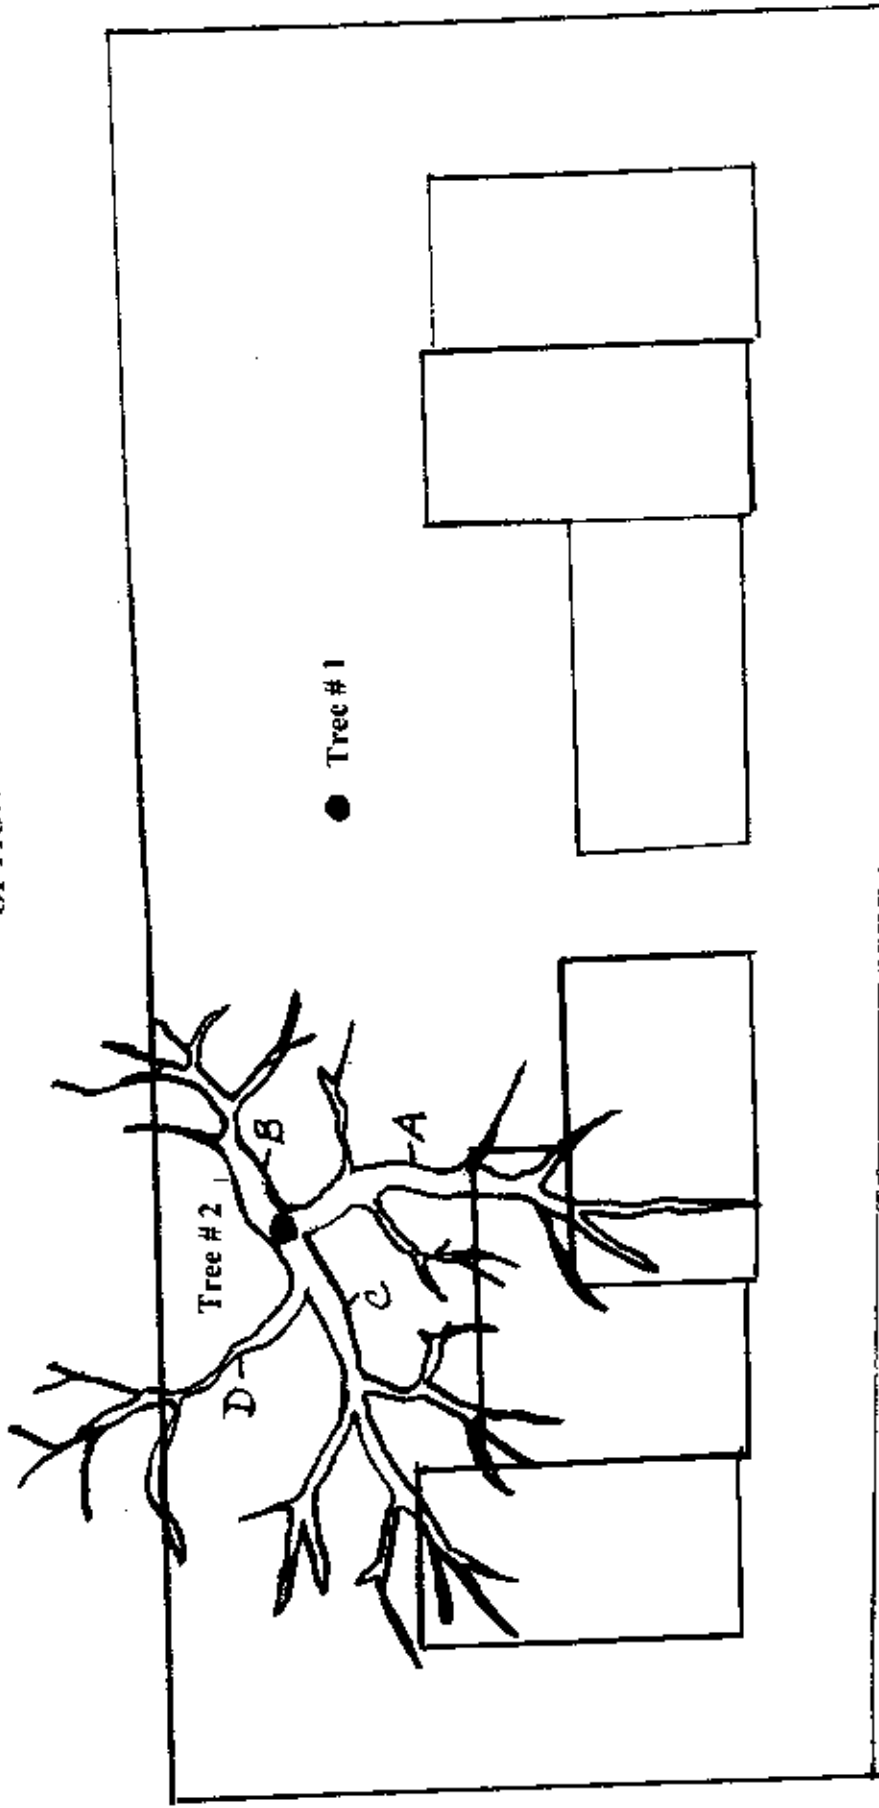
Site Plan Option # 2

The canopy loss to Tree # 2 by the proposed Option # 2 would be approximately 30% by my estimate, but the mere percentage loss does not adequately express the loss. The majority of this loss would be by the removal of one of the primary leaders, which would in time develop into a major trunk cavity. Not only would this tree be badly disfigured, but it could be the beginning of the end for this tree, recognizing that these types of events take a long time to reach full development.
