**Request Name:** Remove 3 large trees, all likely Heritage trees

# Heritage Tree Removal Permit Application

Arborist Report

Report by: Bay Area Tree Specialists, Ken Ohm , ISA Certified Arborist FL-5626

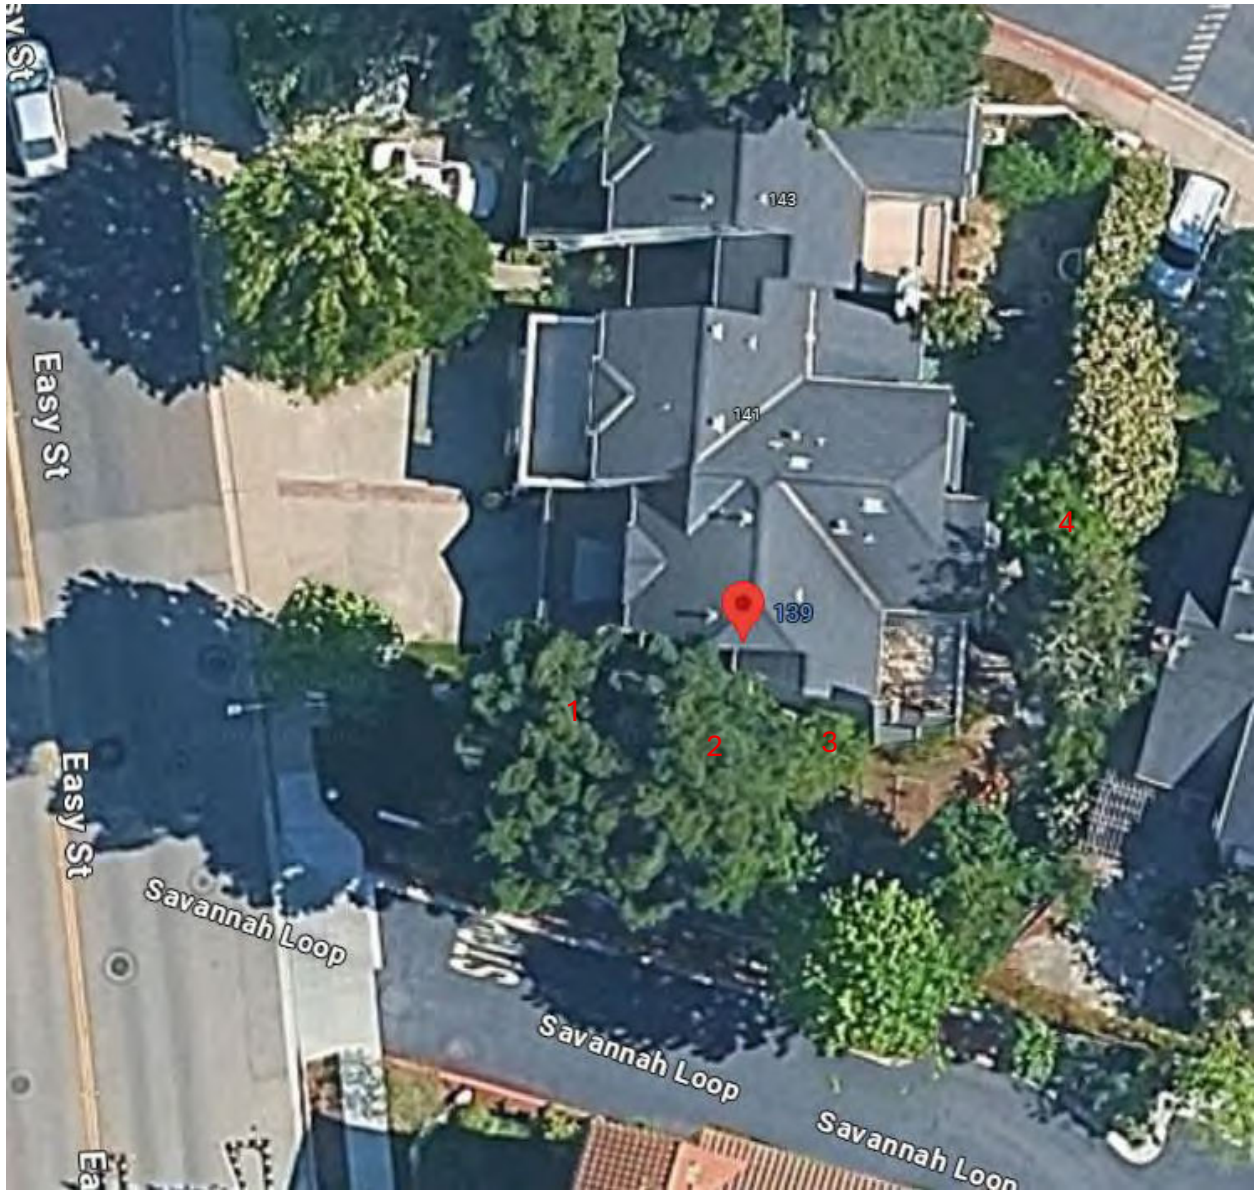
1,2 Coast Redwood **Heritage Trees**

3 Peach, not a Heritage Tree

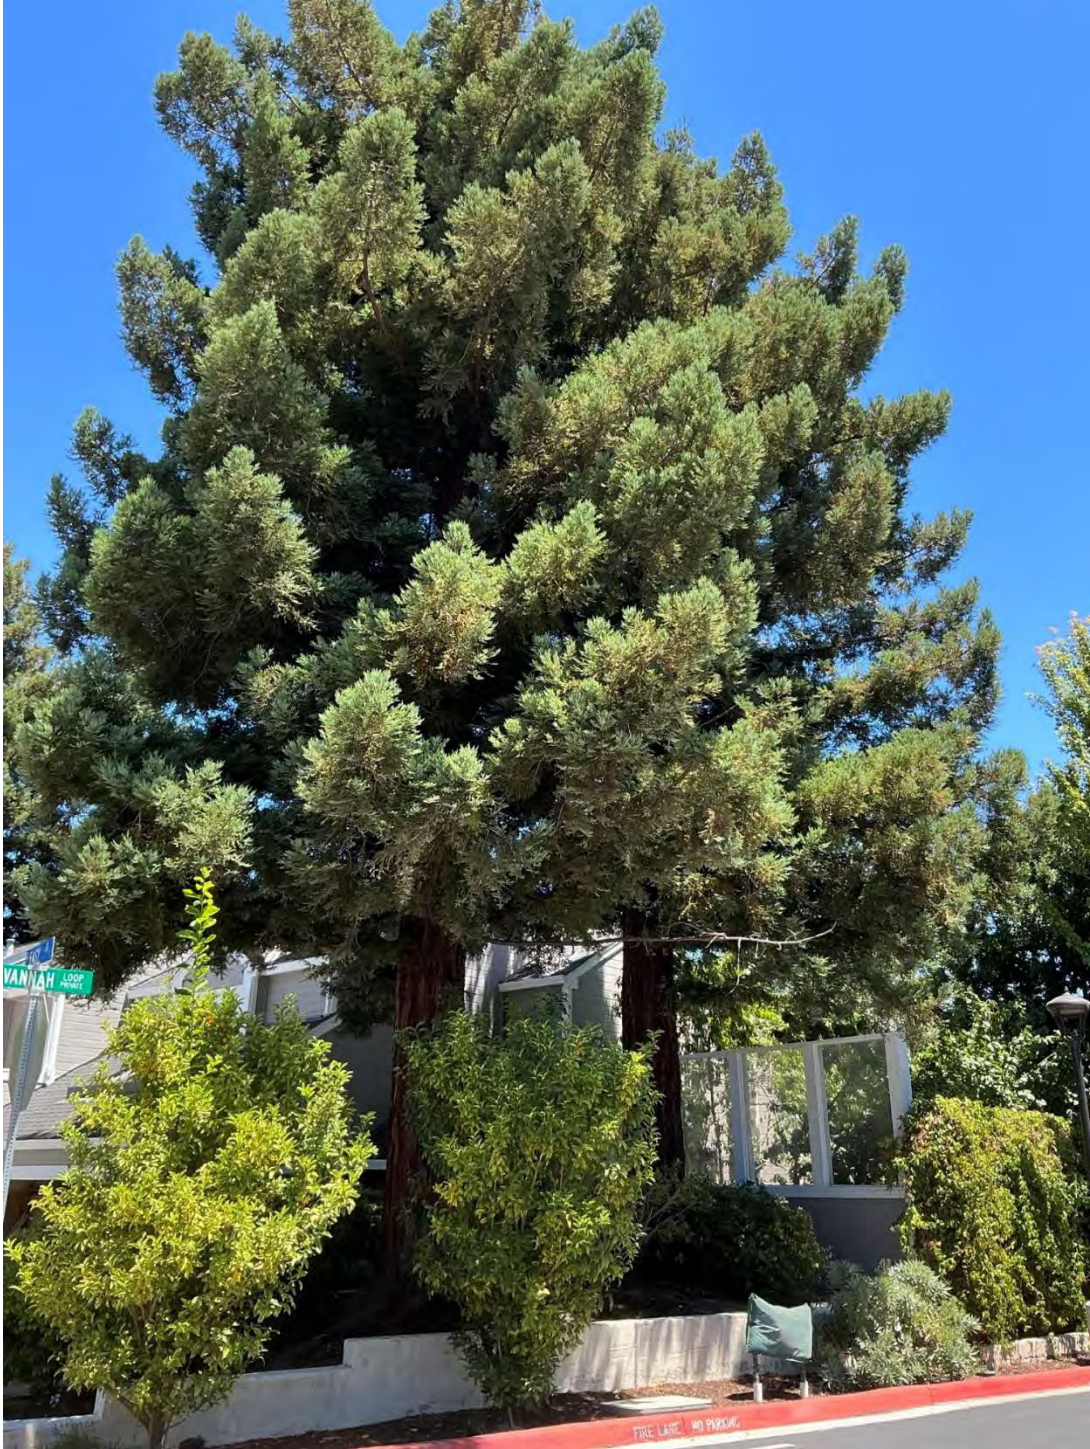
Tree profile and spread

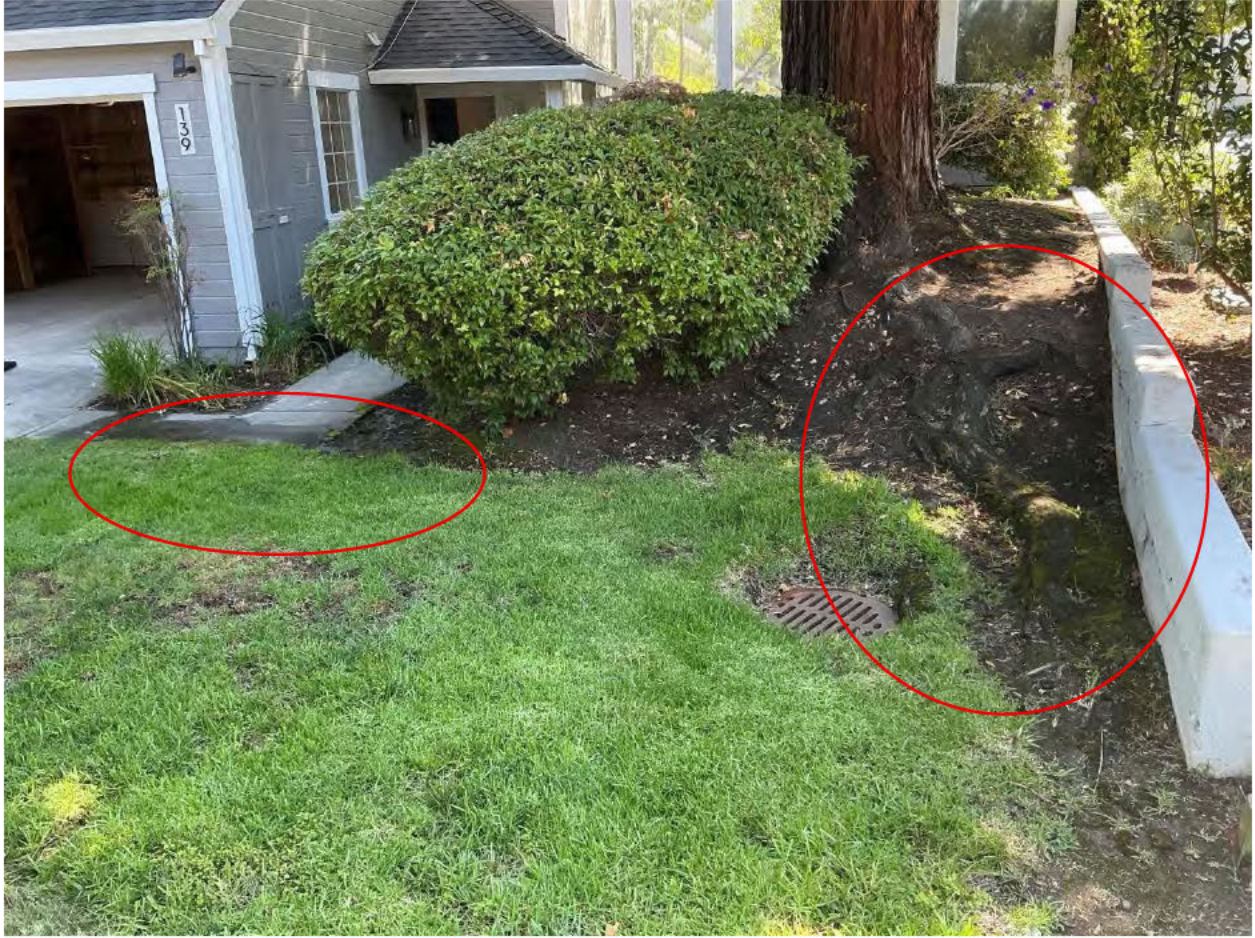
**Root Condition:** Houses, Driveway, Road, raised Planter bed with Retaining Wall, and Drainage system present in the Critical Root Zone. There is Saturated soil/lawn around the Drain, Driveway, House walkway with puddles present in areas. There is Major Surface rooting from the Redwoods into this saturated area. Crack present from Roots in Walkway, Driveway, and inside the Living Room/Kitchen. Multiple 4" d Roots present at the front door. The Redwoods have very large surface roots present in the Planter Bed and have Rooted under the Raised Planter Bed wall and into the House. The Multiple Roots found in the Living Room after trenching. A 2" root is found in the Kitchen after Trenching. These Roots are cut clean to ISA Standards. The Perimeter has been trenched. The Trench is backfilled after the Root Pruning. Note the Roots of both Trees are overlapping and competing. See Pictures for details on all of the above.

Large Surface rooting, saturated lawn, puddles on walkway

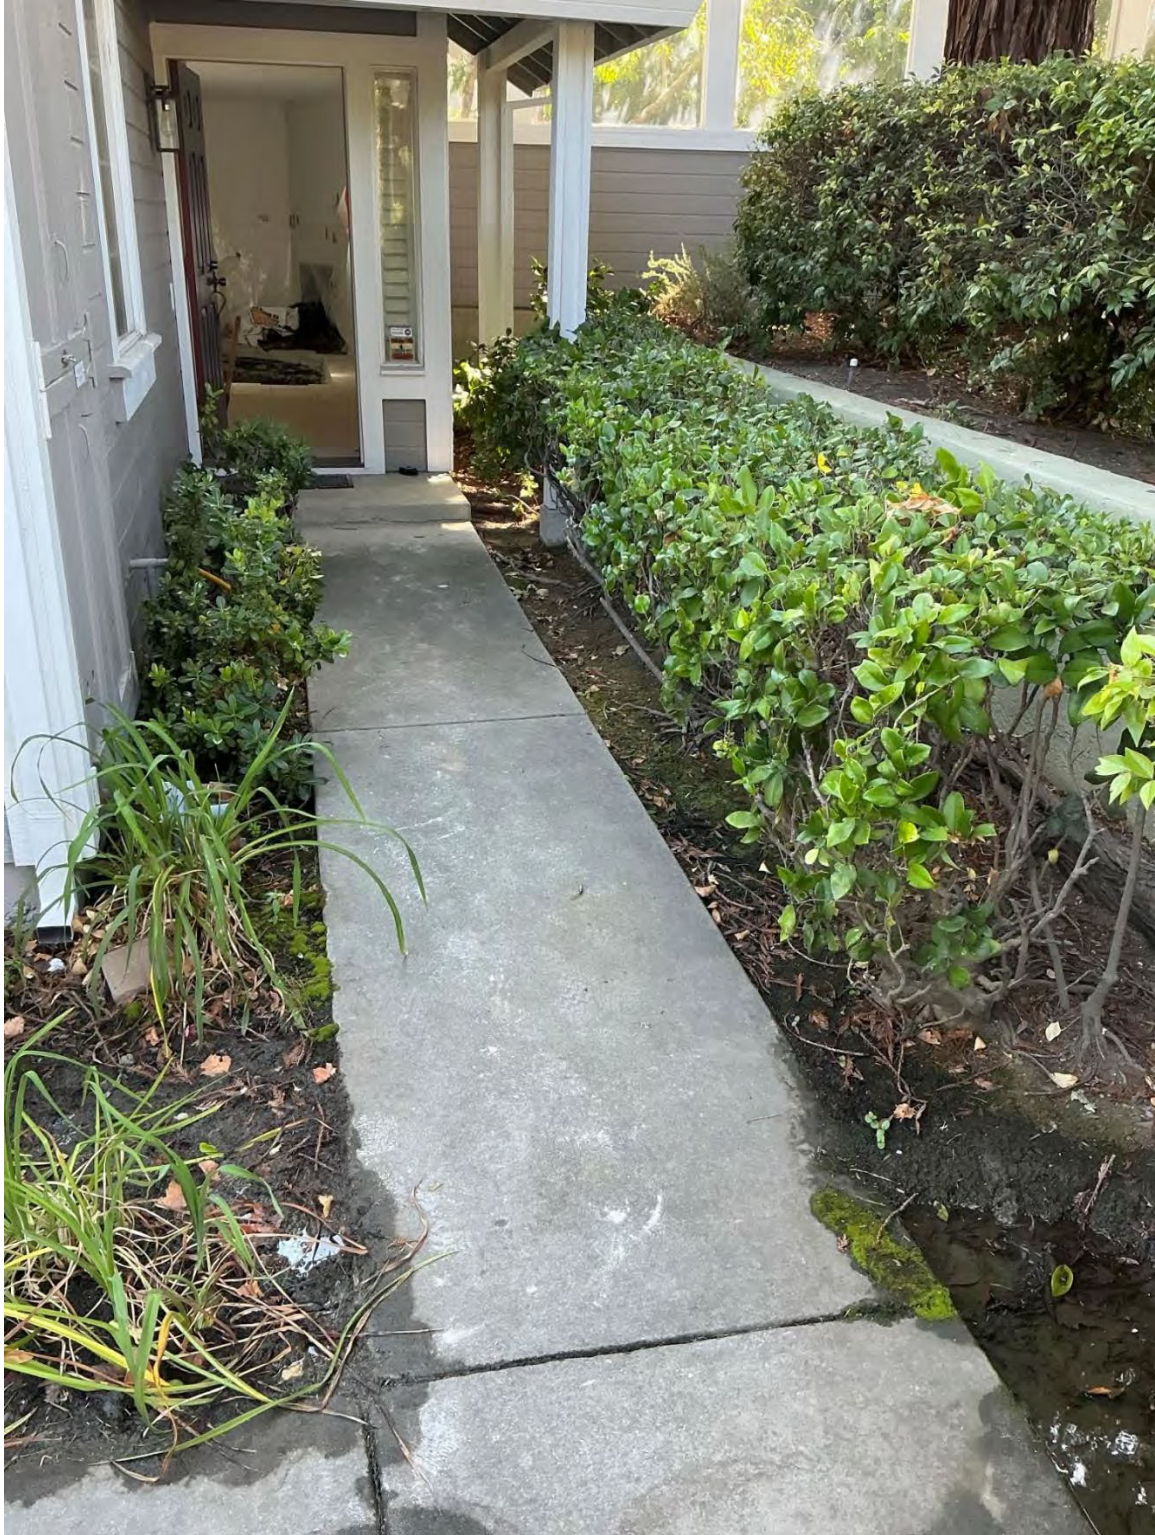
The Redwoods have outgrown the design of the Planter Bed/Retaining Wall. The Saturated soil with standing water has promoted Large Rooting into the Property and House. The Rooting Problems are documented. This is a longstanding problem that is difficult to correct. The Roots have been allowed to grow around and under the house in these wet conditions for too long. The Large Surface Rooting, Standing Water, and Drainage issues should have been addressed earlier. **The Trenching and Root pruning inside the house is not a 100% guarantee that 100% of the Interior Roots were Found or Pruned. The Trenching has Depth and Width limitations due to the Structural Walls, Design, and Equipment Access. Roots can have Rooted outside of the Trenching Area due to the Saturation of the soil and the long time they have been allowed to grow this way.** The Construction Contractor should be contacted for all Cost Estimates/Structural Concerns with current and future Root Problems. **The Arborist's job involves only the Assessment of Trees and Roots.** The Construction Contractor or HOA is involved for all Property/Structural Assessments/Concerns with the effects of current and future roots. Please note there are other Redwoods in the area and they can root far also.

Retaining wall shown for planter and water on walkway

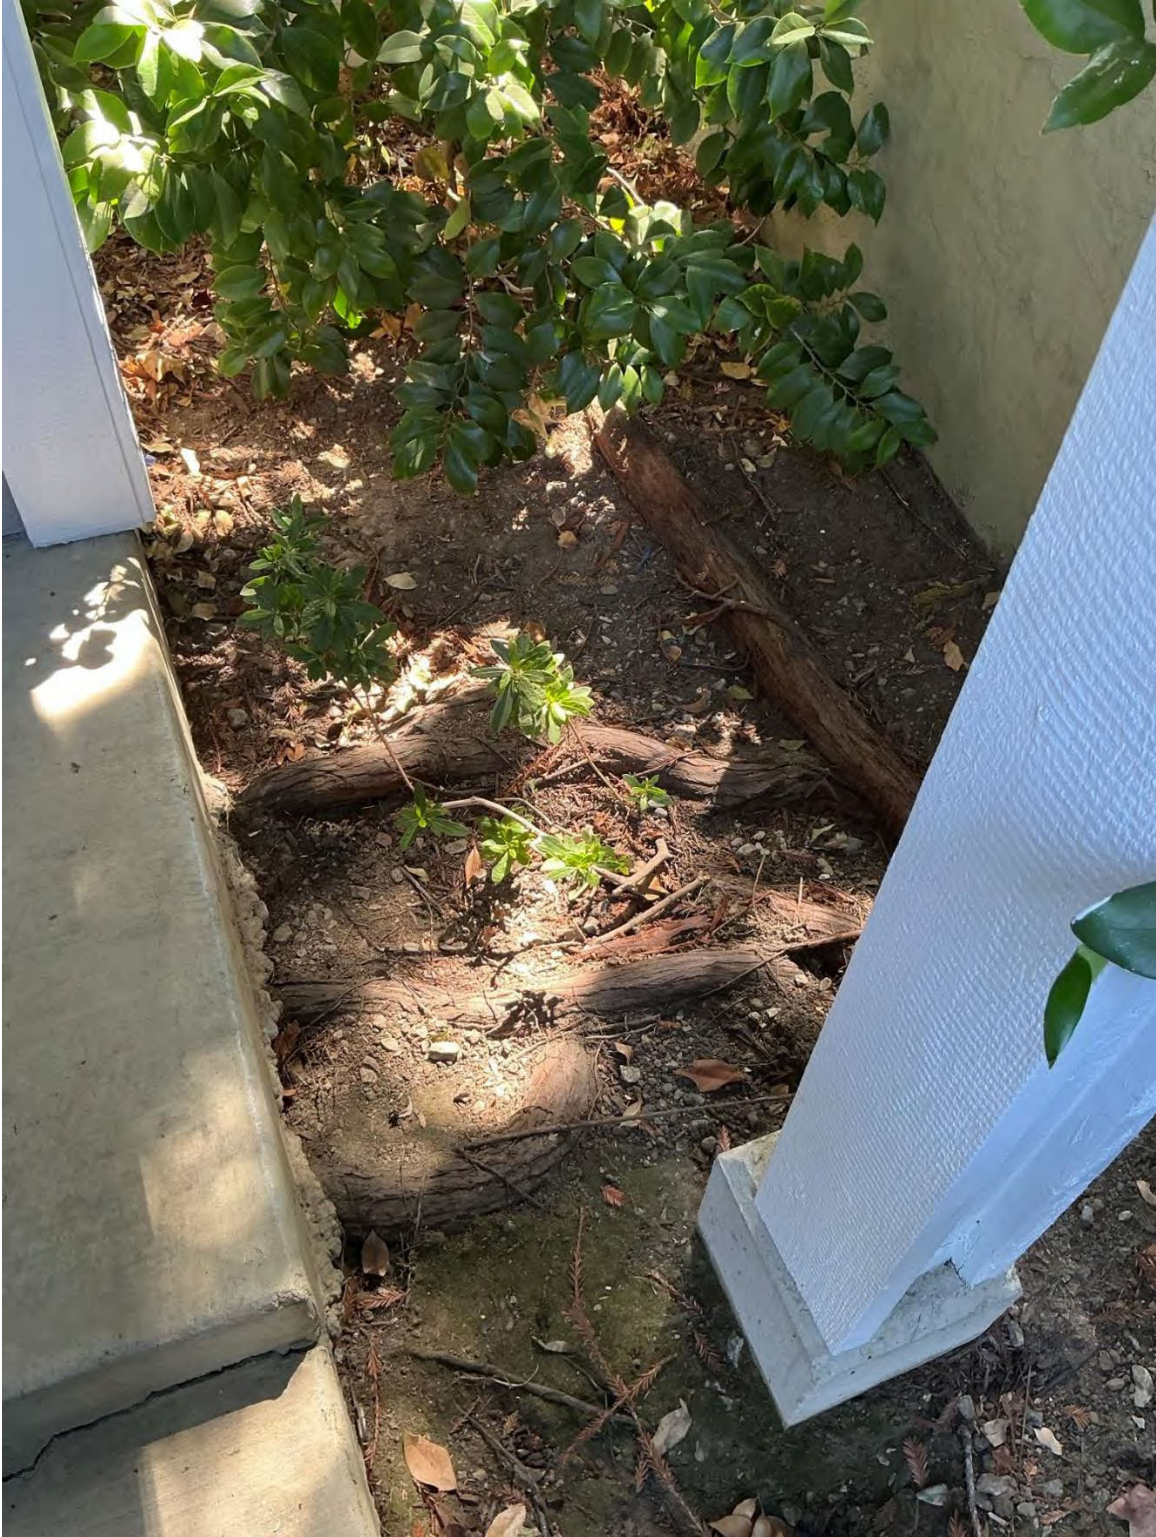
Large Surface rooting at entrance

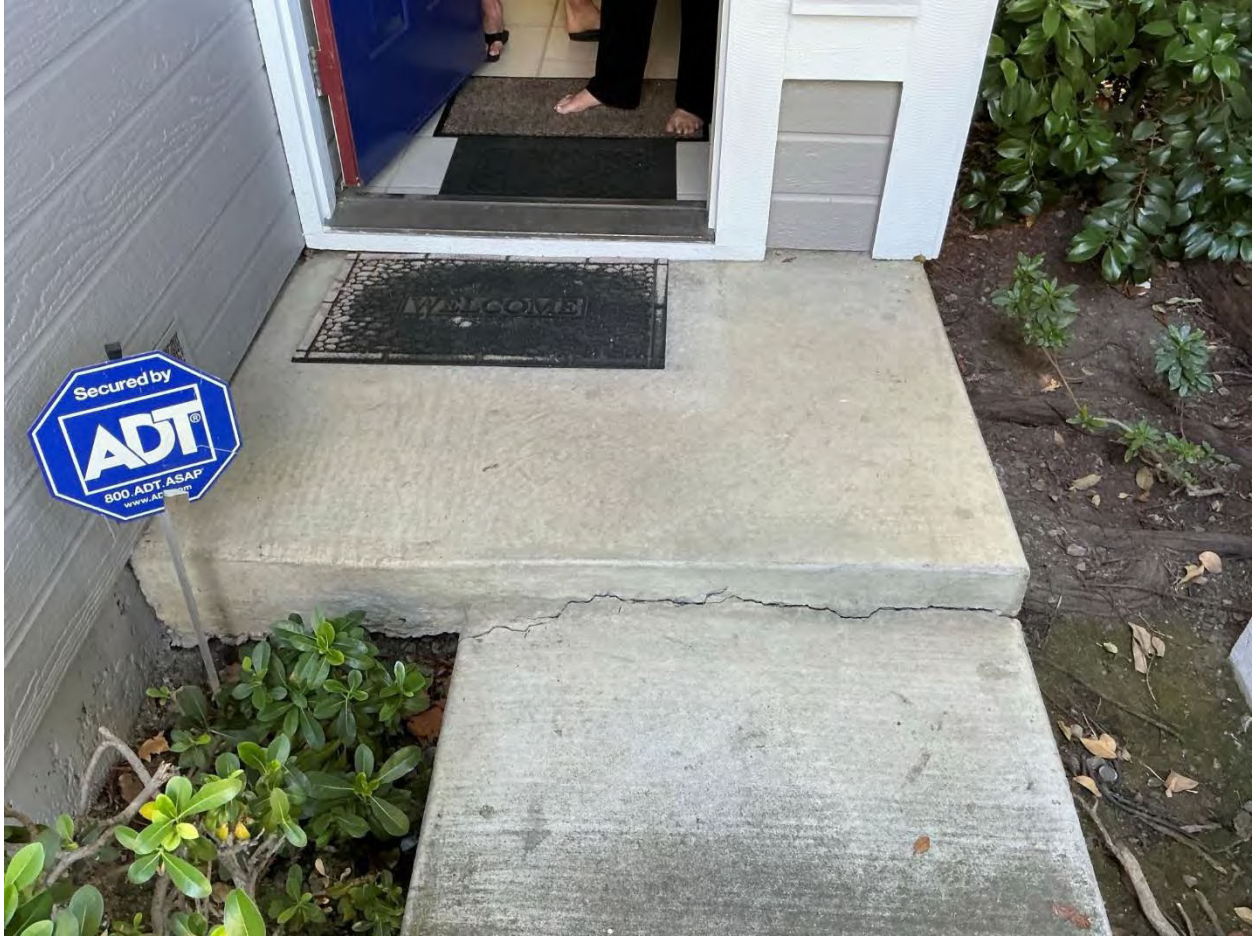
**Targets:** House directly under the canopy with high occupancy rates. Driveway and Road in Target Zone. Targets aren't movable. The Rooting Damage is the major concern from these Trees. Root Damage is already present to the House exterior/interior, Walkway, and Driveway.

Lifting damage from roots

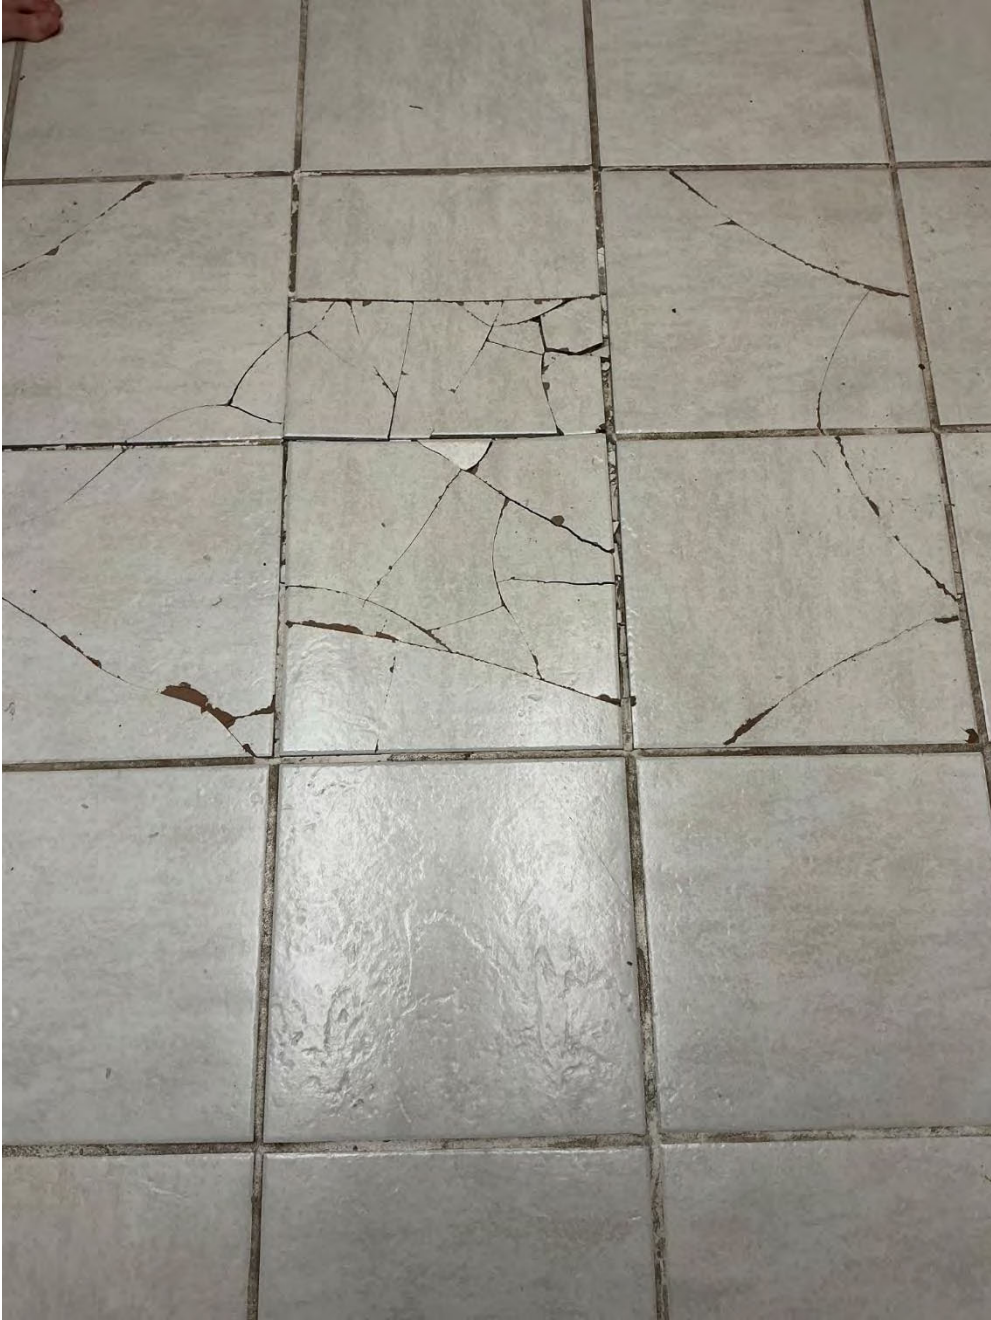
Interior damage

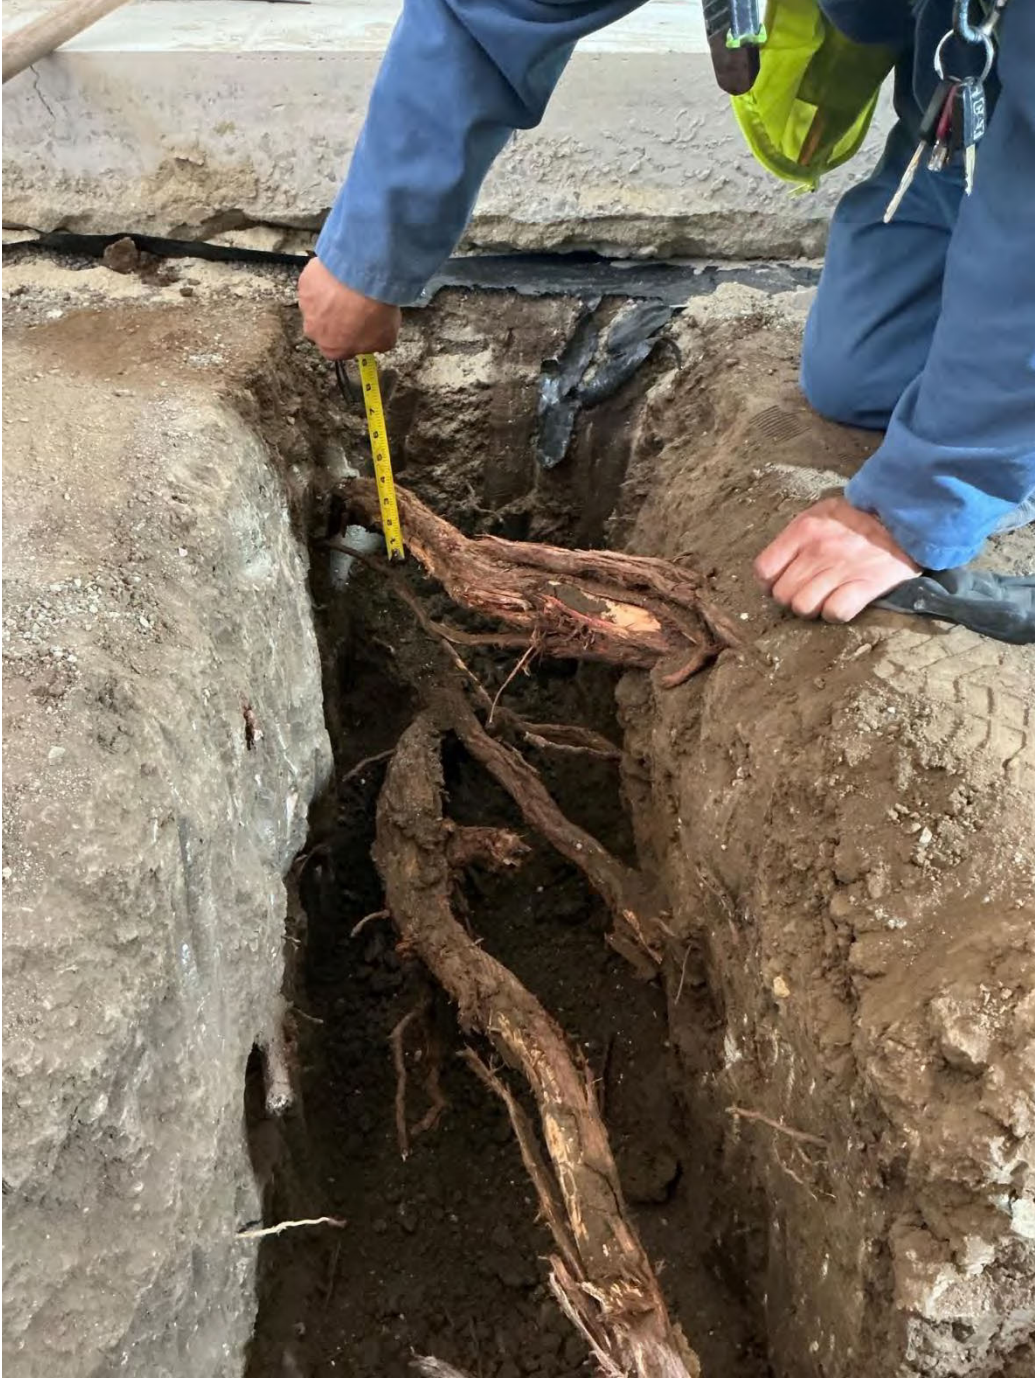
Roots from South Side

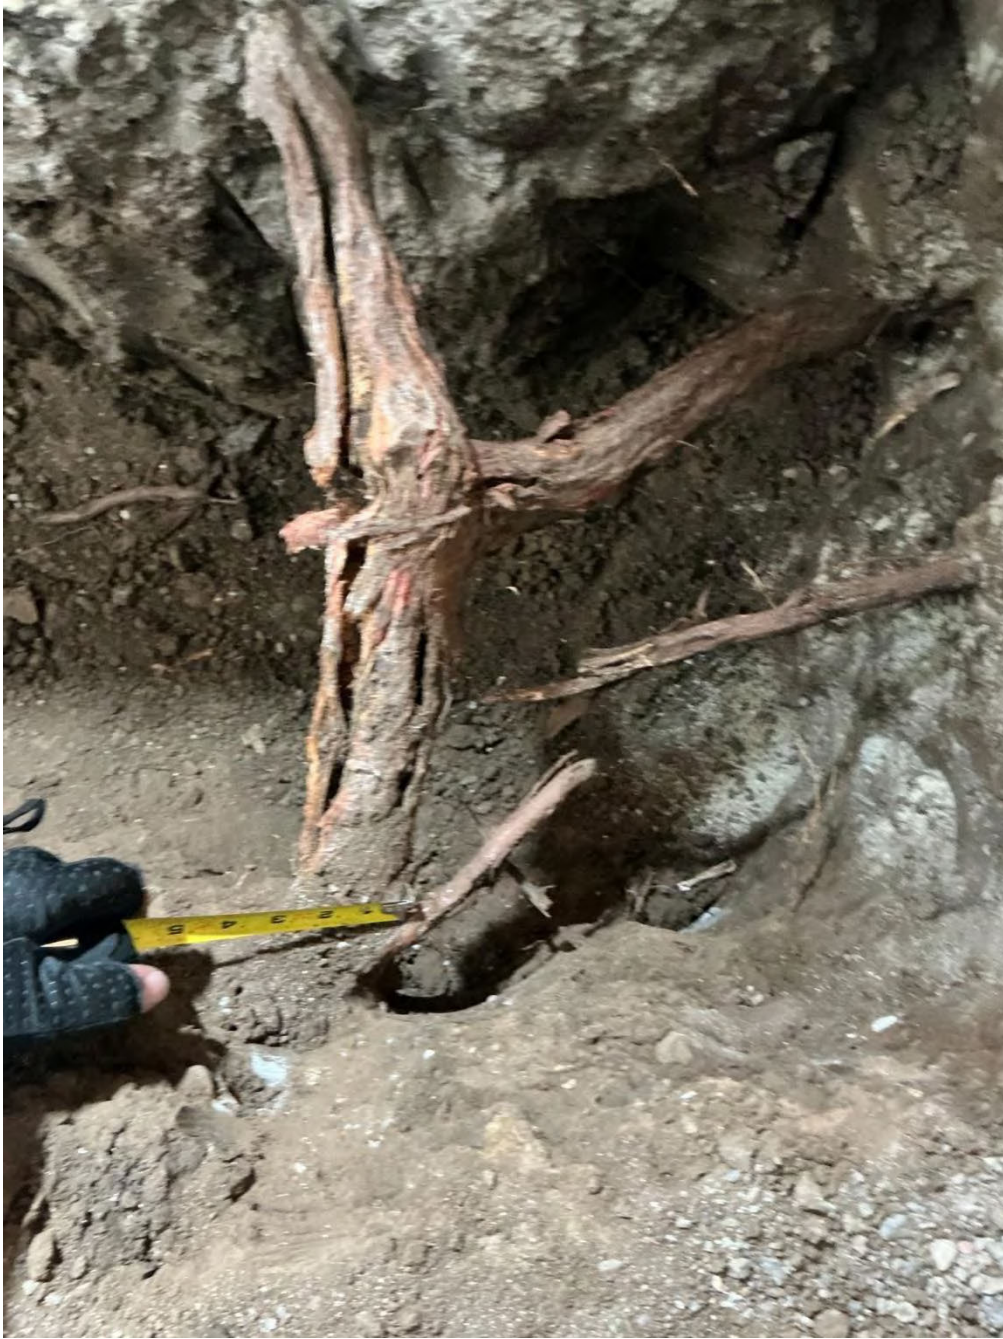
West Side Roots

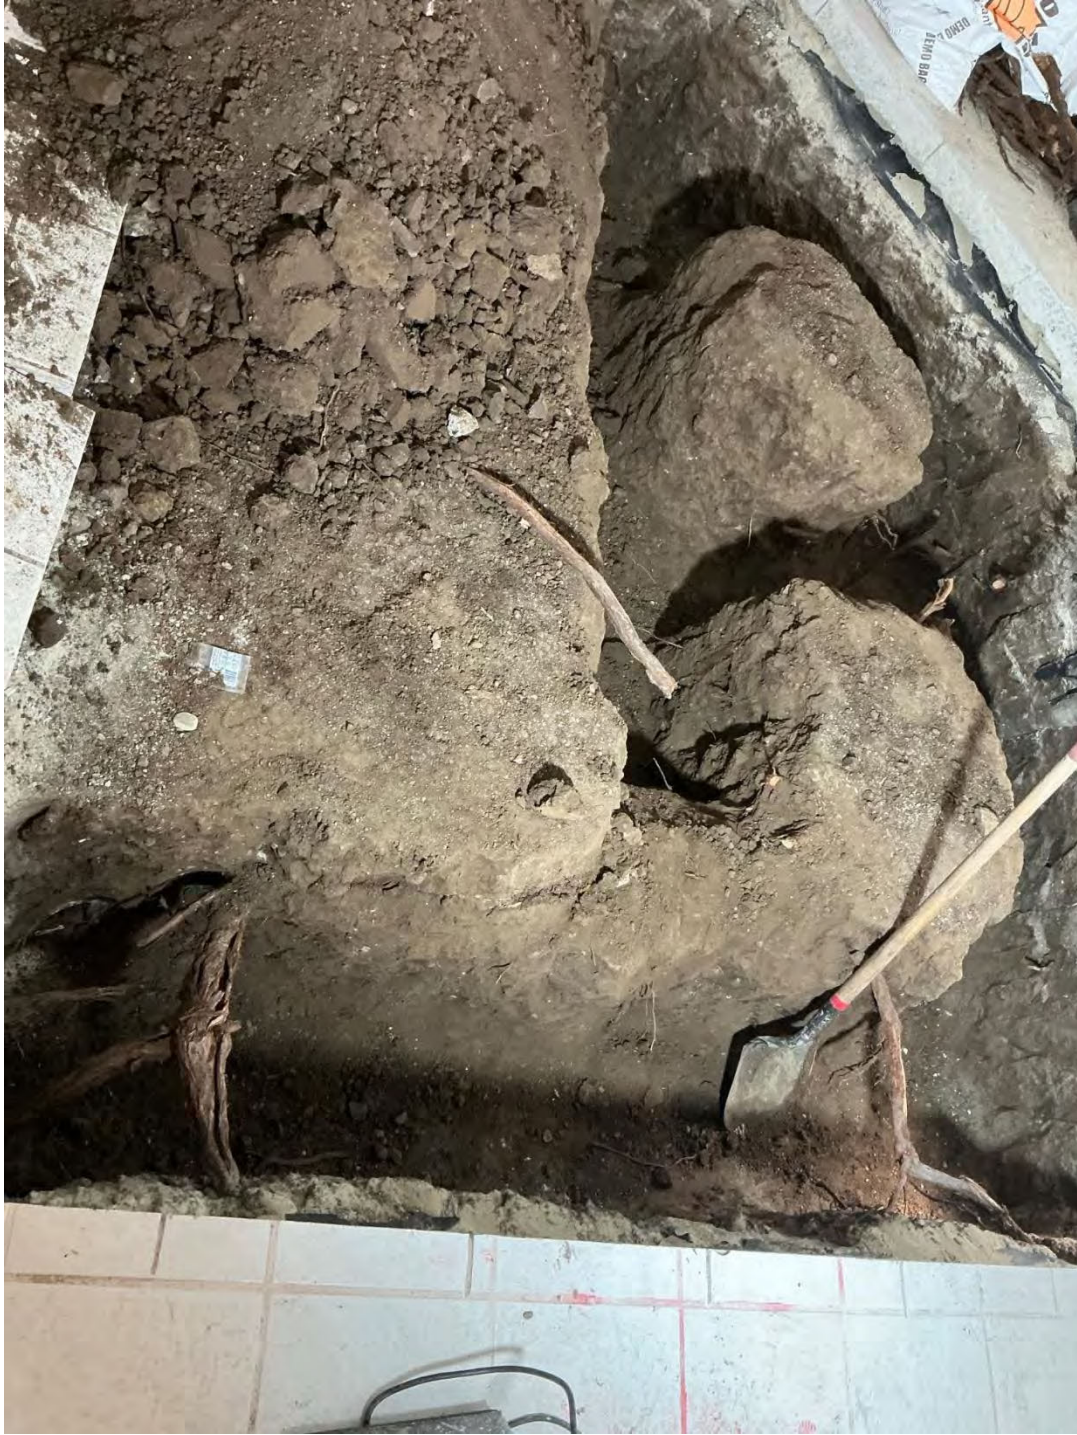
West Side Roots. Perimeter is Trenched

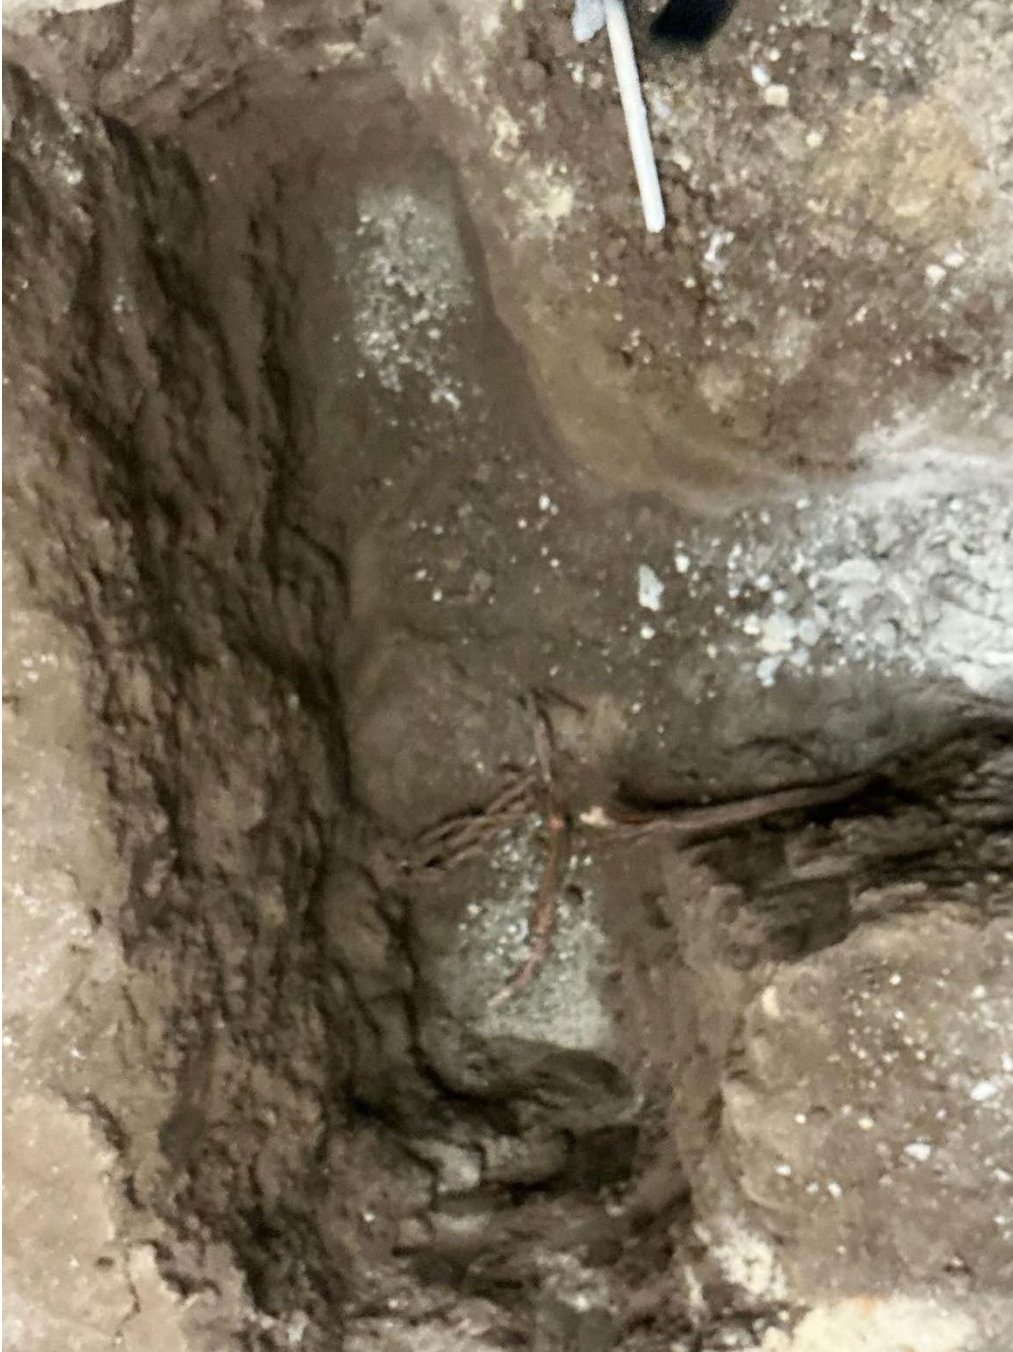
Kitchen Roots

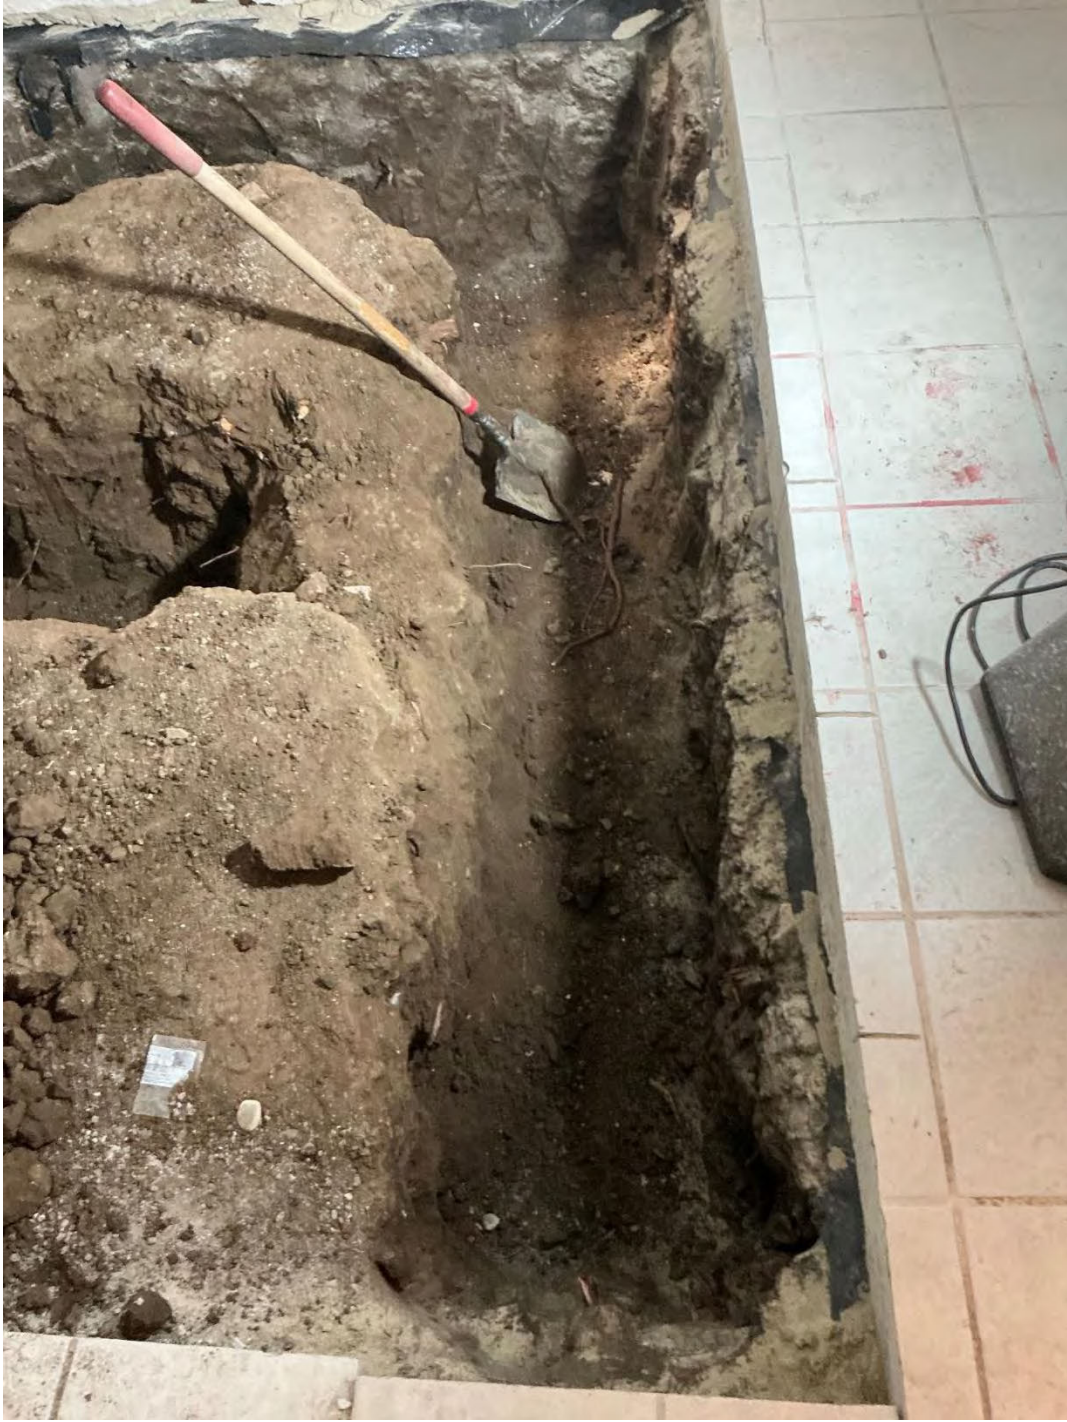
Clean cuts for Root Pruning. Perimeter is Trenched
