Request Name: removal of 1 heritage street tree

Heritage Tree Removal Permit Application

560 Franklin Street Mountain View, CA Arborist Report 2025

Attn: Michael Halleck & Robin Lin
 Subject: Tree protection plan for 560 Franklin Street, Mountain View, CA 94041

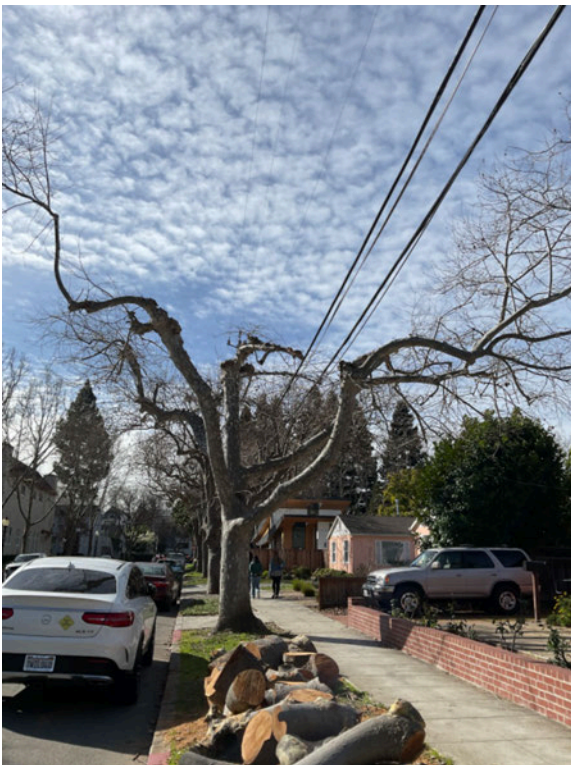
Tree tag #1 - London plane street tree was assigned a poor condition rating. The tree is located in the park strip between the sidewalk and street. A V-shaped crown, very commonly seen on trees planted directly under electrical facilities, is the result of directional pruning completed on a regular basis for high voltage utility line clearance.

While a healthy tree can typically overcome stress related to the constant, irregular pruning, it can lead to weak attachments at the stem or along lateral branches. These growth characteristics are not ideal for the long term health and structure of any tree, and pose a safety hazard for pedestrians, homes, and vehicles parked near the tree. The planting of a tree species that fits the "right tree, right place" methodology would be much more appropriate for this specific location.

The tree is requested for removal and aligns with the following criteria set forth by the City of Mountain View Municipal Code Chapter 32.1-32.21: *the tree is dead, dying, **structurally unsound**, or creating a problem that cannot be resolved without causing great harm to the tree.*

The City of Mountain View Forestry & Roadway Division should be contacted in order to have a staff member evaluate the property to see if there is appropriate planting space. A determination on the planting of a new street tree will take into consideration spacing, proximity to sewer, gas and water service lines, as well as proximity to sidewalks, driveways, and streetlights.

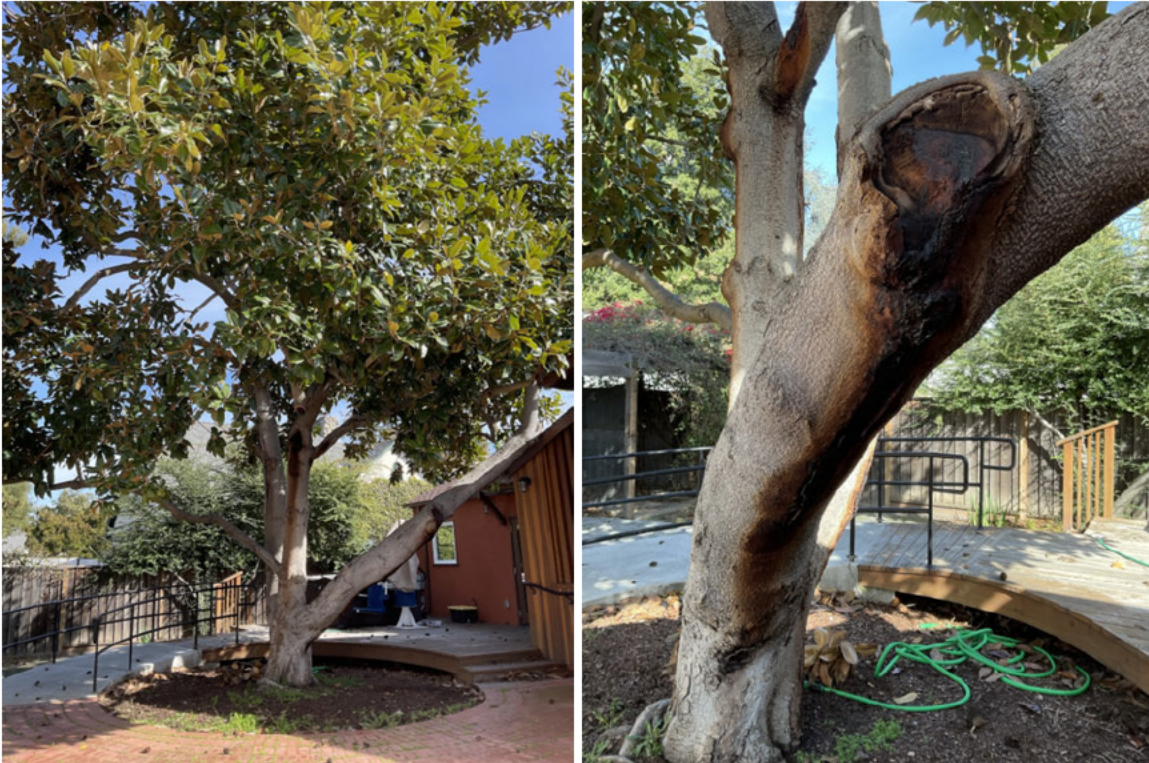
Tree tag #2 - Southern magnolia was assigned a poor condition rating. Codominance of the main stem occurs 30 inches above grade. The tree is located in a circular landscape area, surrounded by a concrete access ramp, brick patio hardscape and deck. Limb failure and removal has occurred in the past, resulting in an uneven crown. Bleeding cankers are visible on all stems.

The tree is requested for removal and aligns with the following criteria set forth by the City of Mountain View Municipal Code Section 32.35:

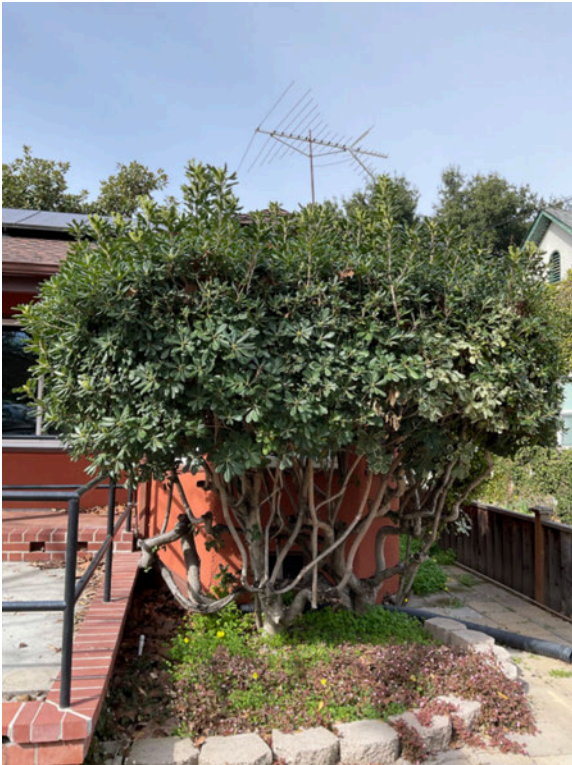
Showing tree #7

Tree tag #7 - Japanese cheesewood was assigned a fair condition rating. The tree is located in a small landscape area with limited soil volume, 2 feet from the existing home, and exhibits topiary pruning. The tree is located within the footprint of the new home proposed for construction on site and is to be removed.

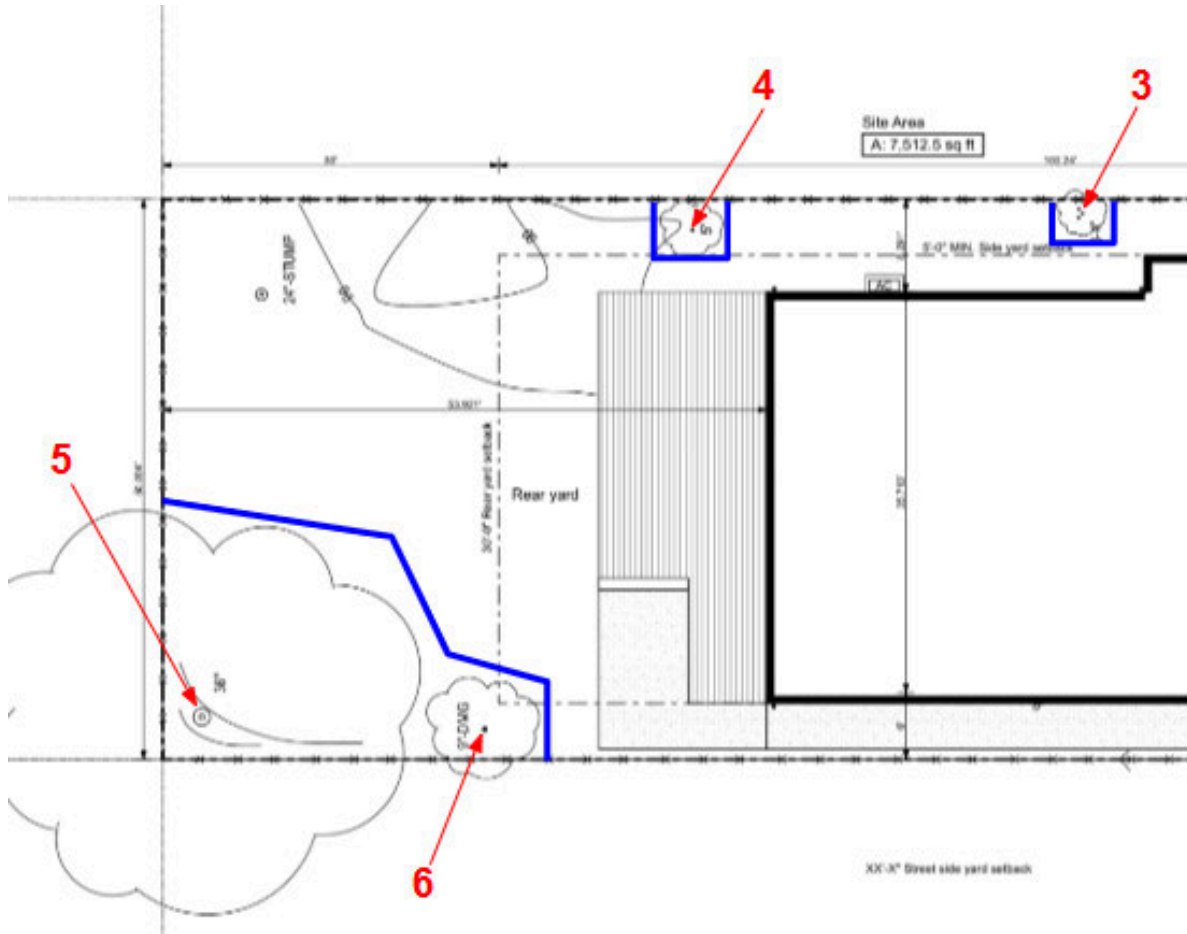
TREE PROTECTION MAP

Approximate placement area of Type I Tree Protection Fencing outlined in **BLUE**.

The fencing shall remain intact throughout the duration of the project or until activities within the TPZ are finalized. Tree protection fencing should be a 6-foot-tall metal chain link type supported by 2-inch thick diameter metal posts pounded into the ground to a depth of no less than 2 feet, ensuring stability even in challenging conditions. Poles should be spaced no more than 10 feet apart from center to center, providing a consistent and strong barrier. For trees near existing hardscapes or structures, tree protection fencing shall be placed as close as possible while still allowing access. Sensitive areas may require a landscape barrier if fencing needs to be reduced for access reasons. The location for tree protection fencing for the protected trees on site should be placed at 10x the tree diameters where possible (TPZ). All other non-protected trees are recommended to be protected by fencing placed at the drip line. No equipment or materials should be stored or cleaned inside protection zones. Apply mulch to the tree protection zones at a depth of 3 inches. Spread the mulch evenly throughout the designated area, ensuring it extends to, but does not touch, the tree trunk. Keep the mulch at least 3 to 4 inches away from the base of the trunk to prevent moisture buildup and potential rot. This will provide the necessary benefits of mulching, such as moisture retention and temperature regulation, while helping to maintain tree health. Signs should be placed on fencing signifying "Tree Protection Zone - Keep Out". If fencing needs to be reduced for access or any other reasons, the non-protected areas must be protected by a landscape buffer. All tree protection and inspection schedule measures, design recommendations, watering, and construction schedules shall be implemented in full by the owner and contractor. Trees #3, 4, 5, and 6 are required to be protected by Type I Tree Protection Fencing.
