Request Name: A Plus Tree is removing 1 Heritage Tree

Heritage Tree Removal Permit Application

Arborist Report for:

**Willow Park Mountain View HOA / Common Interest
500 W Middlefield Rd, Mountain View, CA 94043**

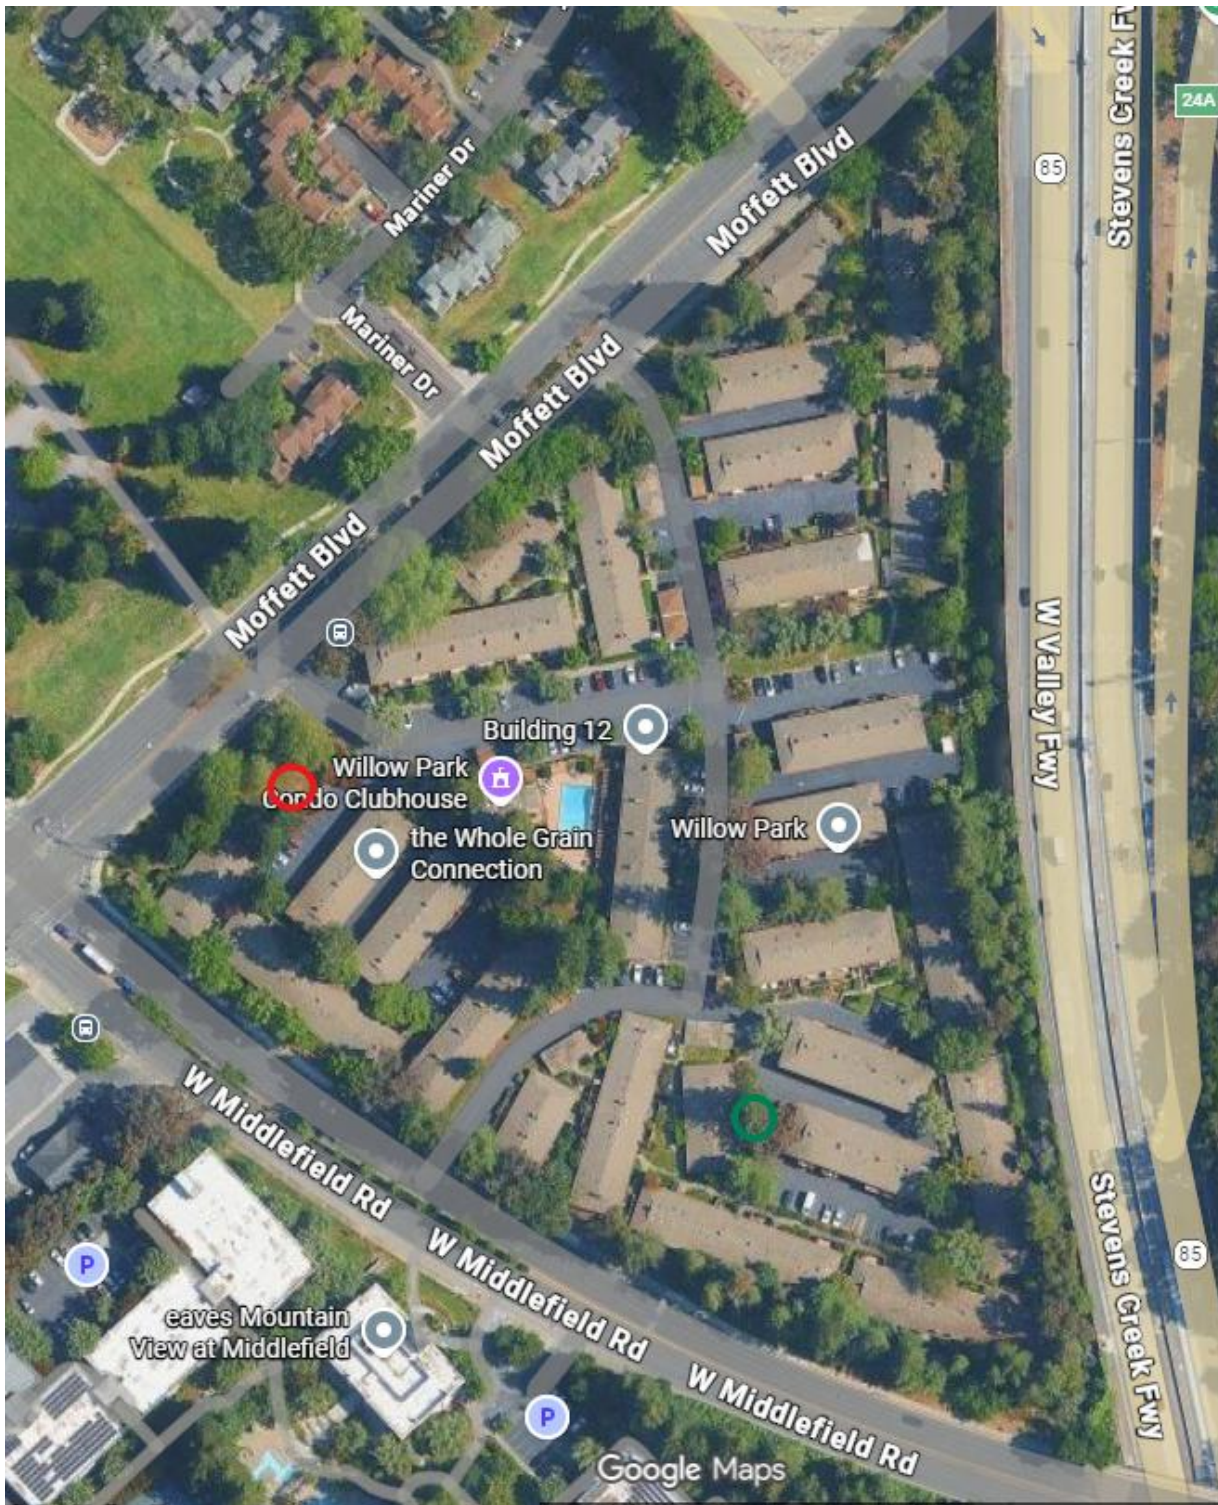
Green Circle = Coast Redwood removal.
Red Circle = 15 gallon replacement tree, Red Maple 'Autumn Blaze'

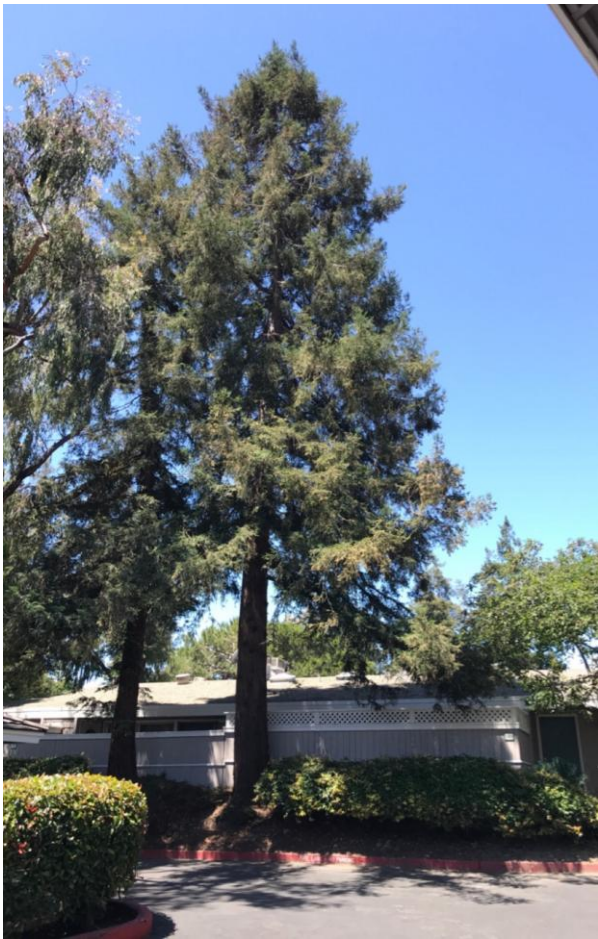
Photo 06/18/2025 Tree #1 -Overall

- Observations**
- 1. Coast Redwood, *Sequoia sempervirens* – 30” DBH**
- Private tree rooted along the East side of Bldg. 20.
 - Tree is in fair health.
 - Tree is outgrowing its space.
 - Tree is rooted against a backyard patio & fence.
 - Requires “Heritage Tree Removal” permit & (1) 15-gallon replacement tree.

Recommendation A Plus Tree recommends removal and replacement with (1) 15-gallon Red Maple ‘Autumn Blaze’ in the turf, west of Bldg. 16.

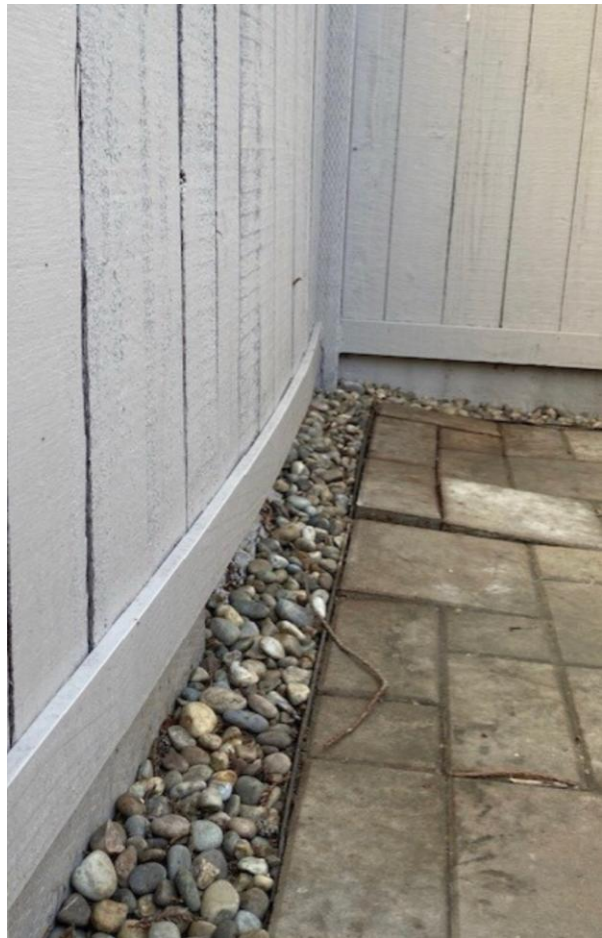
Photo 06/18/2025 Tree #1 -Patio

Discussion *Tree 1, Coast Redwood, Sequoia sempervirens* is outgrowing its space. The trunk presses against the wood patio fence, & root pruning for patio repairs will require cutting into the root collar & removing anchoring roots. If left unmitigated the tree will cause more damage to the fence.
