Heritage Tree Removal Permit Application

ARBORIST REPORT
Prepared for : Elizabeth McAninch
Prepared by : Henry Ardalan
December 22, 2025

961 Eichler Drive, Mountain View

Arborist Report

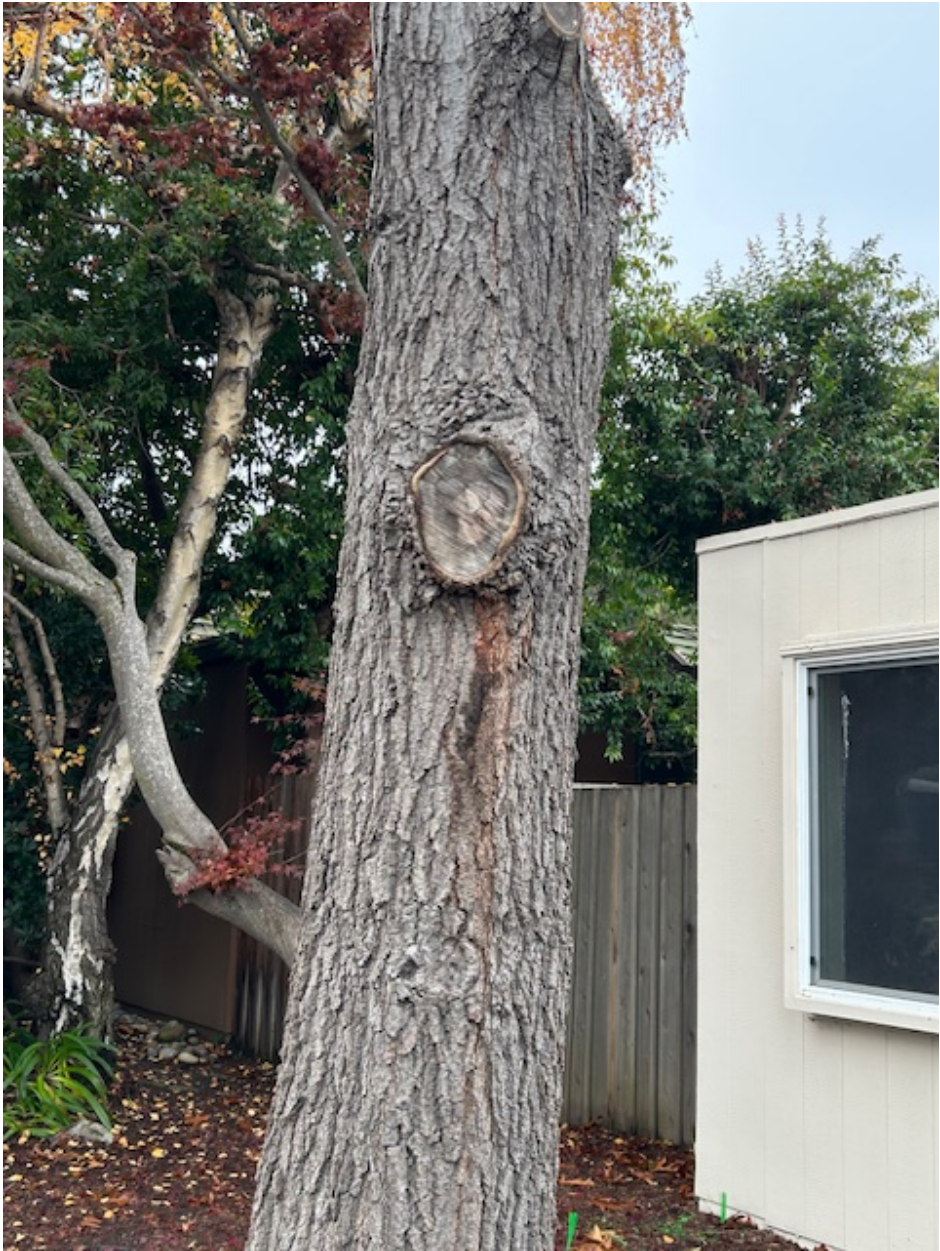
C - There is dark bleeding sign below old open wound at 6 feet from ground level. You can hear a hollow or dull sound when tapping on trunk where it was bleeding , suggesting internal wood decay rather than a superficial bark issue. Since bleeding is the external sign of internal problem, when bleeding combines with hollow sounding of the wood, it raises the risk level, specially when tree is close to the building.
(**photo on page 4**)

I recommend, in order to prevent any unwanted incident in future, remove and replace subject tree with suitable replacement tree species for your specific site (sun, soil, space) according to the City of Mountain View Heritage tree removal ordinance.

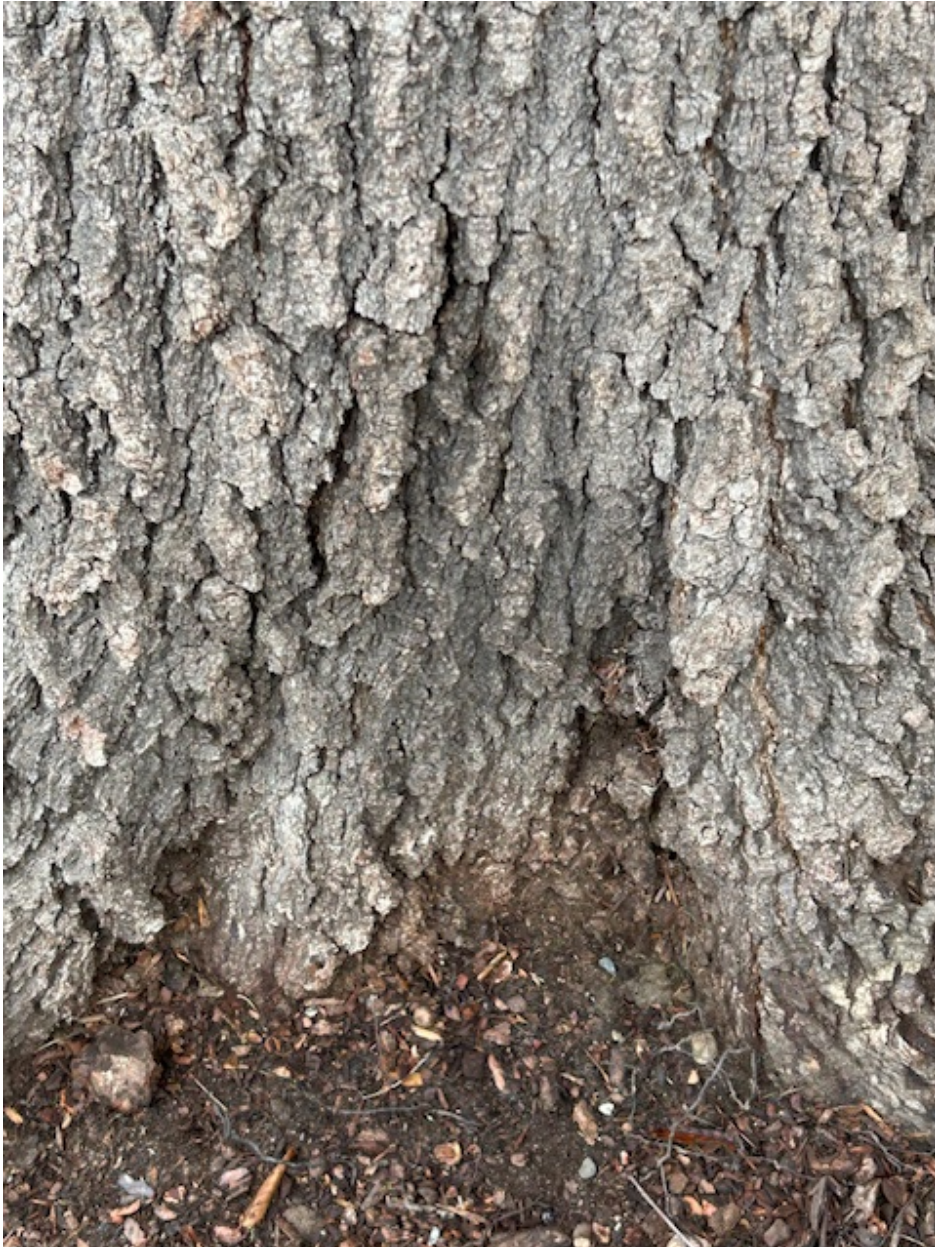
D - Also, tree base shows sign of bark deformation which mildly sunken near ground. There were few fungus fruiting body (mushroom) on the ground near tree base which could be associated with potential root decay. (**photo on page 5**)

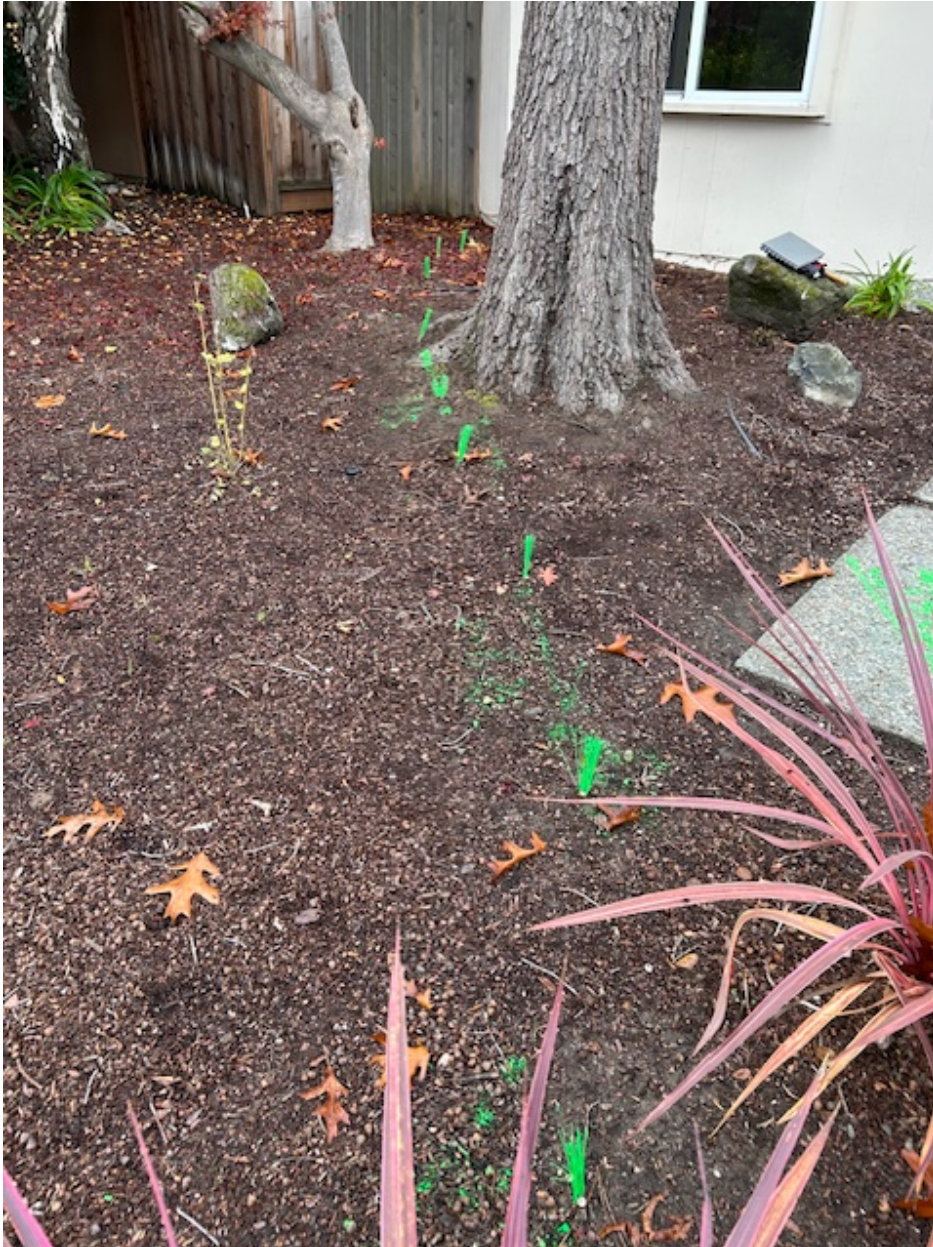
E - As the photo on the **page 6** exhibits, sewer line positioned under the tree root system. This may not be a problem at this time, but given the fact that the tree structural integrity has been compromised, tree failure at the base could seriously damage the sewer line.

Green marking is direction of sewer line

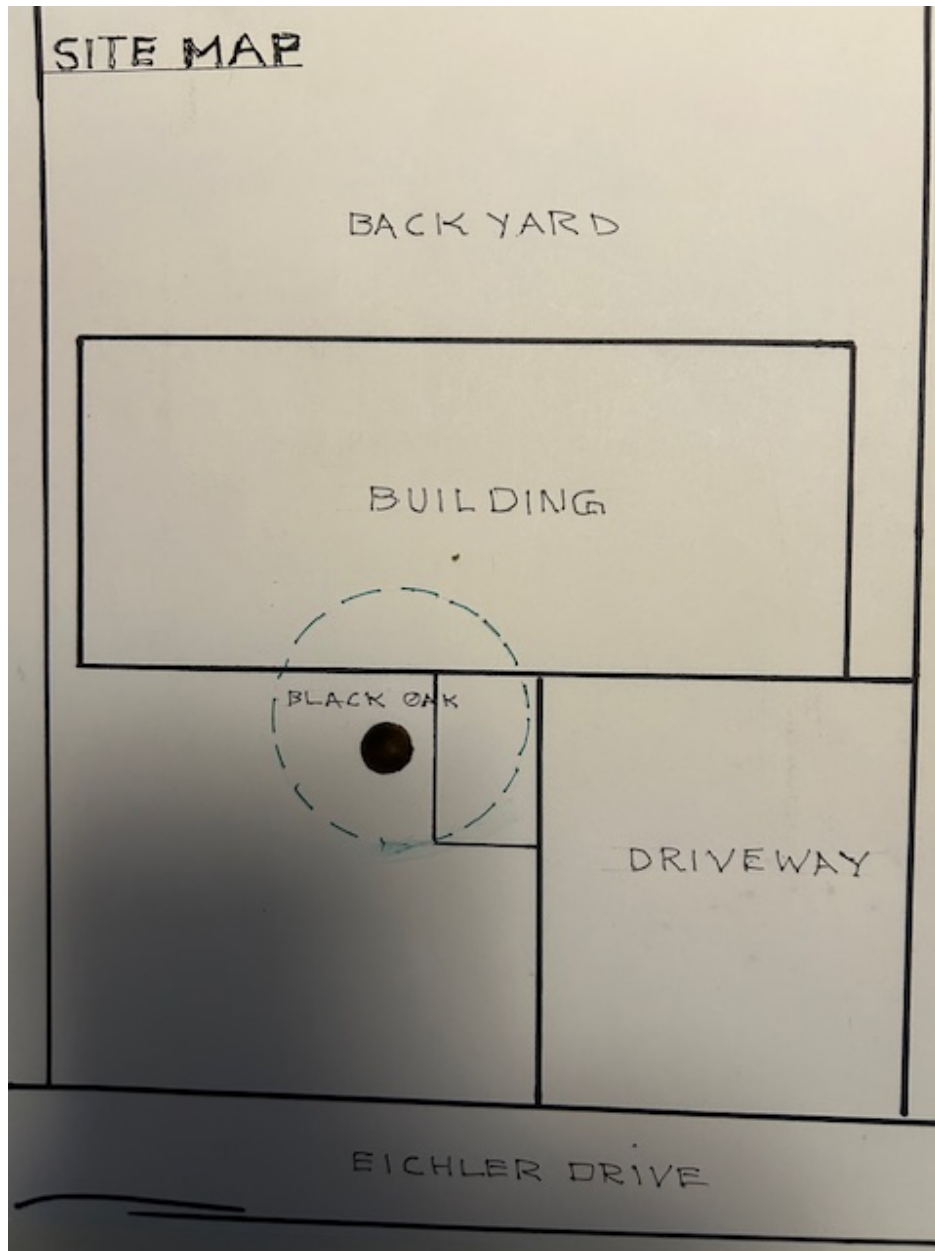
A - Subject tree is a mid size California Black Oak " Quercus keloggii " a **Heritage Tree** located in front, 6 feet from building foot print, and 16 feet from sidewalk. (**Site map on page 7**)
