State of California - The Resources Agency
DEPARTMENT OF PARKS AND RECREATION

PRIMARY RECORD

*Resource Name or #: 938-970 Villa

*P11. Report Citation: (Cite survey report/other sources or "none") Carey & Co. Inc., Downtown Mountain View Precise Plan Area Historic Resources Survey, San Francisco, California, 2003

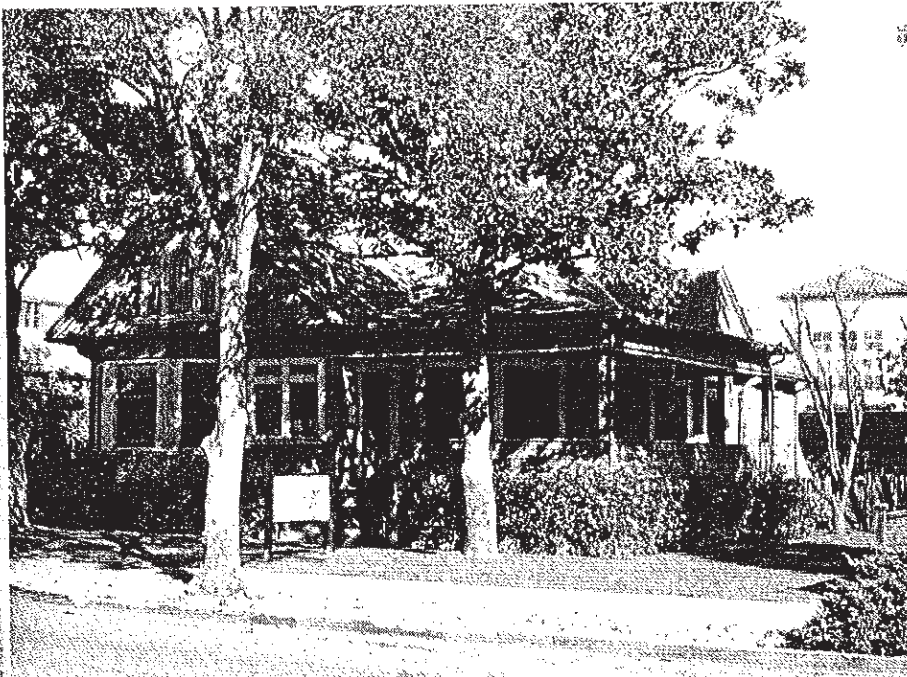
This two story building is rectangular in plan, with a herringbone shingle-clad, intersecting gambrel and hipped roof. It is of wood-frame construction with 1x wood clapboard siding at the first floor and wood shingles at the second. Windows are wood, and one-over-one, and twelve-over-one double hung, as well as awning and casement units. An arched Palladian window graces the front gable end. Trim is unprofiled. The front door is single panel wood, and the side door is eight panel. The open verandah starts at the front door and wraps the corner. It has a closed rail with horizontal clapboard siding, and marbelized wood columns. Projections include a bay at the north side, and a dormer with an arched window at the south. The house is set back from the street with a front lawn that continues to the side, a stone walkway, a paved concrete side driveway, shrubs and trees around the perimeter, and a new sign in the front lawn. This building is in good condition. Associated with this structure is gable-roofed detached garage, clad similarly to the main structure.

P5b. Description of Photo: (View, date, etc.)
south and east facade, view toward northwest, Photo No: 1-1, 2/11/03

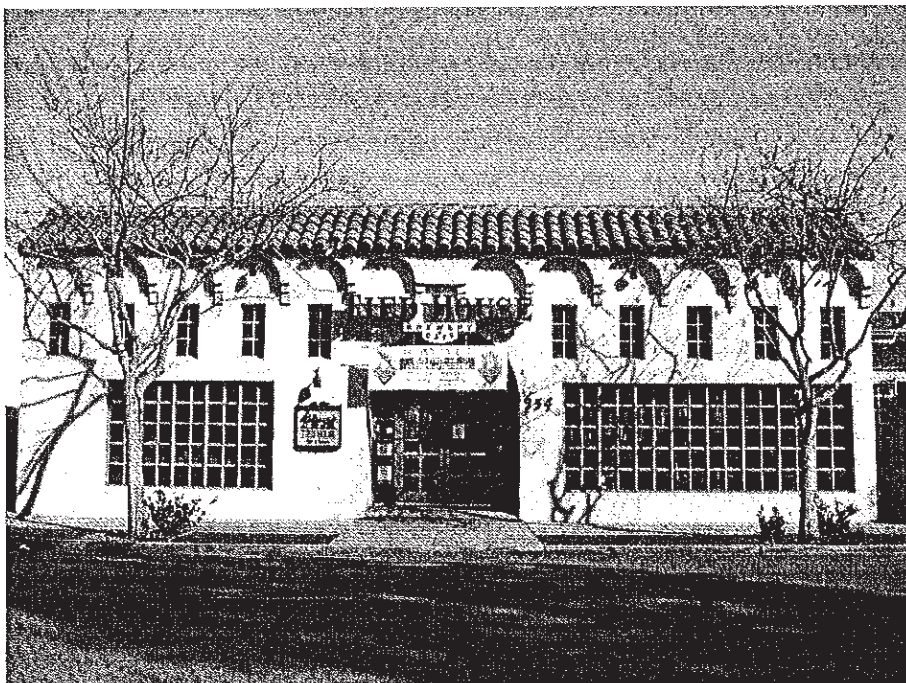
This one-and-a-half story commercial structure is rectangular in plan. It is of concrete construction with a painted exterior finish. The main roof is gabled with a central monitor skylight. The Villa Street (primary) elevation features a decorative barrel tile-clad roof with protruding eaves, visually supported by a machicolation-derived fascia. Windows are mostly steel and include narrow six lite windows with pebbled glazing, and industrial style fixed and casement window systems at the monitor and at each side elevation. Two, non-original aluminum multi-pane windows flank the main arched entry at the base of the primary elevation. This entry also contains a non-original aluminum door and window system. The building's rear elevation contains an entry with a cloth awning, and a tented outdoor seating area. The building appears to be in good condition. Alterations included the addition of the new aluminum door and window systems, new mechanical system units on the roof and one side of the building, and the addition of the rear awning and tented area. Landscaping includes two large street trees in front of the primary elevation and a trellis along one side of the building which creates an outdoor seating area.

P5b. Description of Photo: (View, date, etc.)
south facade, view towards north, Photo
No: 1-1, 02/11/03
