# Shoreline at Mountain View Lake Habitat Island

## Alternatives Analysis Report

City of Mountain View

October 2025

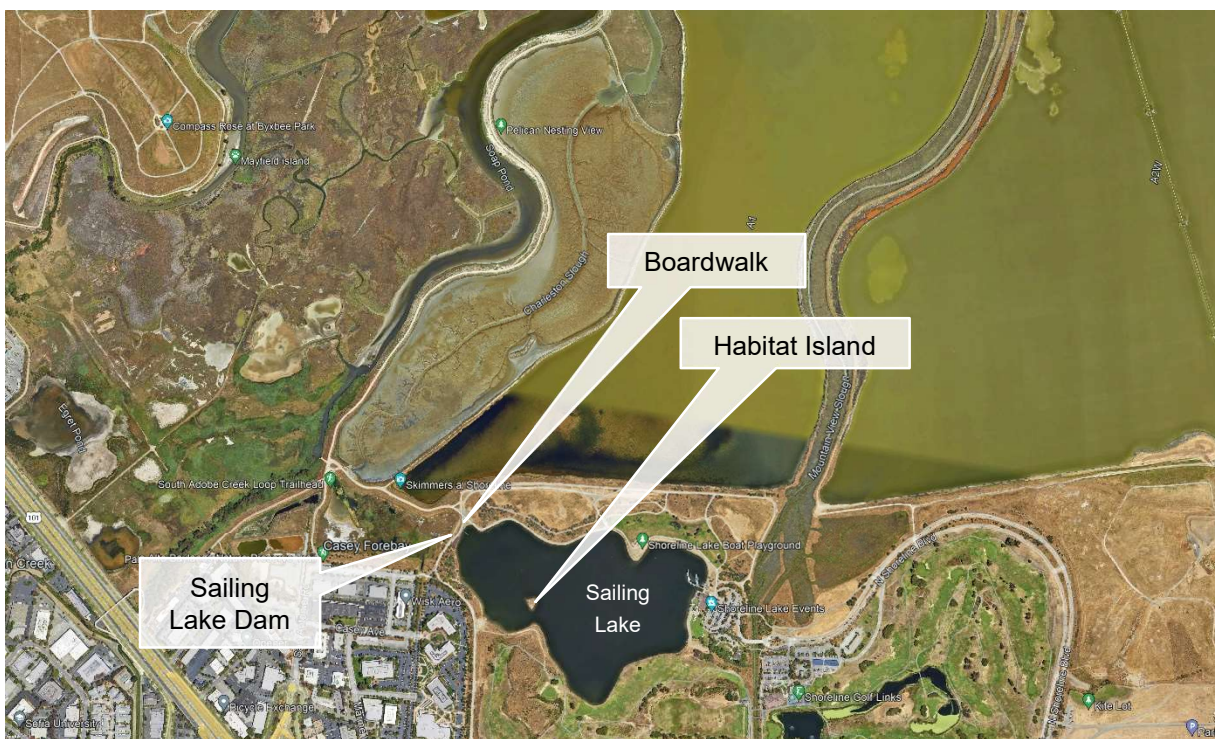
Figure 1-1 Project Site Overview

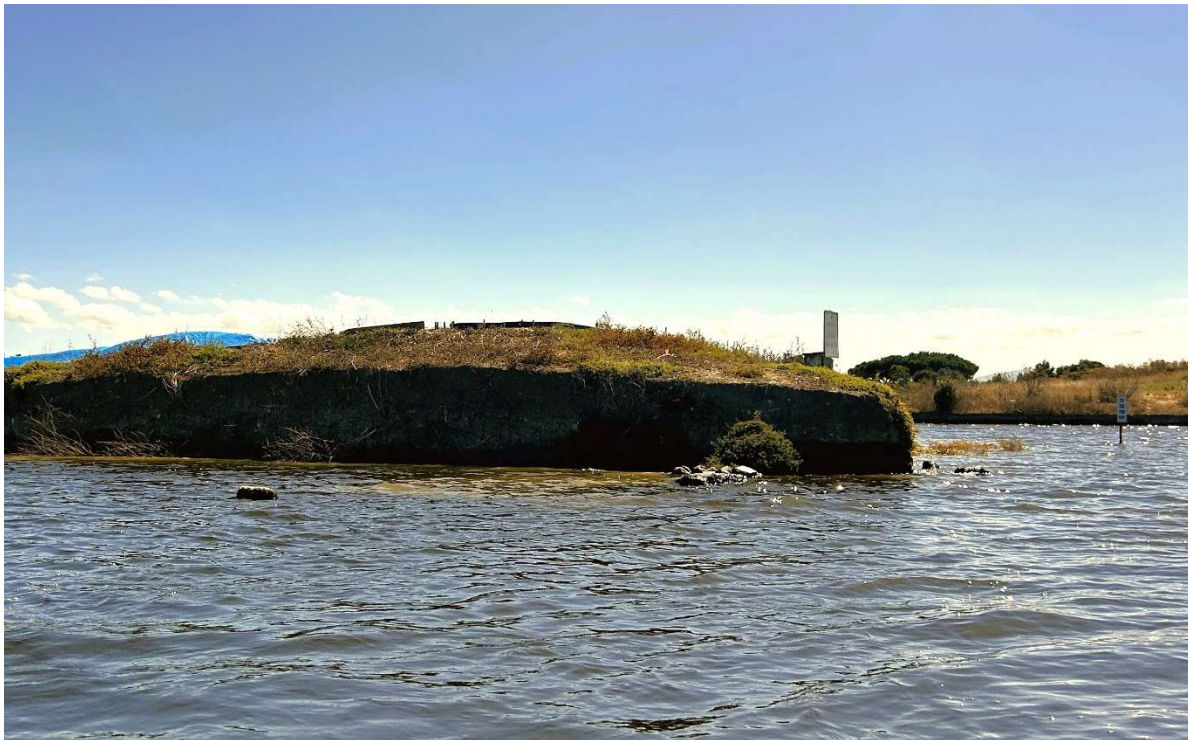
The island has experienced significant erosion over the years, decreasing the overall size of the island and reducing the habitat value provided. Figures 2-2 and 2-3 show the existing near-vertical side slopes that have resulted from decades of wind-wave erosion. These steep slopes have reduced nesting success for waterbirds breeding on the island as chicks that fall into the water are unable to climb back on the island.

**Figure 2-2** Habitat Island

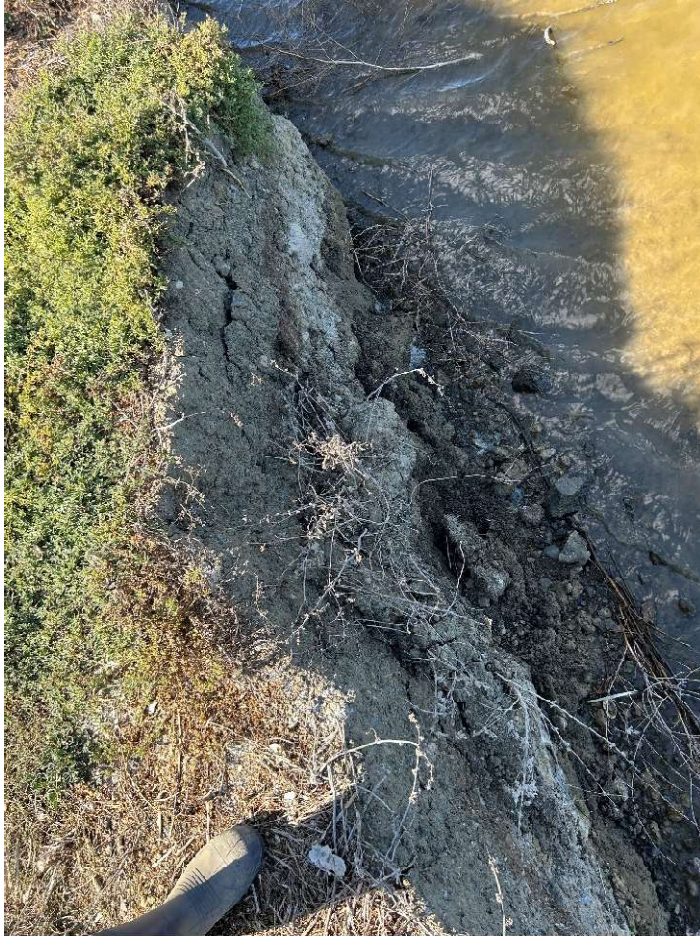
**Figure 2-3 Island Vertical Side Slopes**

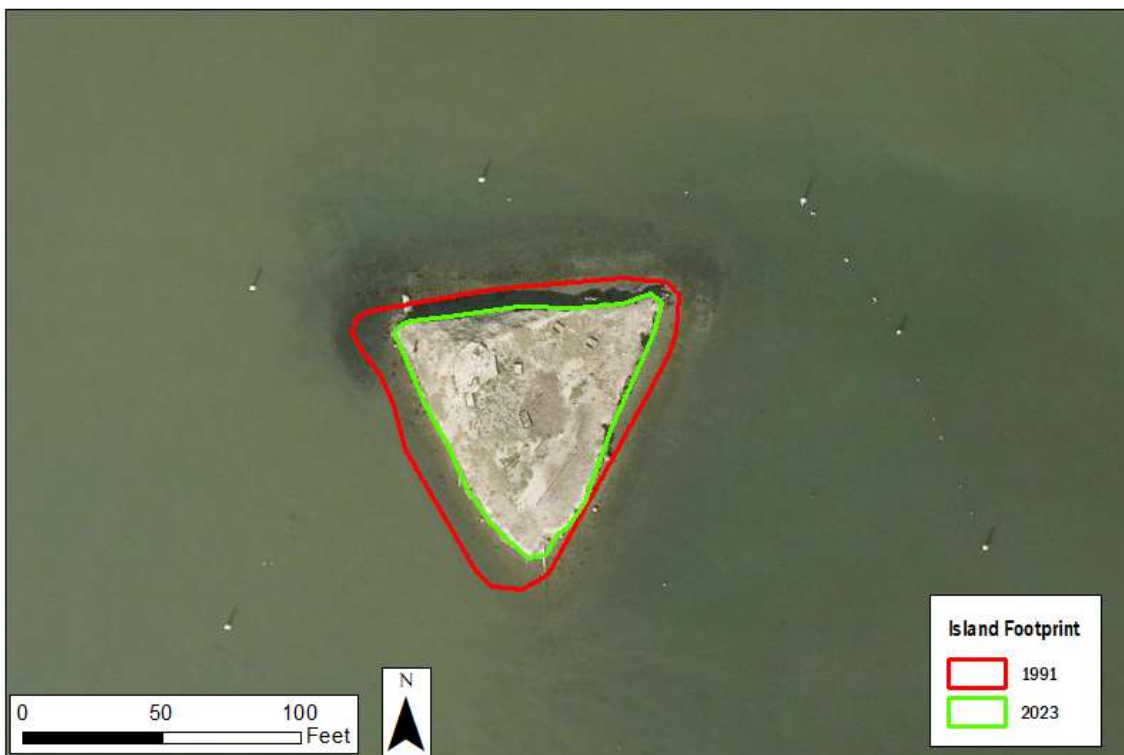
Figure 2-5 shows an overlay of the 1991 island size (in red) compared to a 2023 aerial photograph of the existing island.

**Figure 2-5 1991 Versus 2023 Island Size**

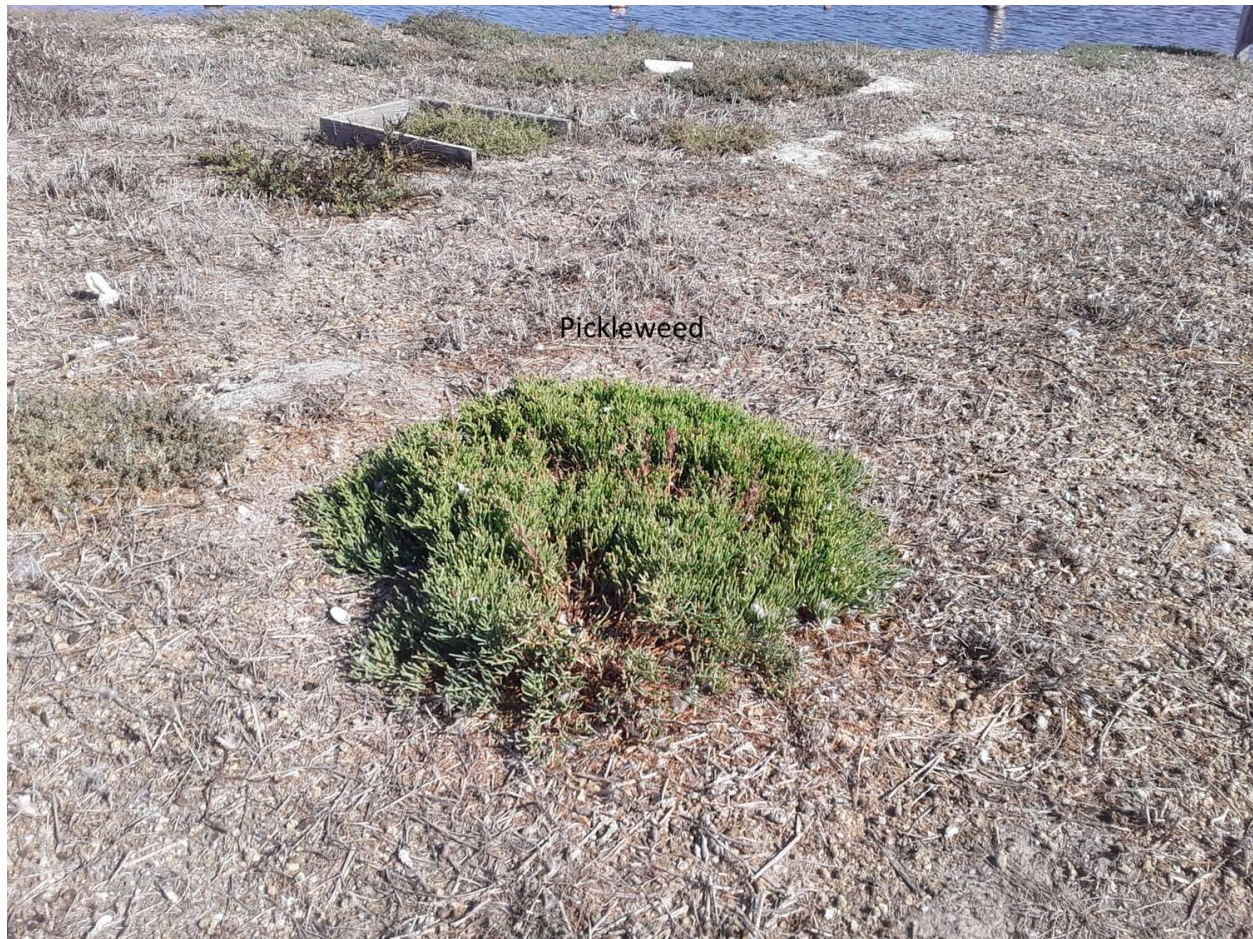
The island surface is predominately vegetated, with a few pockets of native species including alkali heath and pickleweed (see Figures 2-6 and 2-7), and larger areas of non-native species including mallow, mustard, thistles, poison hemlock and non-native grasses. Exposed island surfaces are generally a combination of earth and gravel.

**Figure 2-7 Habitat Island Pickleweed**

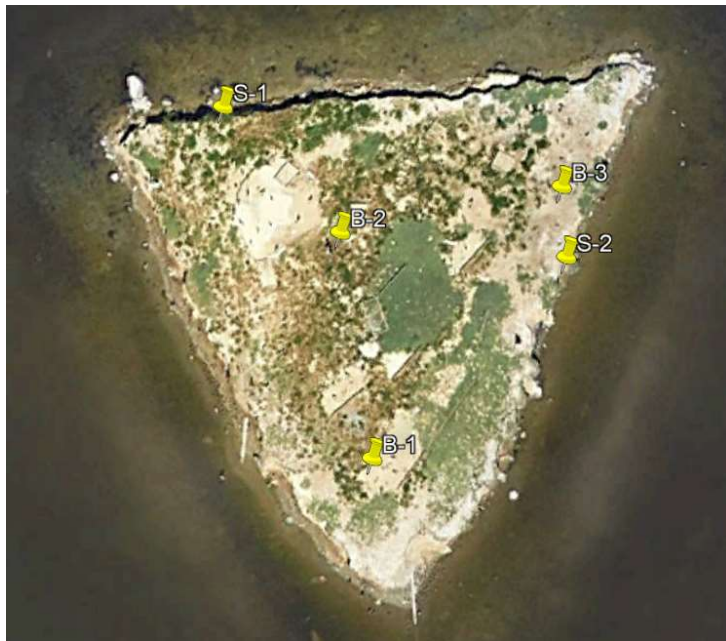
- B1 – LEAN CLAY (CL) with Sand, Dry, Light Brown, Fine to Medium Coarse. Ground was drilled for up to 1.5 feet after which the soil was too hard for the hand auger to drill further.
- B2 – FAT CLAY (CH), Moist, Dark Brown, Fine. The sample was collected between the depths of 1.5 feet to 2 feet and 3 inches. The material in the top 1.5 feet was similar to that collected at B-1.
- B3-A – LEAN CLAY (CL) with Sand and Gravel, Dry, Light Brown, Fine to Coarse. The sample was collected between the depths of 0-1 foot 6 inches below ground surface.
- B3-B – LEAN CLAY with Sand & Gravel. Moist, Dark Brown with red, Fine. The sample was collected between depths of 1 foot 6 inches to 2 feet and 3 inches.
- S-1 – Sample collected was similar to the soil collected in B-1.
- S-2 – Sample collected was similar to the soil collected in B-2.

**Figure 2-8 Boring and Soil Sample Locations**

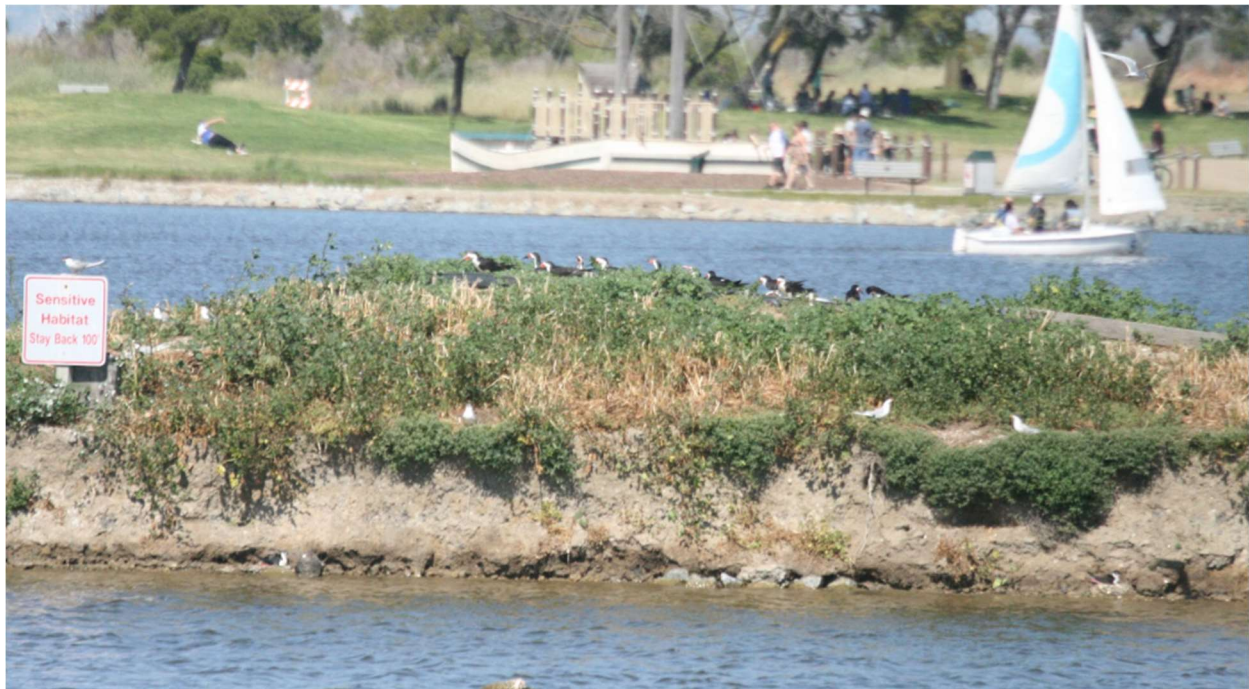
**Figure 2-9 Habitat Island Bird Observations**

Bird use is monitored by City staff, who typically see birds arrive for courtship in mid-March, quickly followed by observations of first eggs, and final bird observations in late September. In any given breeding season, up to 200 nests are observed by the City (see Figure 2-9). The first nesting pair of black skimmers were seen in 2013, numbers have increased to approximately 50 nesting pairs in 2021 and 2022 (H.T. Harvey & Associates, 2023).

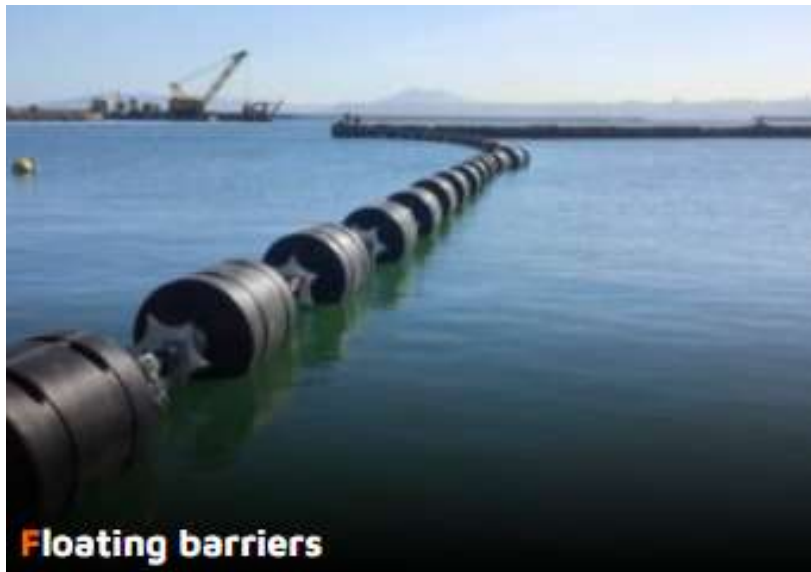
**Figure 4-8 Musthane Floating Barrier**
