**TO:** Parks and Recreation Commission

**SUBJECT:** **Sailing Lake Habitat Island Alternative Analysis, Project 23-44**

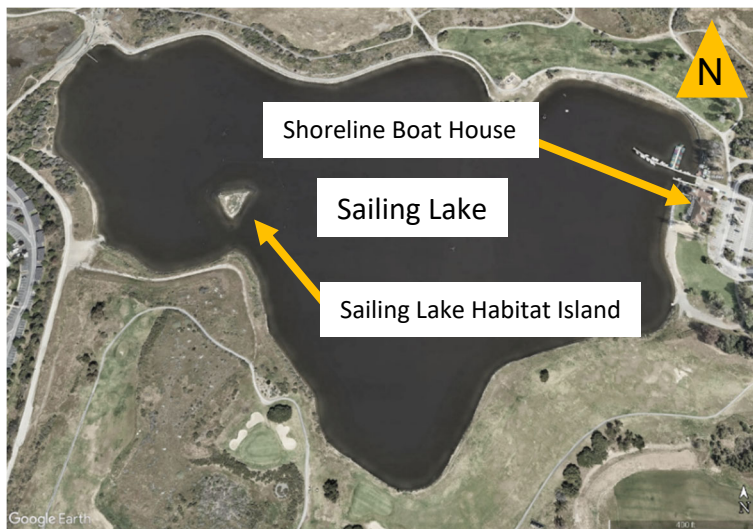
**Figure 1 – Sailing Lake Habitat Island**

Over the years, the habitat island has experienced significant erosion due to wind and wave actions. A 1991 aerial photograph shows the island surface area was approximately 0.18 acre. A 2023 field survey shows the current island surface area has decreased to approximately 0.11 acre. The erosion has reduced the overall size of the island and its habitat value. The existing

near-vertical side slopes have further impacted nesting success for waterbirds breeding on the island, as chicks that fall into the water are unable to climb back on the island. Nesting activities have also been negatively impacted by frequent disturbance from recreational users on the lake during the breeding season, despite ongoing efforts to reduce human disturbance with additional signage and buoy placement.

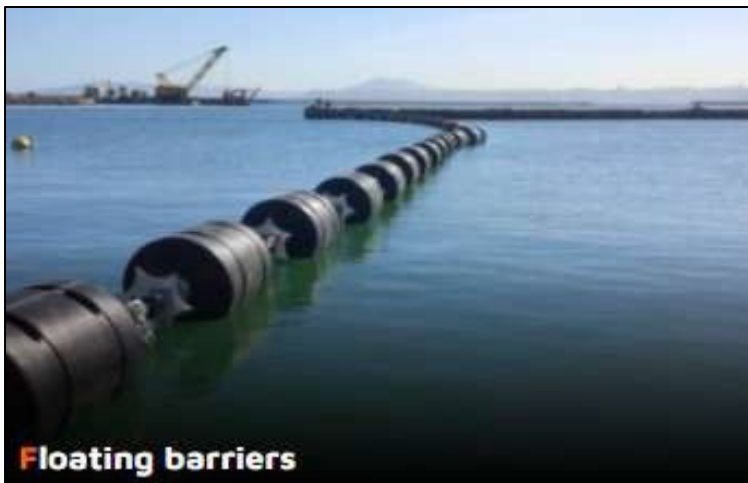
**Figure 5 – Barrier Improvement Alternative B**

This alternative includes a Musthane floating security barrier system with large floats and chain connectors. The floating security barriers are larger in size than the Walsh Marine system in Alternative 1, offering better protection against boater entry, as well as easier installation and maintenance. Anchors to the lake bottom will be installed at key locations to prevent significant movement of the buoy system. Preliminary data from the supplier suggest that this product is robust enough to resist sinking due to mussel and algae accumulation. However, additional evaluation of its maintenance requirements will be needed during detailed design.

The planning level Engineer's Opinion of Probable Construction Cost (OPCC) of Alternative B is approximately \$590,000.

The lowest cost alternative was Alternative A, and the highest cost alternative was Alternative B. In terms of aesthetics, Alternative C, featuring the traditional drilled wooden pile design, was considered the most aesthetically pleasing. In contrast, the large black buoys used in Alternative B were viewed as the least visually appealing.

Alternative B is expected to require the least maintenance, due to its robust buoy design, which limits biofouling and reduces the risk of sinking. Alternative A is likely requiring the most effort due to potential biofouling and the risk of damage from boats. Alternative C is expected to have the lowest risk of buoy sinking due to the piles support.

Regarding effectiveness, Alternative B would be the most effective at deterring boaters from approaching the habitat island, while Alternative A would be the least effective, as smaller boats could potentially float over the lower-profile buoys.
