MEMORANDUM

REGARDING 302 Loreto Street, Mountain View – *Secretary of the Interior's Standards for Rehabilitation* Analysis

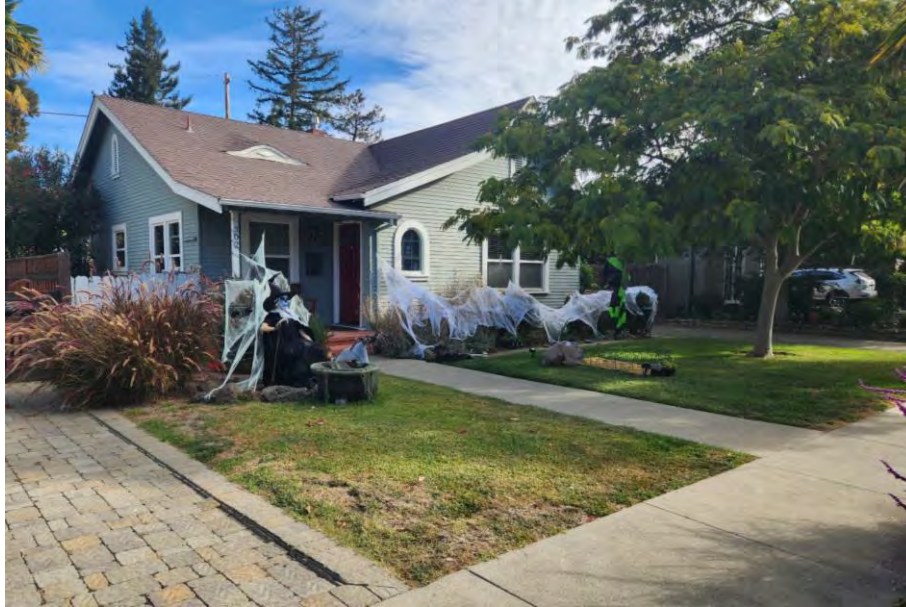
302 Loreto Street is located in Palmita Park between Anza Street and Calderon Avenue (**Figure 1**). The building is rectangular shaped in plan, set on a concrete foundation, and clad in wood lap siding

with exposed rafter tails and fascia boards. The residence is capped with a steeply pitched cross gable roof clad in asphalt shingles with a flared eave at the south (primary) façade. An eyebrow dormer is located over the integrated entrance porch at the west end of the primary façade.⁴ Arched wood-frame louvered vents are featured in all three gable ends. A brick chimney is located on the east façade. Typical windows are double-hung vinyl windows.

Figure 1. Residence at 302 Loreto Street, looking northeast.

The primary (south) façade features a concrete integral porch at the west (left) end. The Porch features a typical window on its south facing wall, and a wood panel door on its west (left) facing wall. East of the porch is an arched fixed replacement window and a set of two typical windows (**Figure 2**). An arched wood louver vent is featured in the gable end.

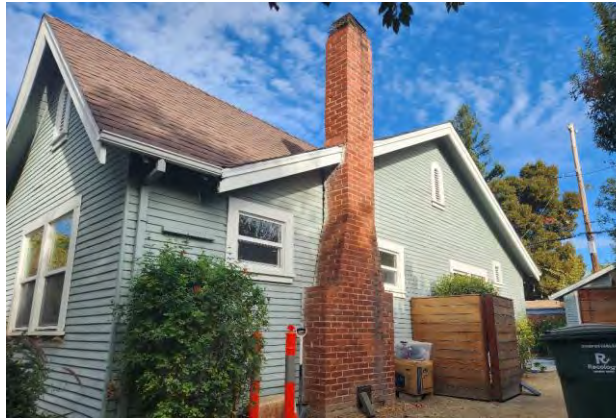
The east façade features, from south (left) to north (right), typical windows flanking an exterior brick chimney, a pair of replacement wood windows, and a square wood louver vent (**Figure 3**). An arched wood louver vent is featured in the gable end.

Figure 3. Oblique view of east façade, looking northwest.

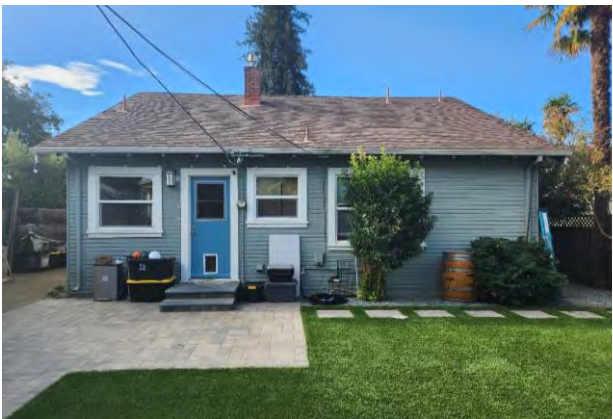
The rear (north) façade features a partially glazed wood door flanked by typical windows to the east (left), and a pair of typical windows to the west (right) (**Figure 4**). The west façade features a pair of typical windows at the north (left) and south (right) ends, and a single typical window centered underneath the arched wood louver vent in the gable end (**Figure 5**).

Figure 4. View of the rear façade, looking south.

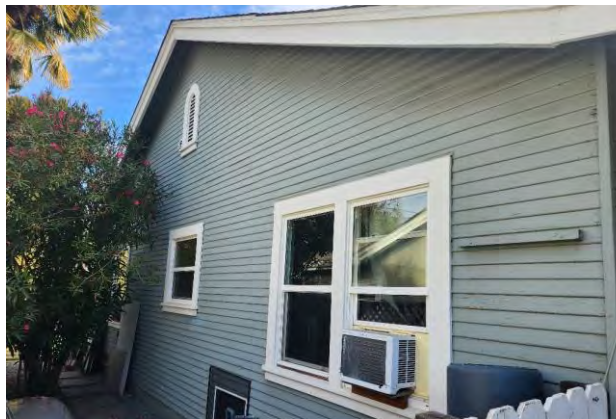
Figure 5. Oblique view of the west façade, looking northeast.

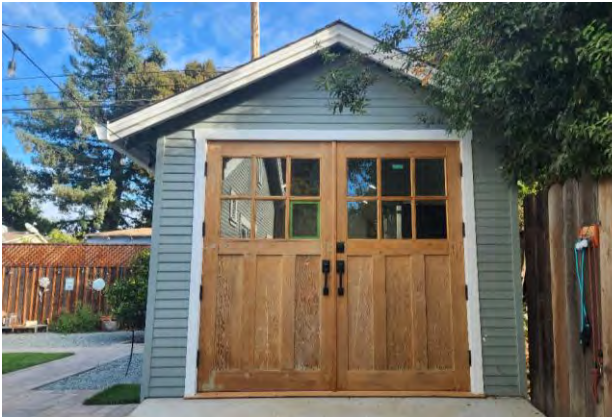
A gravel driveway along the east side of the property to a rear detached garage (**Figure 6**). The rear yard features gravel, a lawn, and tile pavers that connect the rear entrance, driveway, and surround the lawn area (**Figure 7**).

Figure 6. Detached garage, looking north.

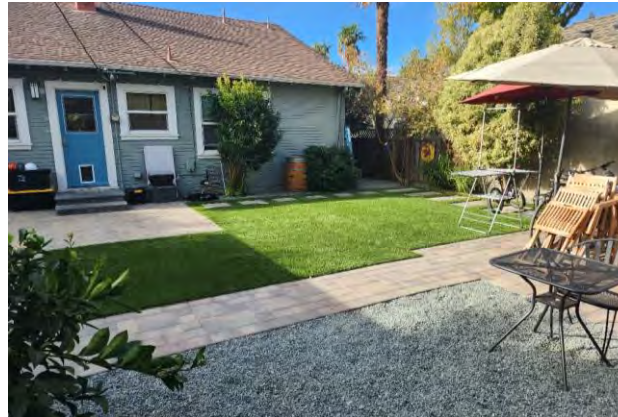
Figure 7. Rear yard, looking southwest.

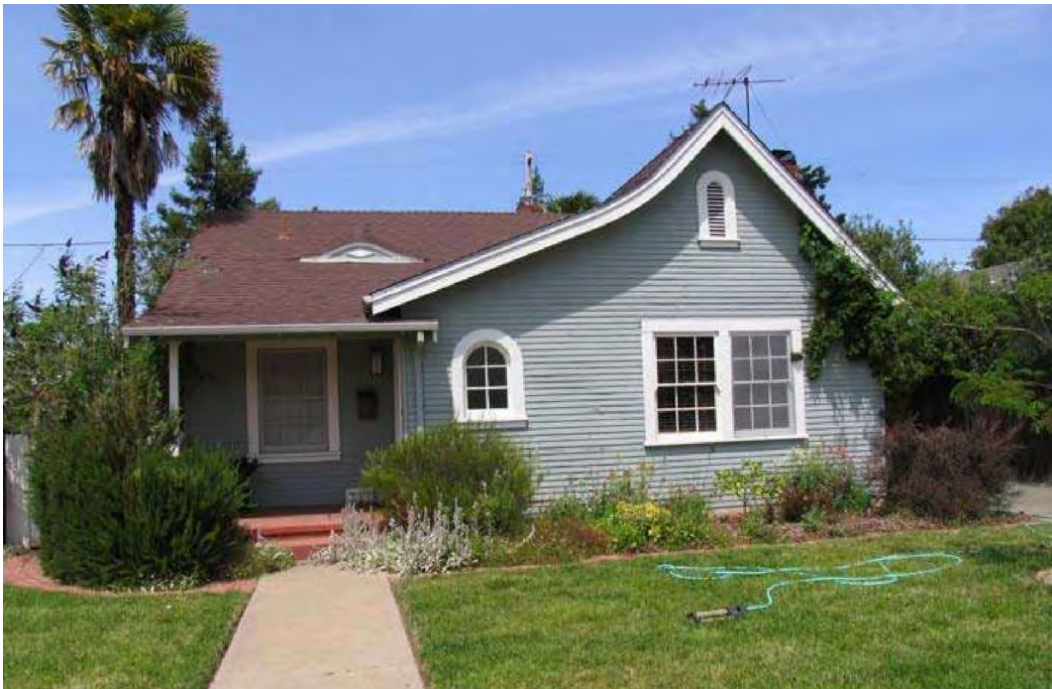
Figure 9. Photograph of 302 Loreto Street, May 25, 2007. Source: Carey & Co.

The residence and detached garage were both constructed in 1927 by the Minton Company, a local developer. The building was originally purchased by John J. Clancy in April of 1927, shortly before its completion.⁵ However, eleven months later the property was transferred back to the Minton Company. A *Mountain View Register Leader* article from 1930 lists the property for sale by the Minton Company again and includes a photograph and a brief description of the property (**Figure 8**). The 2007 Carey & Co. DPR shows what appear to be the original windows on the primary façade, while the original wood shutters had been removed (**Figure 9**).

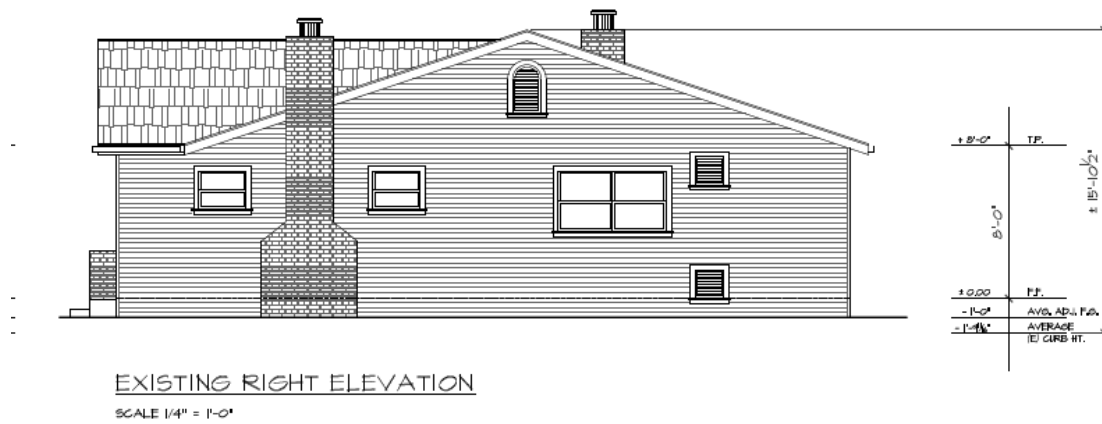
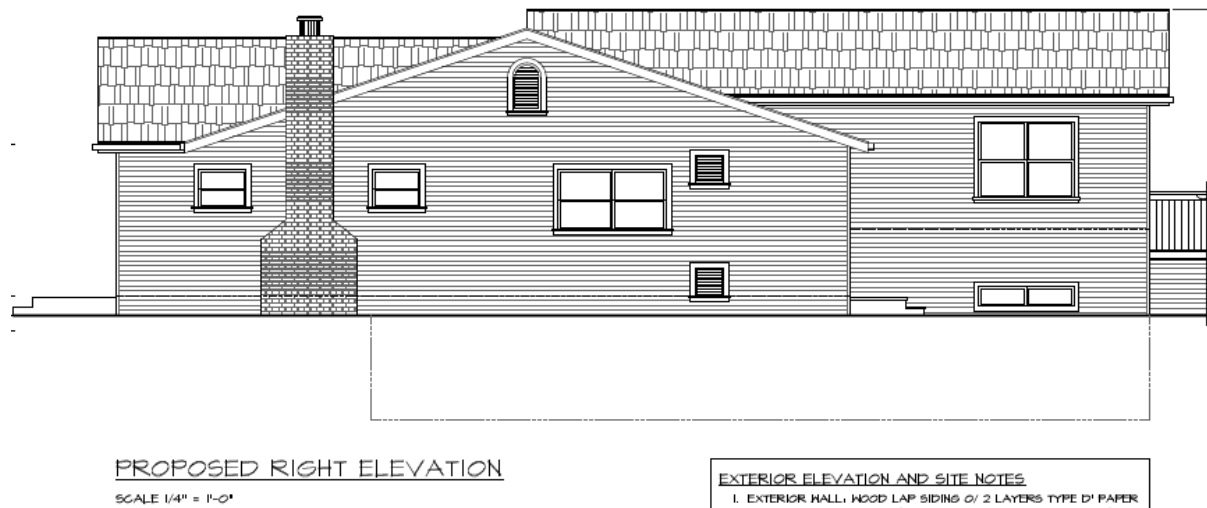
Figure 13. East (right) elevations, showing the proposed addition, removed brick sidewall, and removed internal chimney. Source: "Single Family House", by Better Built Builders, (February 2, 2025), Sheet A-7.

February 2, 2025 (included in the **Appendix B** of this memorandum). The proposed project includes the following alterations (**Figure 10 through Figure 13**):

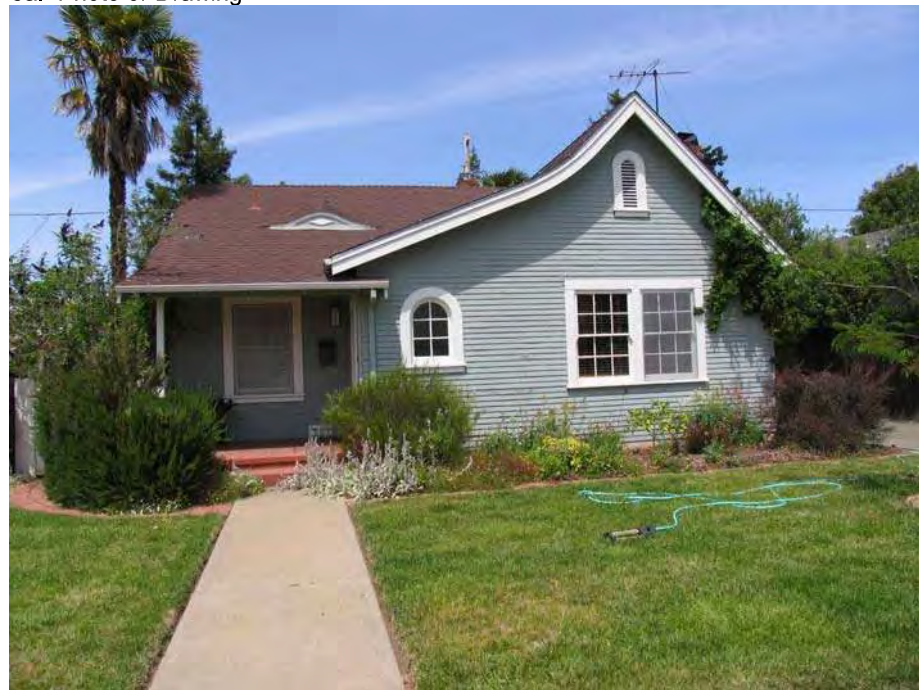
P5b. Description of Photo:
View of the southwest façade; May
25, 2007

This one-story, single-family residence combines Colonial and Tudor Revival elements and is situated on a flat parcel with grass, trees, and small plantings. The house is rectangular in plan and features an asymmetrical, asphalt-shingle-clad, cross-gable roof, with an arched, louvered vent in the front gable and an eyebrow dormer on the projecting cross gable. The building also has a wide eave overhang. Horizontal wood boards clad the structure, which features six-over-six, wood-sash, double-hung windows with lamb's tongues as well as an arched, multi-light, wood-sash window. A simple wood post supports the small front porch.
