December 3rd, 2018

Arborist Report

Andy Martin
1187 High School Street
Mountain View CA 94041
650-575-6076

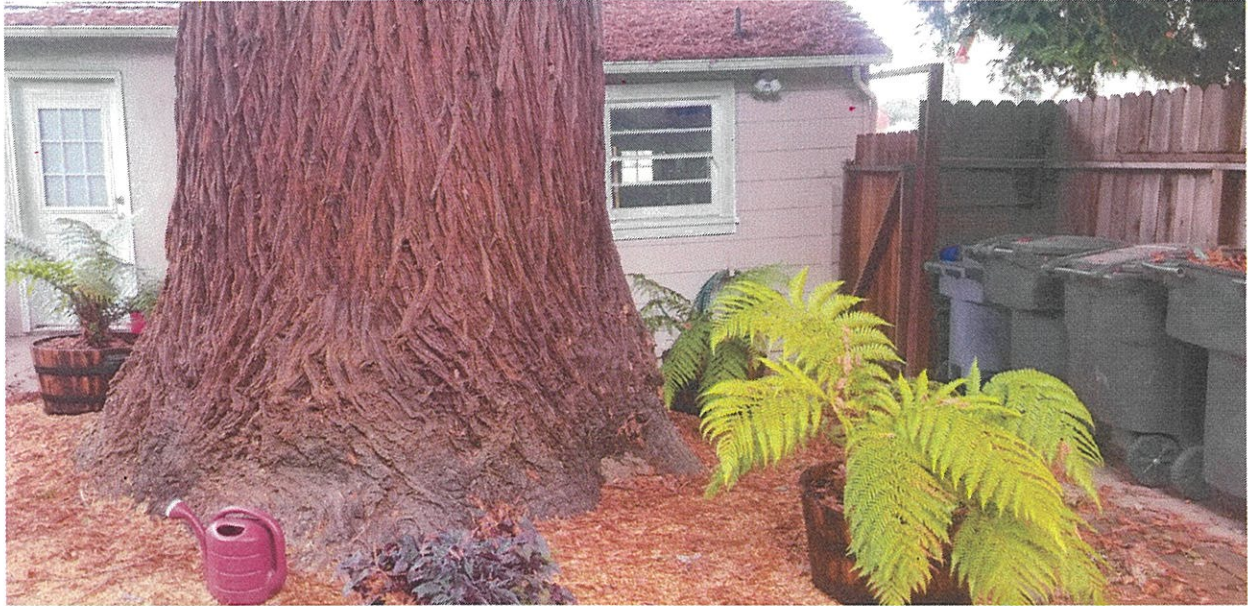
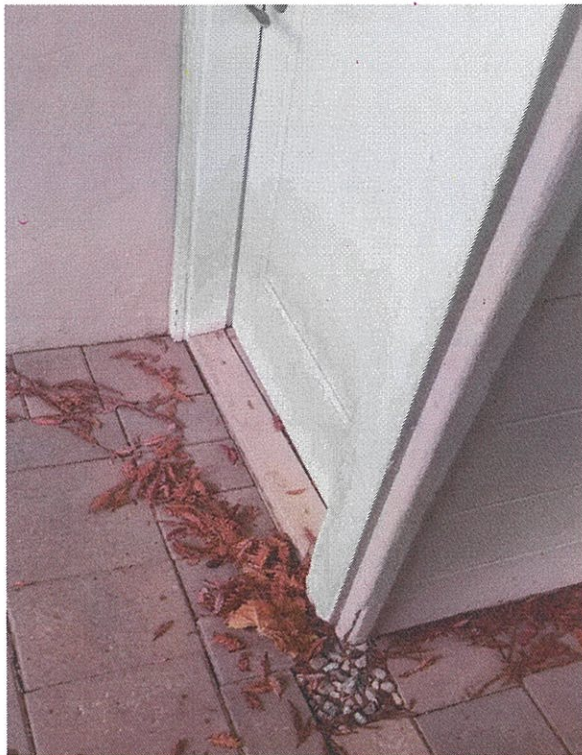
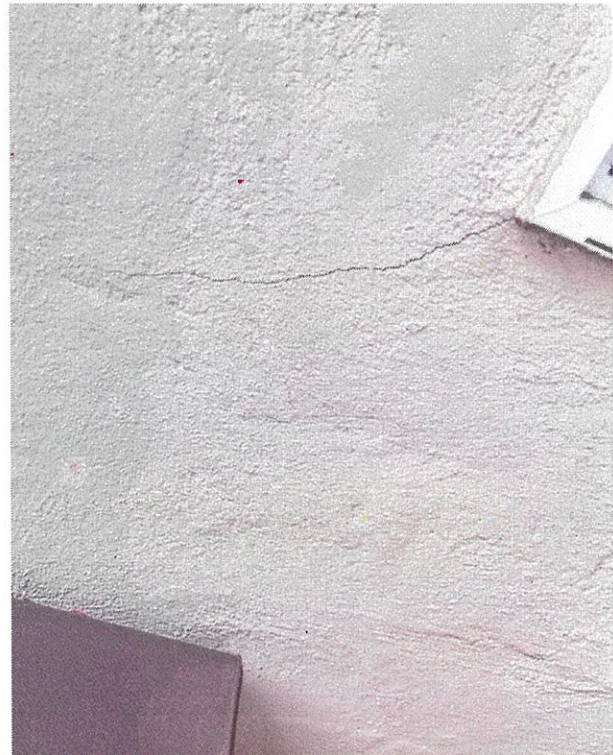
The Coast Redwood Tree it was planted many years back at the wrong spot where now is causing several damages to the property. With this tree we cannot due any root pruning due of the size and their age to install a root barrier; that type of technique will only make more hazardous the tree because by cutting that size of roots it will cause several damages to the root system because roots support the tree and absorb water.

- Remove the tree and stump to prevent any more future damages to the property
- After the removal; plant a new 48" inch box tree far away from the house to comply with the City of Mountain View conditions and regulations
- Trees to replant: Coast Live Oak, Valley Oak or Deodar Cedar Trees
- Hire a professional tree trimming company that employs a Certified Arborist and Contractor Licensed
