## Kielty Arborist Services

April 13<sup>th</sup>, 2021  
773 Cuesta LLC  
C/O DeNardi Wang Homes  
Attn: Mr. Kevin DeNardi  
4962 El Camino Real, Suite 223  
Los Altos, CA 94022

Site: 773 Cuesta, Mountain View, CA

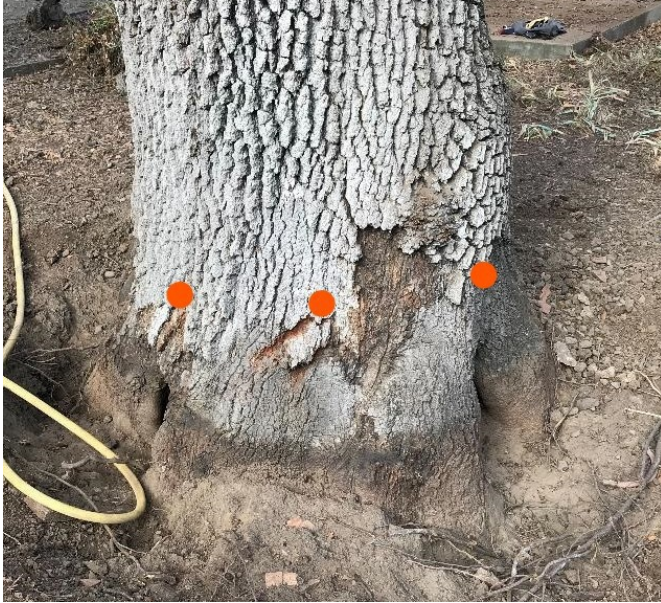
Once excavating around the root crown was completed, I was able to reach the inside of the tree through the decay pockets using my hands. Using my hands, I was able to reach at least a foot into the trunk of the tree where I encountered rotting wood. The wood was wet to the touch and easily removed. The feel of the wood was spongy. Within the inner wood removed by hand, mycelium was observed between the wood fibers. All these findings have resulted in the conclusion that the tree is infected with *Armillaria*, an oak root fungus disease.

**Showing sponge like wood inside of tree**

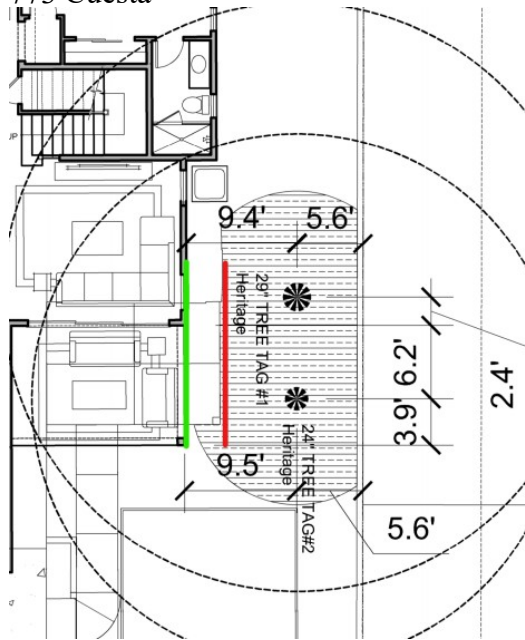
All hardscapes below the tree dripline shall be built up on top of grade where possible. The small decks at the back of the property are recommended to be supported above ground by individual piers with no continuous grade beam. Impacts are expected to be minor.
