EXISTING CONDITION ASSESSMENT

400 MOFFETT BLVD
MOUNTAIN VIEW, CA

August 2, 2023 ; Revised September 27, 2023

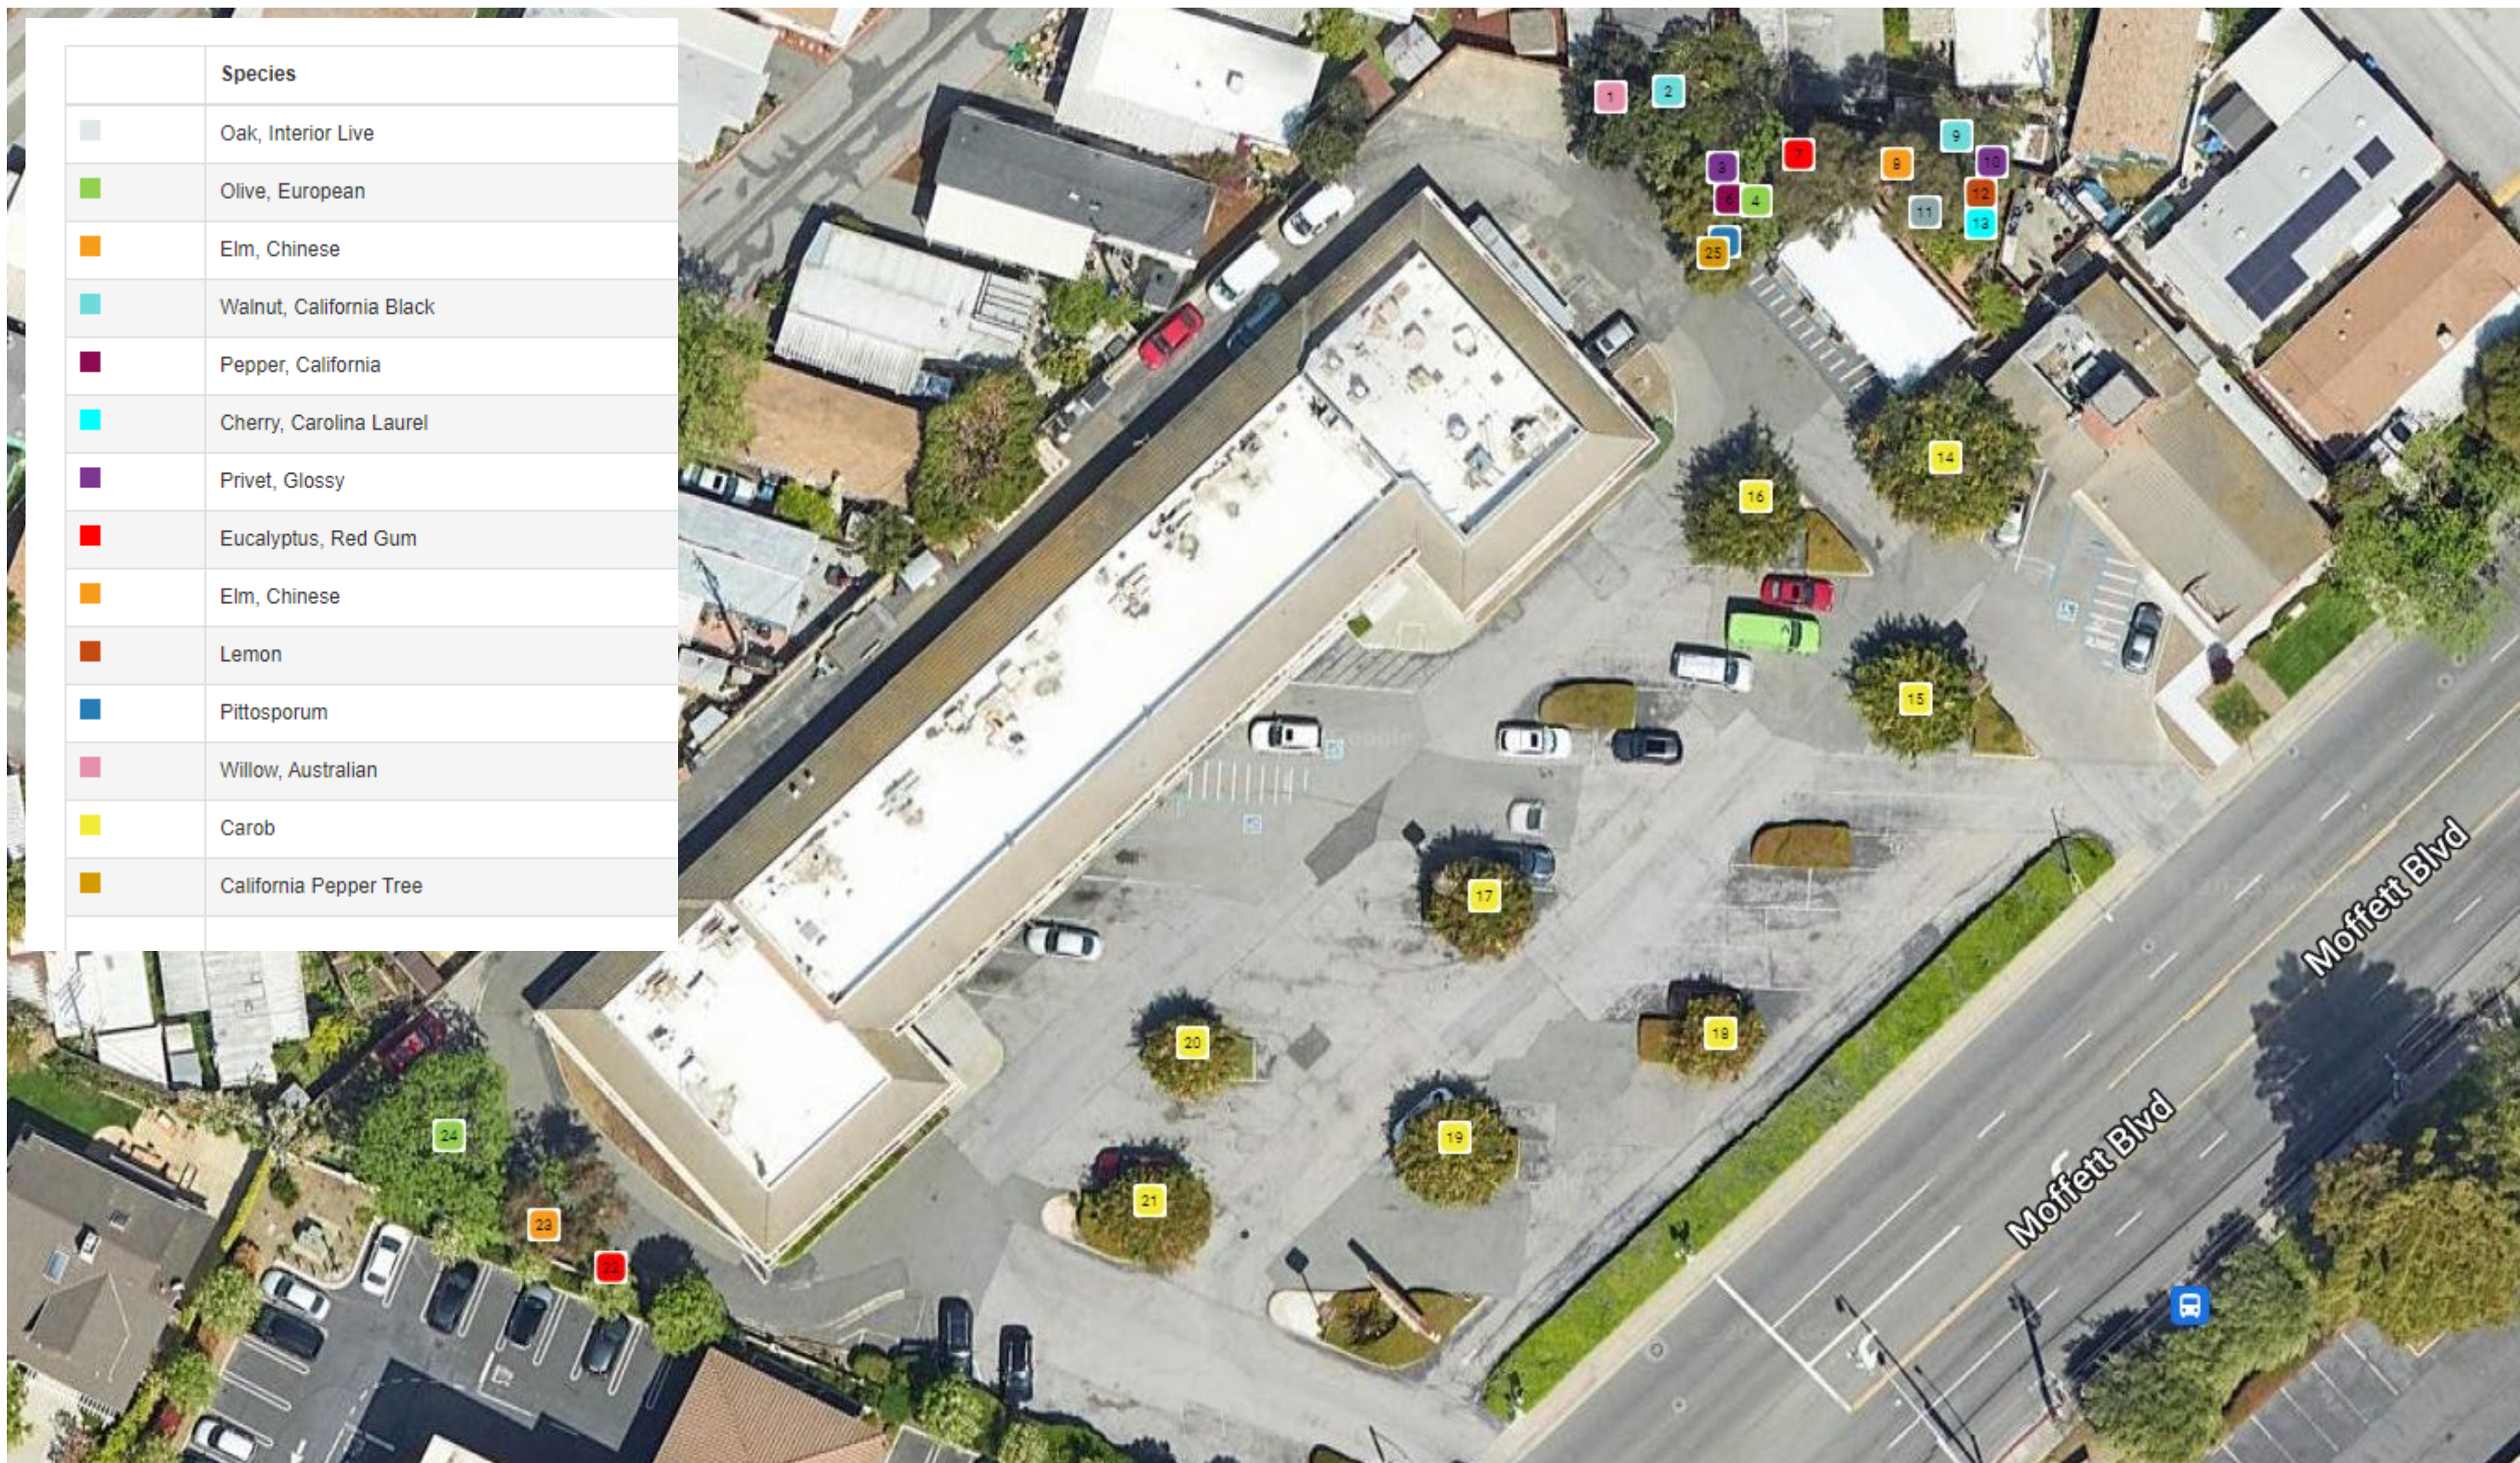
Figure 2 - Proposed footprint of new development.

All twenty-five trees found on the property will be impacted by the proposed development (Appendix - Figure 2). It is assumed, based upon tree location and footprint of proposed development, that none of these trees are suitable for preservation.

The tree locations are in direct conflict with the proposed site plan. Tree locations are located in Figure 3 and 4 in the Appendix. Of the trees that are on the border of the property and appear to fall within the green zone highlighted in Figure 2, only tree #4 (California black walnut), and tree #6 (Carolina Cherry Laurel) have a condition better than fair. Both are in good condition. Both trees additionally would be subject to significant impact from construction activity, with a reduced life cycle.
